Technical Service Bulletin

Transaction No.: **2022583/1**

48 Power steering is noisy

Release date: Jan 19, 2010

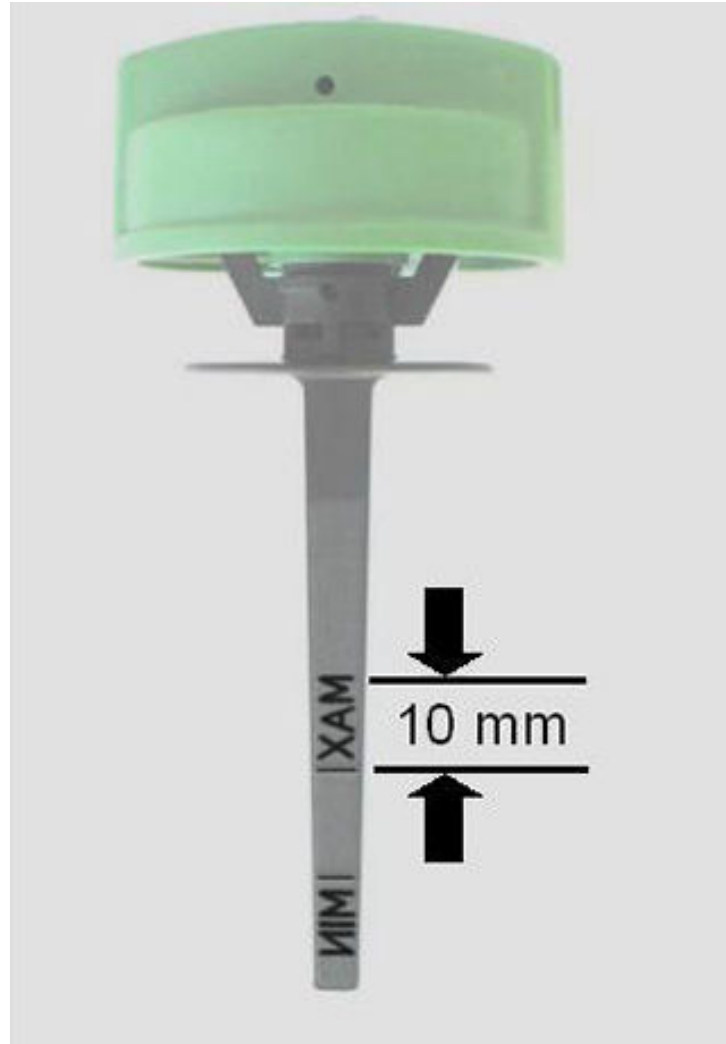
- If the power steering fluid is below the minimum mark during cold conditions, air may be drawn into the power steering pump.
- If system components were replaced or disconnected, system filling or bleeding procedures may not have been carried out properly.

Figure 1. The fluid level must be 10 mm above MAX level when the engine is warm.

9. If the fluid level is below the MIN mark (engine hot or cold), there is a chance that air has entered the system. Follow these steps in order to eliminate any air trapped in the system:
 - a. Test drive vehicle to warm up the fluid.
 - b. Park vehicle. Switch ignition off and let vehicle sit for 1 minute.
 - c. After 1 minute, open fluid reservoir and inspect for air bubbles.
 - If air bubbles are not present, no air is in the system. Air is not causing the noise. Check other system components.
 - If air bubbles are present:
 - i. Allow vehicle to sit for at least 2 hours.

- ii. Check fluid level and add fluid as necessary.
- iii. Perform test drive to ensure noise has been eliminated.
- iv. It may be necessary to repeat this procedure more than once.
