**Technical Service Bulletin**Transaction No.: **2016453/3**

40 Clacking noise from front upper suspension or bushings torn (B6)

Release date: Jul 15, 2010

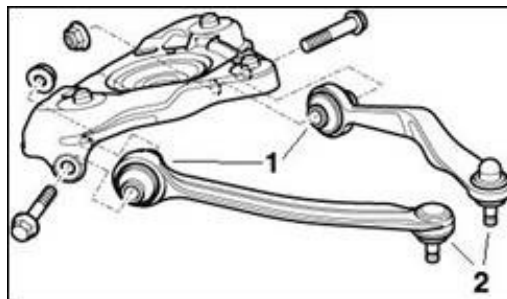
Visually inspect the front suspension upper link rubber bushing (Figure 1, 1) on all four upper links for damaged bushings. Confirm wear as shown in Figures 2-5:

**Figure 1.** Inner bushing (1).

If the rubber is clearly cracked (as shown in Figure 2) or the bushing insert is displaced (as shown in Figures 3 and 4), replace all four rubber bushings (Figure 1, 1) with part **8D0 407 515 C** on all upper links as per the *Upper Link Bushing Replacement* instructions

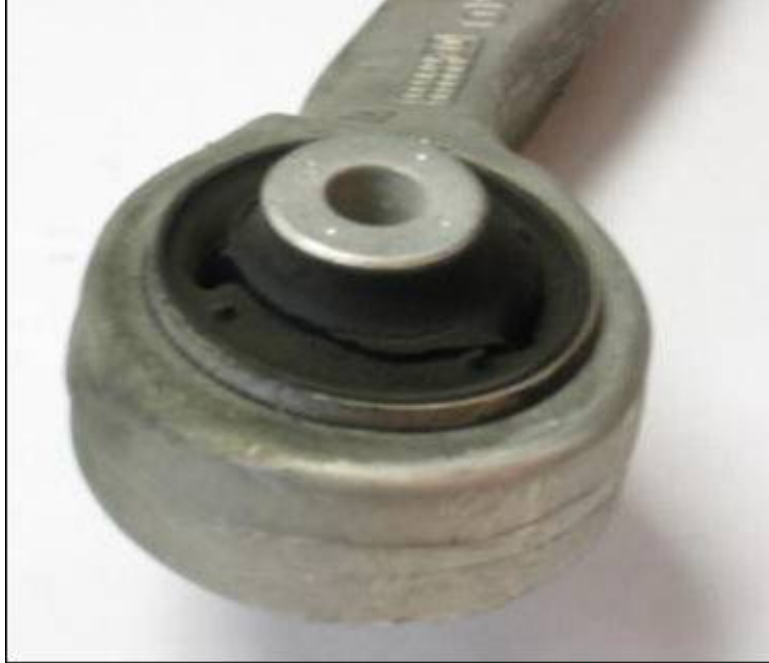
- The rubber is clearly cracked, as in Figure 2.

**Figure 2.** A bushing with cracked rubber.

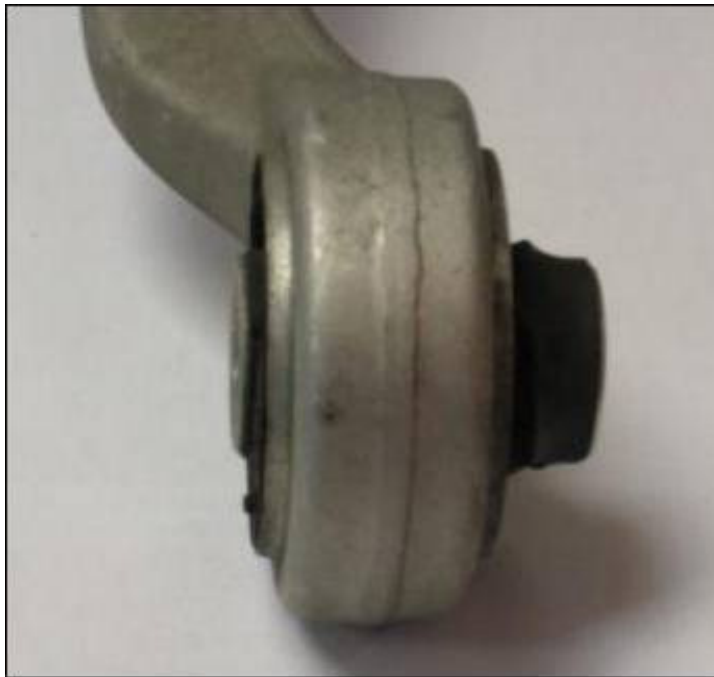
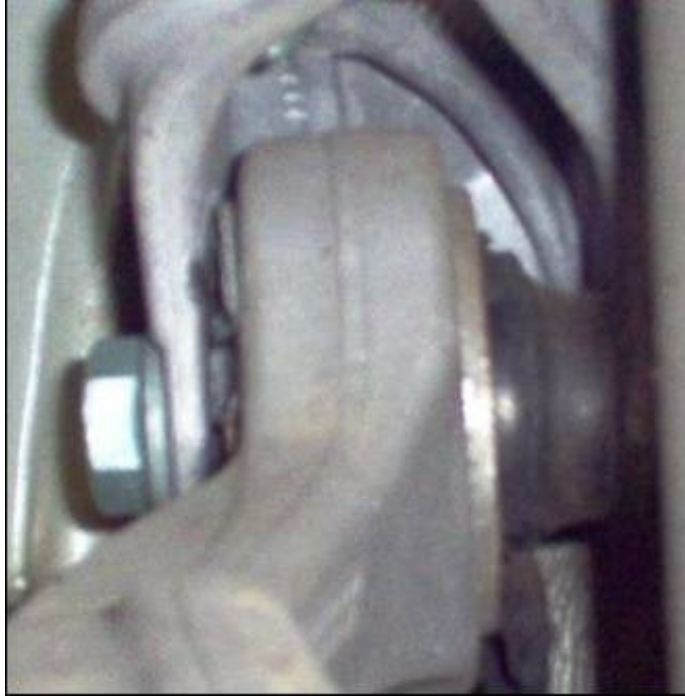
- The bushing insert is displaced due to a complete rip in the bushing, as shown in Figures 3 and 4.

**Figure 3.** A bushing with a displaced insert.

**Figure 4.** A bushing with a displaced insert, shown installed in the vehicle.

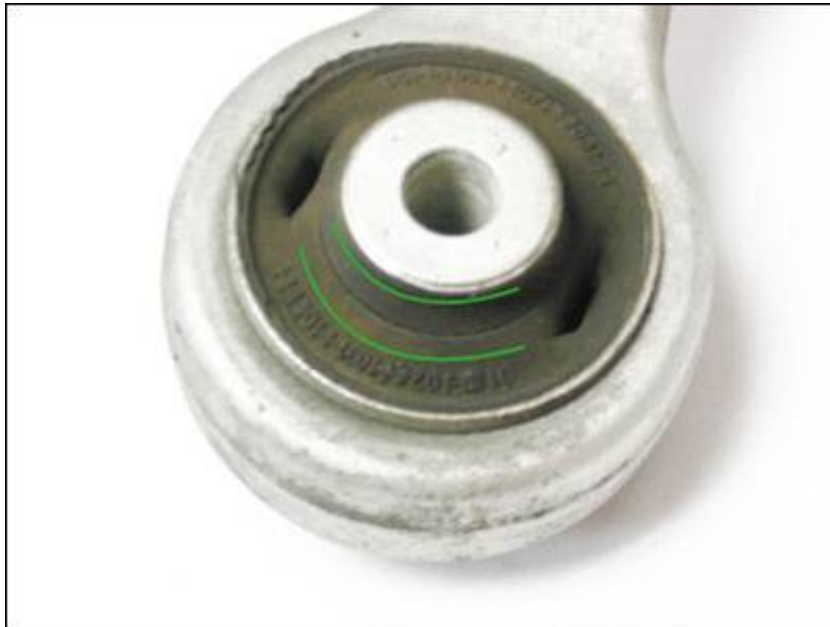
- The bushing insert has a hairline crack in the surface, as shown between the green lines in Figure 5.

**Figure 5.** A bushing with a hairline crack. This is an acceptable amount of wear.

*A hairline crack in the surface (as shown in Figure 5) does not require the bushing to be replaced.*

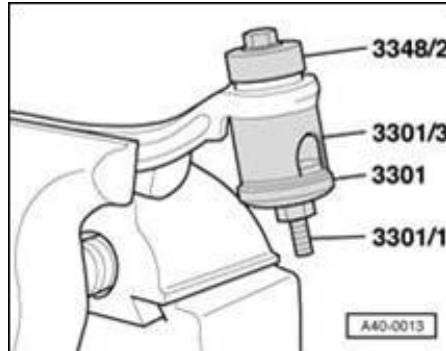
**Figure 6.** Proper assembly of tools 3348 and 3301 for bushing removal.

2. Once the links are removed from the vehicle, hold the link in a vice with protective jaw covers. Assemble the 3348 and 3301 tools as shown in Figure 6, and tighten nut until the bushing is pressed out.

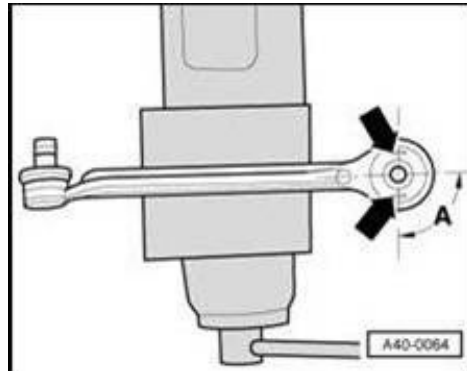
**Figure 7.** Proper alignment of the bushing. Angle A *must* be  $90^{\circ} \pm 1^{\circ}$

**!** **Note:** Improper alignment of the bushing may cause premature wear and failure of this bushing.

3. Place and align the new bushing in the link as shown in Figure 7 with the cutouts (see arrows) placed and aligned in the link according to Angle A. This angle *must* be  $90^{\circ} \pm 1^{\circ}$ .

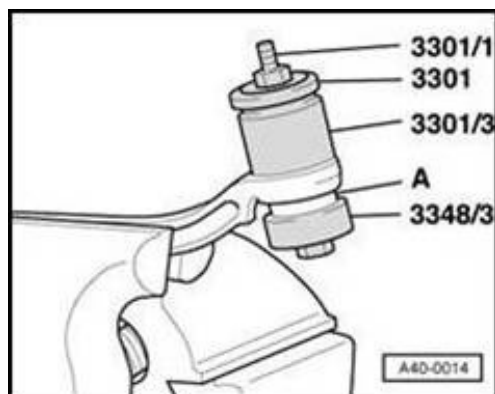
**Figure 8.** Proper assembly of tools 3348 and 3301 for bushing installation.

4. Press the bushing into place, assemble the 3348 and 3301 tools as shown in Figure

8 and tighten the nut until the bushing is pressed into place.
