Technical Service Handbook (HST)

Technical Service Bulletin

Transaction No.: **2030465/10**

91 MMI 3G+ MMI inop; blank screen at startup; various technical issues (K0942 ZUG update; supersedes K0814 update)

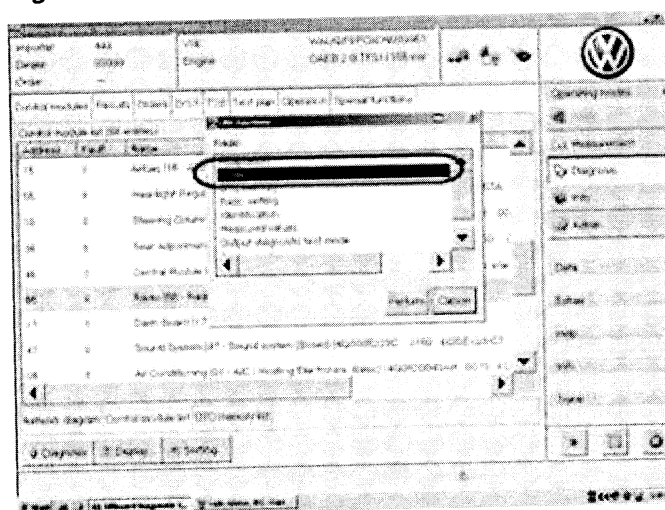
Figure 3. Code radio option.

- Select **Code** (Figure 3).

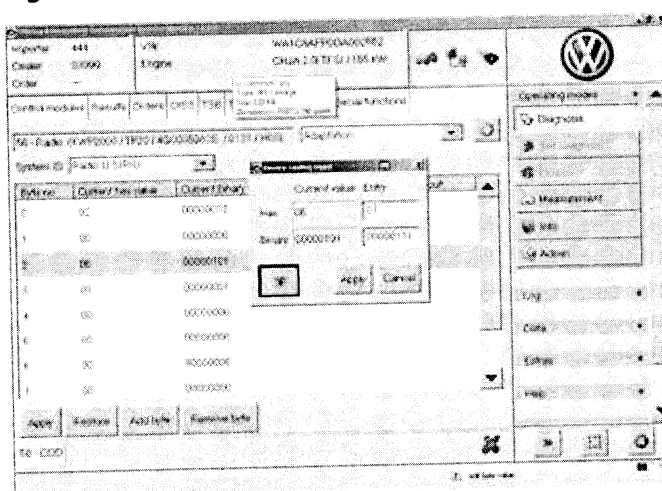
Figure 4. Changed radio coding.

- Verify the coding in byte 2 is HEX 07.

- If it is not HEX 07, change the coding to HEX 07. Apply changes (Figure 4).

- If the coding had to be changed, perform a 3-finger reset on the MMI system. When the coding is successful, the HD radio options will show in the Band settings on the MMI.
