Model description: **A6 Sal. qu. 3.0 V6228 A8**

Technical Service Bulletin

Transaction No.: **2044717/2**

87 Faint noise heard in cabin from air conditioning circuit

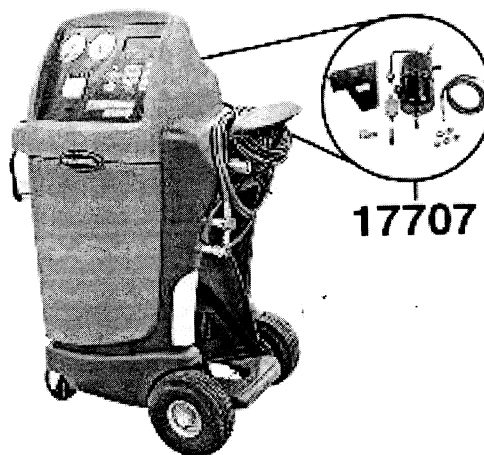
Figure 1. A/C flushing unit.

Perform a complete recovery and flush of the air conditioning refrigerant circuit (Figure 1 and Figure 2).

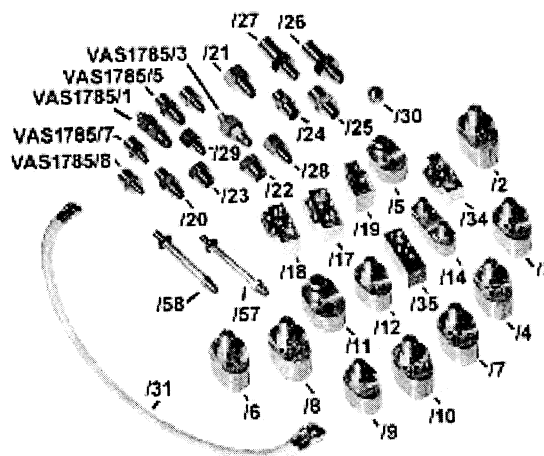
Figure 2. Flushing fitting set.

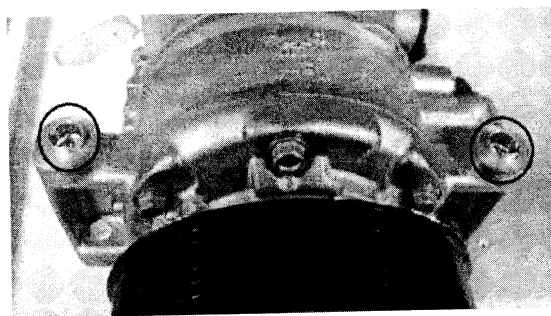
Figure 3. Mounting bolt centering sleeves on the air conditioning compressor housing.

It is imperative that the compressor mounting bolt centering sleeves be reinstalled with the compressor (Figure 3). Failure to reinstall these sleeves will result in compressor failure (as well as possible engine and/or ancillary component damage) in a short period of time. If any sleeves were misplaced during the removal and reinstallation process, new sleeves should be ordered and installed on the compressor housing before reassembly. Compressor or consequential component damage resulting from a failure to install the centering sleeves will not be accepted under warranty.

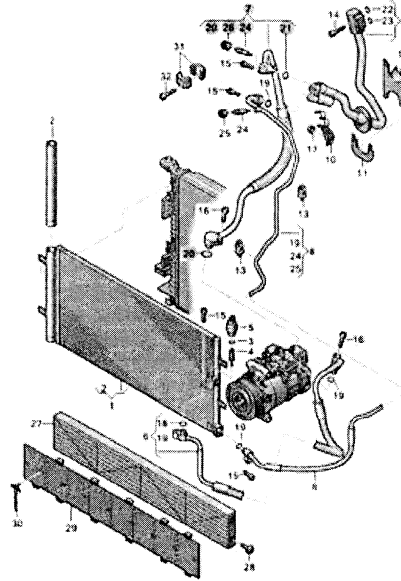
Figure 4. Low side line to be replaced.

- Replace the low side refrigerant line that connects the air conditioning compressor suction port to the hybrid refrigerant line to the expansion valve (Figure 4). Be certain to use new O-rings at these and all refrigerant circuit joints that are disconnected.

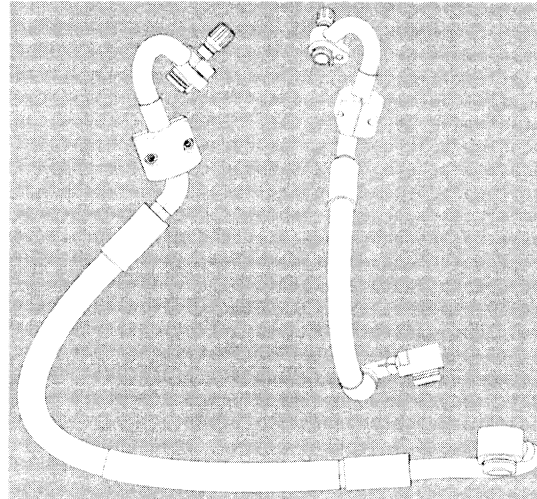
Figure 5. Balance weight position on low side line.

4. Install the balance weight (part number 4G0513621A) to the line in the position shown in the illustration (Figure 5).
