Technical Service Bulletin

15 Oil leak and/or camshaft DTCs stored - 3.0L

15 08 09 2005587/6 November 7, 2008. Supersedes Technical Service Bulletin Group 15 number 08-08 dated 2005587/5 for reasons listed below.

Model(s)	Year	VIN Range	Vehicle-Specific Equipment
A4	2002 – 2005	All	3.0L V6 Engine
A4 Cabriolet	2003 – 2006	All	
A6	2002 – 2004	All

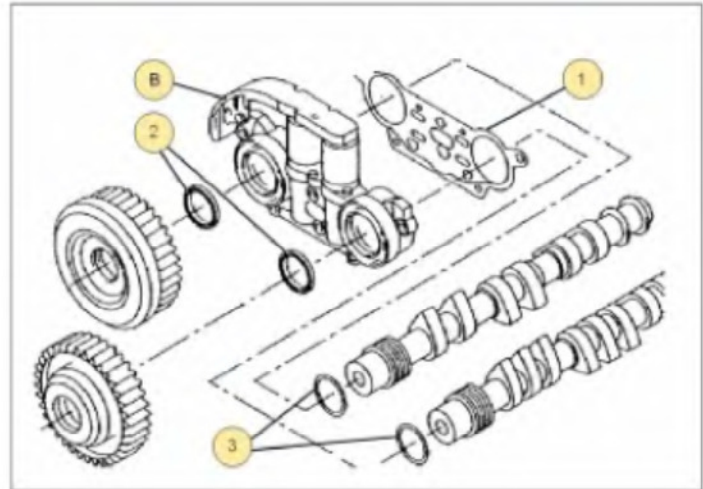
Gaskets and/or sealing rings of camshaft adjusters and/or timing case might be leaking.

Figure 2. The gasket (1), camshaft adjustment housing (B), camshaft sealing rings (2) and O-rings (3).

- a. Do not replace the camshaft adjusters (Figure 1, A) or camshaft adjustment housings (Figure 1, B)
- b. Replace gasket (Figure 2, 1) and O-rings (Figure 2, 3) between camshaft adjustment housing (Figure 2, B) and cylinder head.

Replace both camshaft sealing rings (Figure 2, 2) (See Repair Manual, Group 15, "Camshaft and camshaft adjusters, removing and installing")
