# Technical Service Bulletin

15 Oil leak and/or camshaft DTCs stored - 3.0L

15 08 09 2005587/6 November 7, 2008. Supersedes Technical Service Bulletin Group 15 number 08-08 dated 2005587/5 for reasons listed below.

Model(s)	Year	VIN Range	Vehicle-Specific Equipment
A4	2002 – 2005	All	3.0L V6 Engine
A4 Cabriolet	2003 – 2006	All	
A6	2002 – 2004	All

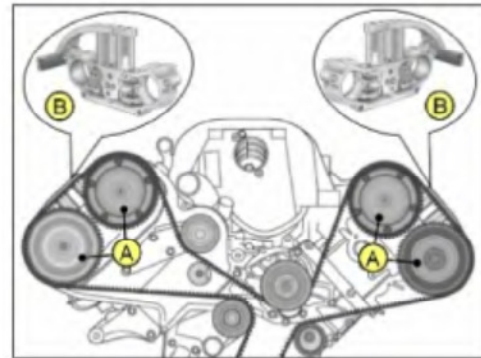
1. Check for a DTC for a camshaft position sensor (P0340 - P0348, P0365, P0368, P0390 - P0393).  
Do not replace the camshaft adjusters (A) or the camshaft adjustment housings (B) if any camshaft position sensor DTC is present.

Figure 1. The camshaft adjusters (A) and camshaft adjustment housings (B).

1. Do not replace the camshaft adjusters (Figure 1, A) or camshaft adjustment housings (Figure 1, B) because of these DTCs.
2. Follow Guided Fault Finding test plan for diagnosis.
3. Erase the DTC memory. These DTCs only occur during the break-in period of the cylinder head and are not causing the MIL.
4. Check for sufficient oil pressure. If the oil pressure is too low, also check for oil leaks from/around the camshaft adjusters.

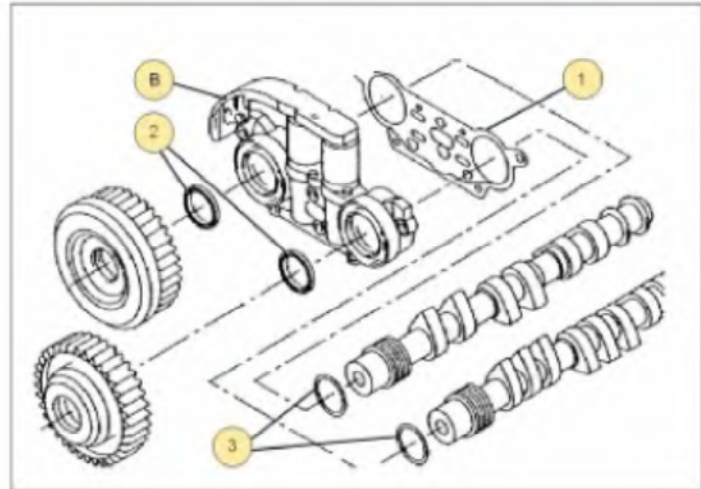
Gaskets and/or sealing rings of camshaft adjusters and/or timing case might be leaking.

Figure 2. The gasket (1), camshaft adjustment housing (B), camshaft sealing rings (2) and O-rings (3).

- a. Do not replace the camshaft adjusters (Figure 1, A) or camshaft adjustment housings (Figure 1, B)
- b. Replace gasket (Figure 2, 1) and O-rings (Figure 2, 3) between camshaft adjustment housing (Figure 2, B) and cylinder head.

Replace both camshaft sealing rings (Figure 2, 2) (See Repair Manual, Group 15, "Camshaft and camshaft adjusters, removing and installing")

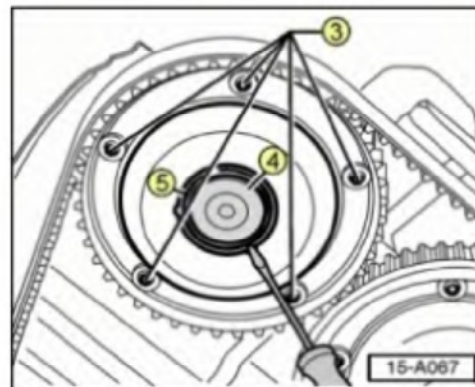
The internal bolts of camshaft adjuster(s) might have a reduced torque.

Figure 3. The outer bolts (3), caps (4), and O-Rings (5).

1. Retorque all five outer bolts (Figure 3, 3) on all four camshaft adjusters to 15 Nm. (The bolt heads are located on the back side of the camshaft adjuster gears.)
2. Replace missing or damaged bolts (part number WHT 003 121).
3. Replace caps (Figure 3, 4) and O-Rings (Figure 3, 5) and secure with securing ring (See Repair Manual, Group 15, "Camshaft and camshaft adjusters, removing and installing.")
4. Reassemble removed components and complete the repair.
