**AIR CONDITIONING INOPERATIVE****TECHNICAL SERVICE BULLETIN**

Reference Number(s): GROUP 87, NO. 10-05 (2020124/3), Date of Issue: August 24, 2010

AUDI: A4 2009 - 2011; A5, S5 2008 - 2011; A5 Cabriolet 2010 - 2011; A6 2005 - 2011; A8 2004 - 2010

**SUBJECT****Air conditioning inoperative**

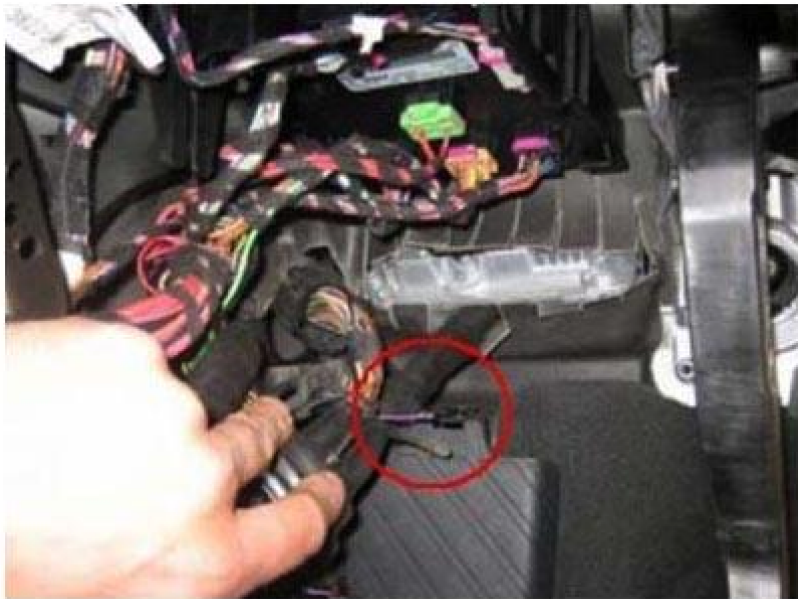
There are two known sections in the wiring harness that can be affected, but the potentially affected areas are not limited to these two known sections. One of the known sections is in the driver's footwell area where the wire harness enters the interior of the car from the engine bay (**Fig. 1**).

**Fig. 1: Wire Harness In Driver Footwell Area**

6. If a cut wire is found, then install an overlay wire for the LIN bus signal. Do not attempt to repair the existing wire harness.
  - a. Route the new LIN bus wire so that it enters the interior of the vehicle through the driver's side fender/lower A-pillar area through the grommet indicated in **Fig. 3** and **Fig. 4**.

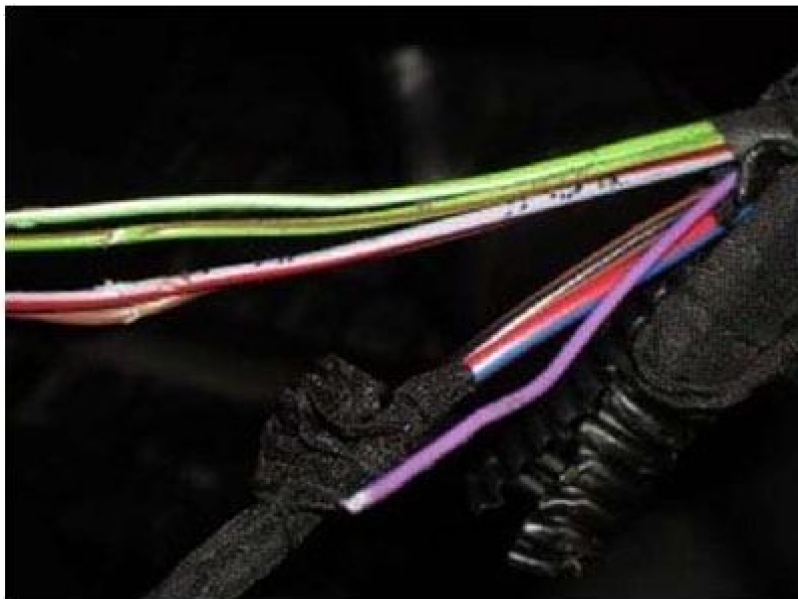
The second known section is in the wire harness located under the driver's side headlight (**Fig. 2**).

**Fig. 2: Wire Harness Under Driver's Side Headlight**

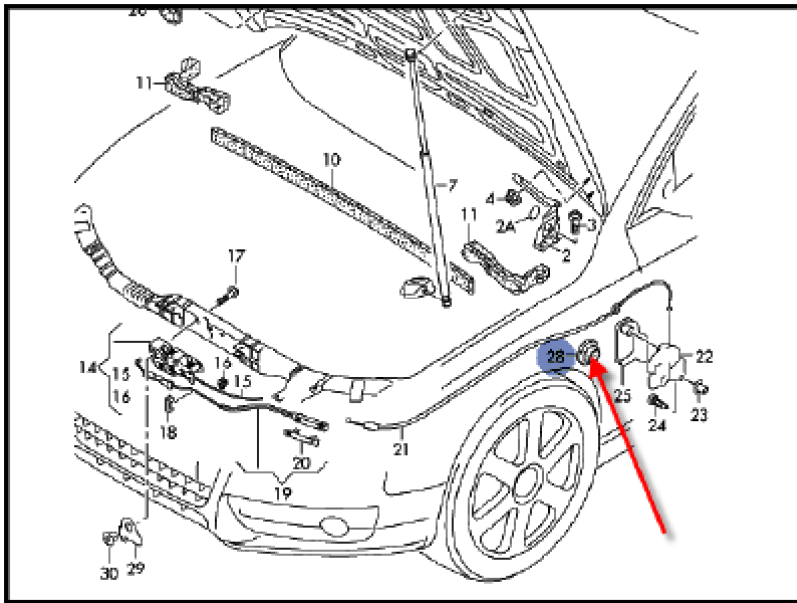
**Fig. 3: Grommet In Driver's Side Fender/Lower A-Pillar Area Used For Pass-Through For New Overlay Wire**

**Tip:** Do not route the wire through the same opening used by the existing wire harness.

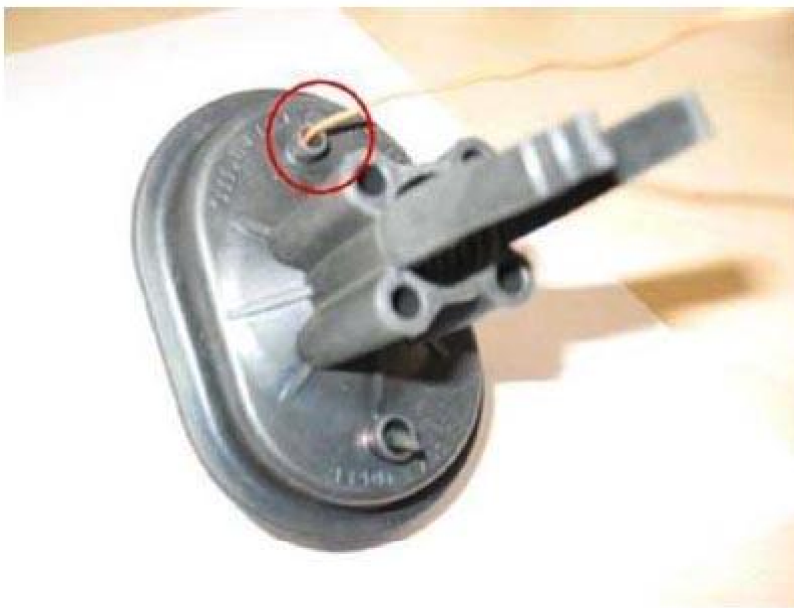
**Fig. 4: Seal Off Access Hole In Grommet With Butyl Sealant**

- b. Seal off the opening around the wire with Butyl sealant to prevent water intrusion.
