## Interior - Creaking Noises From The Dash Area

85 08 04

2017483/3

December 4, 2008.

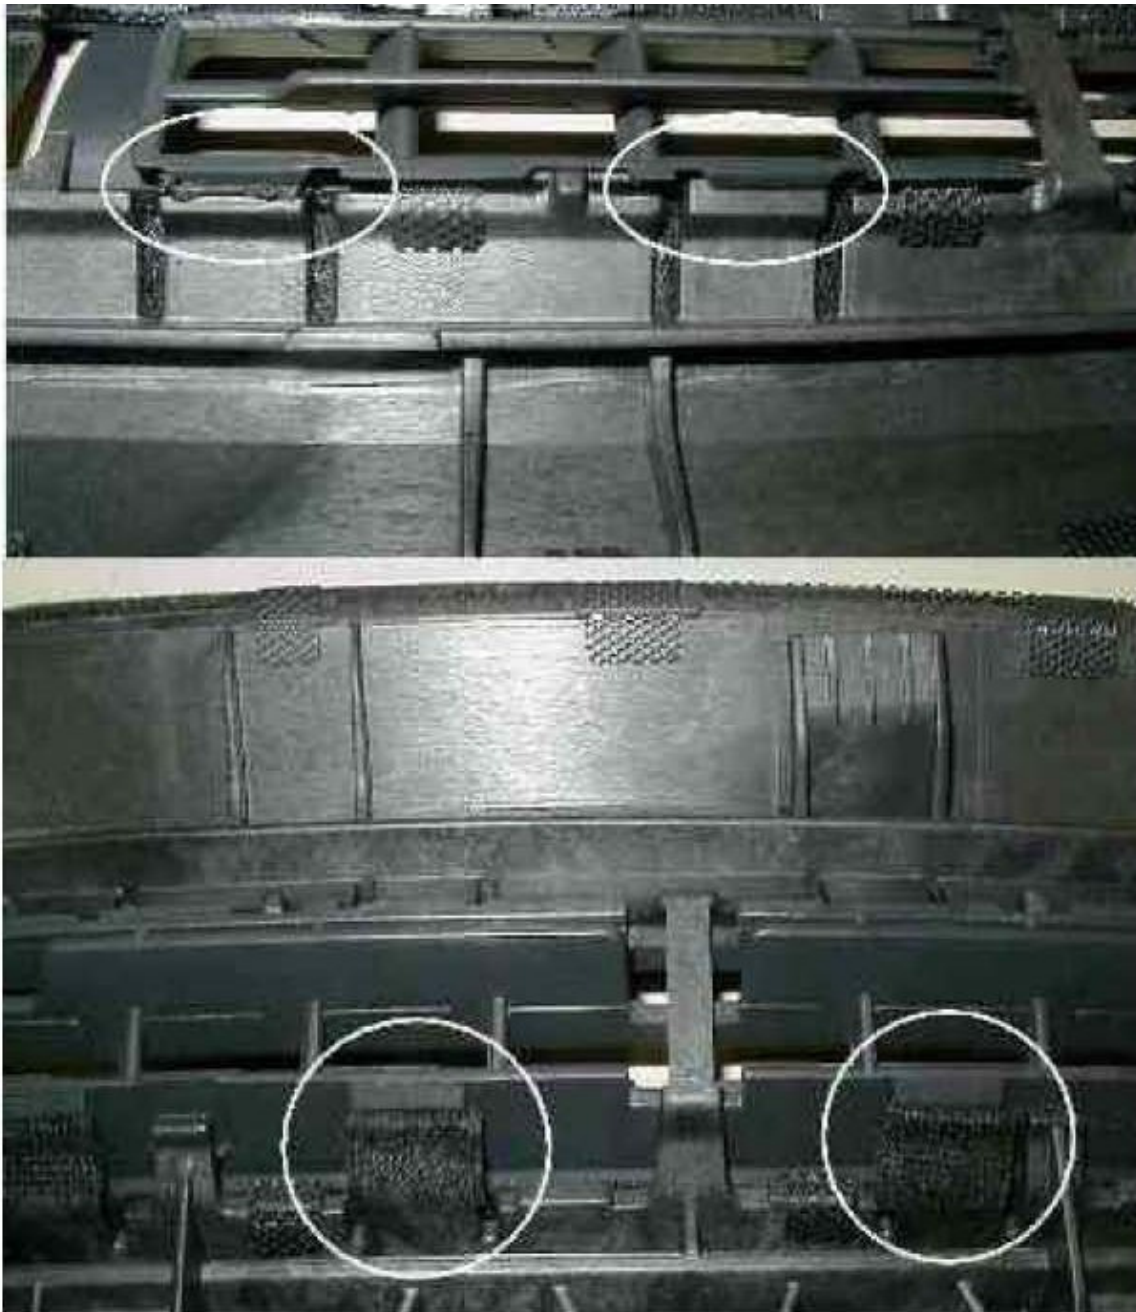
Figure 1

Condition 1: Creaking noises from the upper air (defrost) outlet in the instrument panel.

Condition 1: Defroster trim creaks due to poor air outlet fit in the instrument panel.

**Figure 1.** The defroster trim clips, plain (above) and wrapped with textile tape (below).

Wrap textile tape around all defroster trim clips (Figure 1).

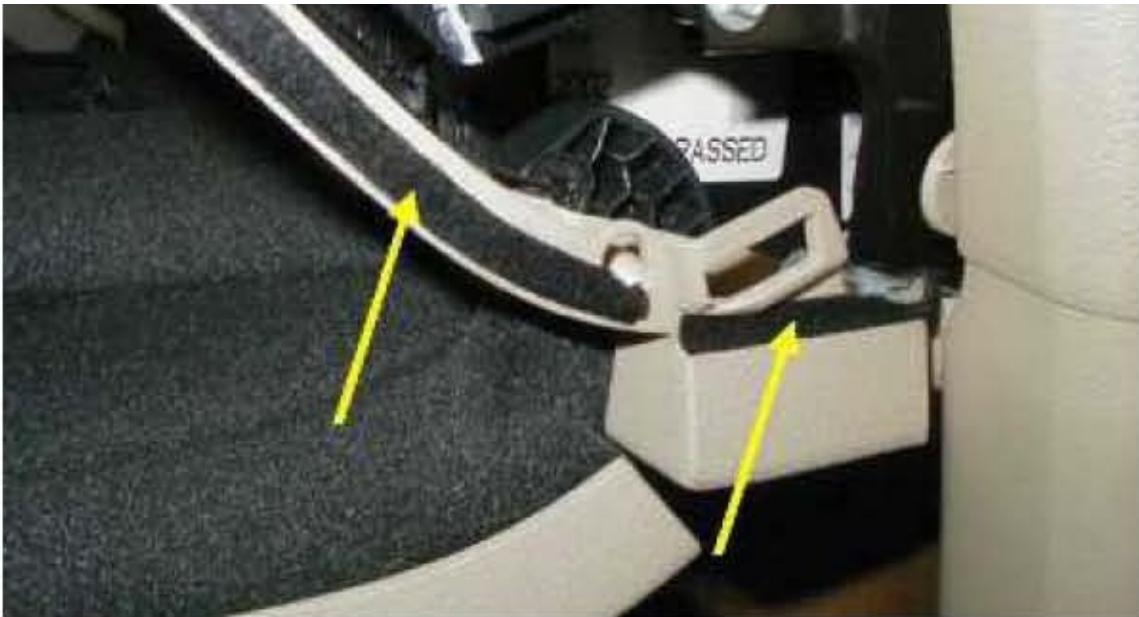
Figure 2

Condition 2: Creaking noises from the right side of the instrument panel cover area.

Condition 2: The right instrument panel cover contacts the glove compartment.

**Figure 2. Areas to apply felt.**

1. Check the position of the glove compartment and apply two pieces of felt material (533 867 910A) as shown in the illustration.
2. Spray the clips of the side cover with a Teflon based lubricant.

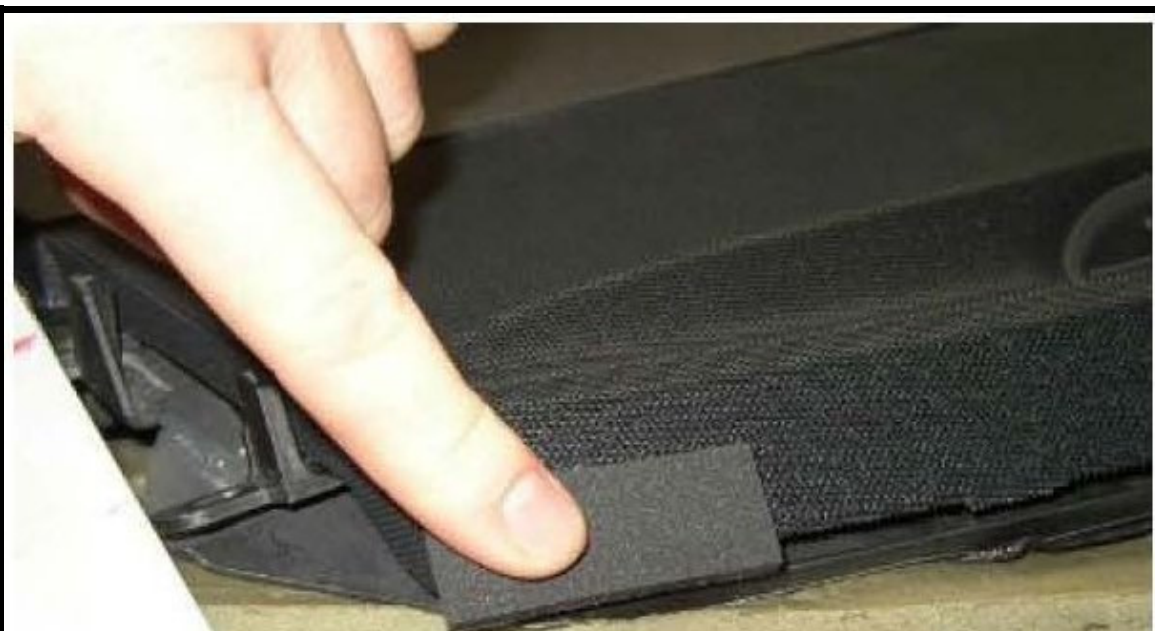
Figure 3

Condition 3: Creaking noises from the right side of the upper instrument panel area.

Condition 3: The instrument panel contacts the windshield.

**Figure 3.** Area to install foam block.

Install a foam block (20 x 50 x 6 mm , part number 443 201 365B), as shown in Figure 3.
