91 MMI High System software update (Zug 864 - update)  
procedure

Release date: Jul 31, 2009

This document describes the MMI System Software Update procedure (also called Zug Update procedure) for all MMI High-equipped models prior to model year 2009.

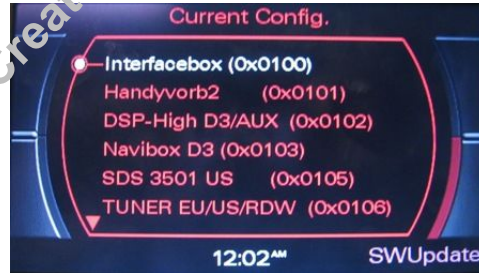
3. Select Interfacebox (0x0100) to verify its software version.

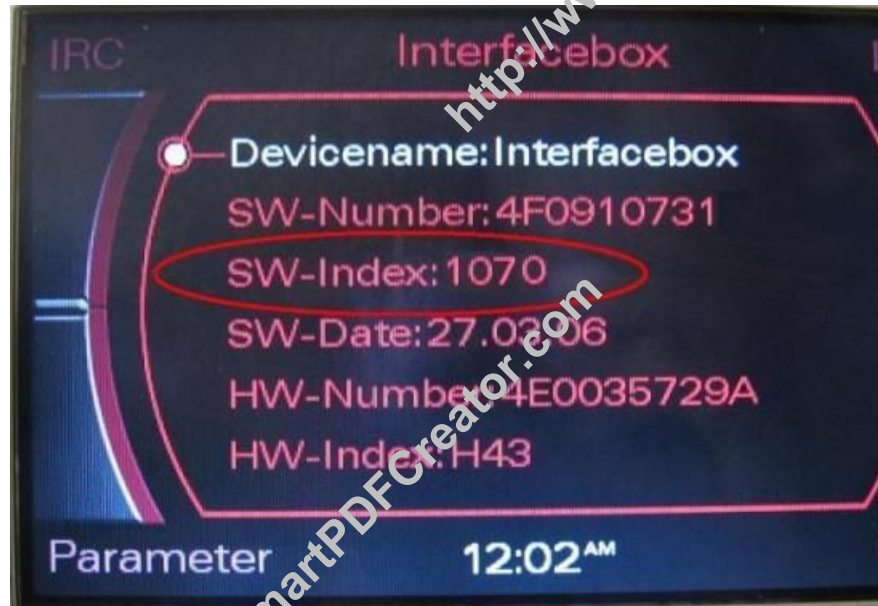
- If SW -Index is higher or equal to 1070: The vehicle the MMI system can be directly updated with the Zug 864 Update CD bundle.

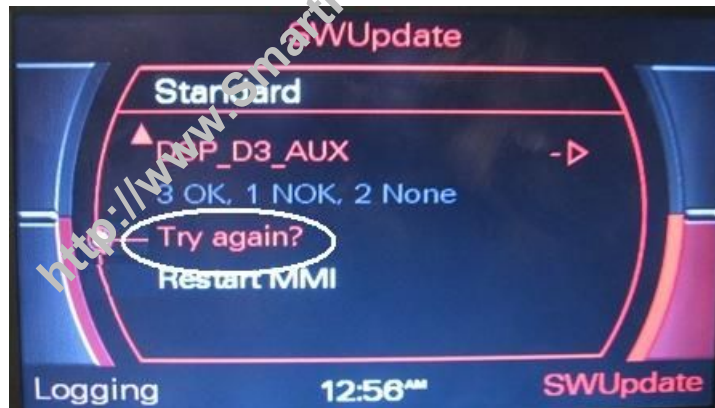
11. If you scroll down the component list, you may discover that not all necessary component updates were performed in the first step. In this case, select Try again.

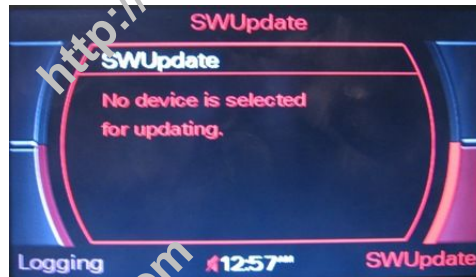
If No device is selected for updating appears, then all components are updated.

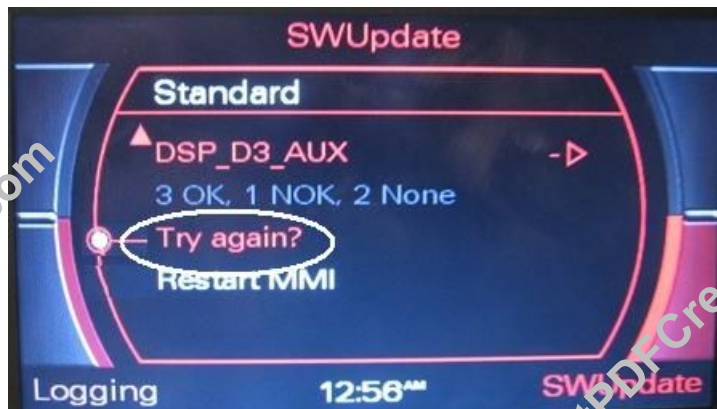
13. If the option Try again? is highlighted, it is necessary to try the firmware update again.

If the second repair attempt is not completed successfully either, replace the telephone control module (see Required parts and tools) and claim the part under this RVU. (See
