Technical Service Bulletin

MIL on (DTC P310B and/or P129F)

24 07 19 2015106/3 Nov. 19, 2007. Supersedes Technical Service Bulletin Group 24 number 07-08 dated June 19, 2007 to update parts numbers.

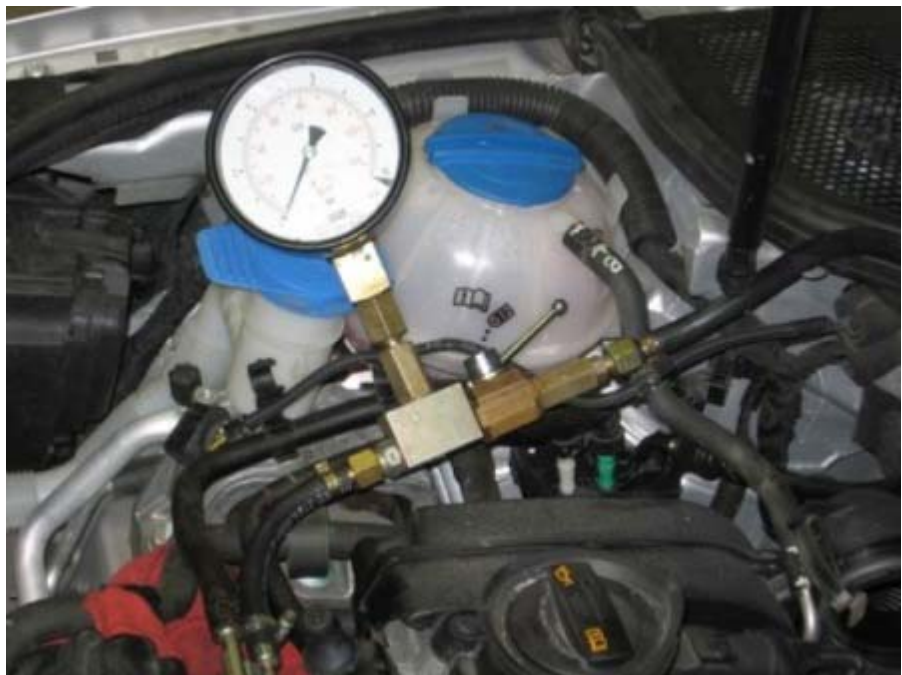
Figure 1. VAG 1318 gauge installed on an A3 2.0L TFSI vehicle.

2. Start engine and allow to idle for at least one minute.
3. Stop the engine.
4. Keep the ignition on.
5. Measure actual low-side fuel pressure via mechanical gauge (VAG 1318) on the low pressure supply line in the engine compartment (Figure 1).

6. Add 1 bar to the value obtained from the mechanical gauge to calculate the adjusted gauge measurement.
7. Compare the adjusted gauge measurement to the value stored in MVB 103 field 1.

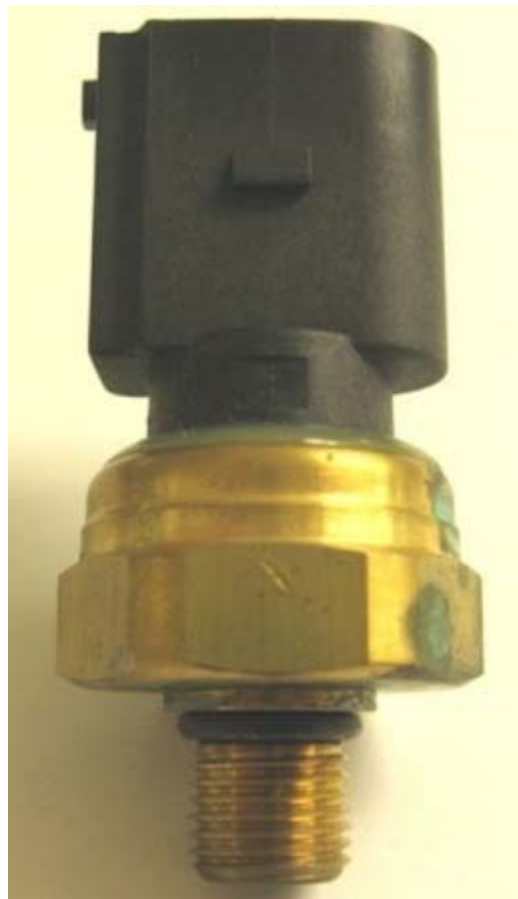
Figure 2. Fuel pressure sensor 06E 906 051 J.

1. Replace the G410 low-side fuel pressure sensor.

2. Clear DTCs and verify that the problem was eliminated.
