96 Engine intermittently or consistently does not start using advance
key start button, starts w/ key & ignition switch

Release date: Nov 14,
2008

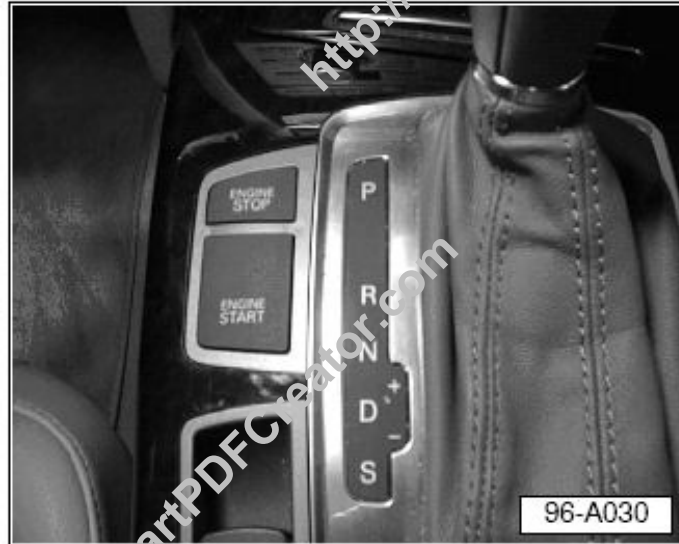
Customer states that engine does not start or intermittently does not start when Advance Key engine start button is depressed. Engine will start using ignition key and ignition switch.

Figure 1. The Advance Key engine start button.

Engine start button has two detents. Similar to ignition switch, the first detent will activate 15 power. Second detent activates starter.

When depressing engine start button, flow from initial push through to second detent should be smooth; audible clicks should be heard as detents are reached.

In some cases, second detent, starter activation, cannot be achieved due to mechanical tolerances within the switch.

1. Interrogate fault memory of access start control unit, address word (05), with VAS 5051/5052.
 - a. If no fault is found in access start control unit, check engine start button functionality by observing measuring value block 2, fields 1 and 2, of access start control unit.
 - If engine start button is found to be non-functional, replace Advance Key engine start / engine stop switch.Refer to Repair Manual >> Group 96 - Lights, Switches >> Interior, Anti-Theft for appropriate repair procedure.
 - b. If DTC 02764 008 (Button for start/access authorization - incorrect signal) is found in access start control unit, go to B – Electrical issue with the engine stop button below.
