80 Temperature different between front driver and passenger sides

Release date: Dec 5, 2008

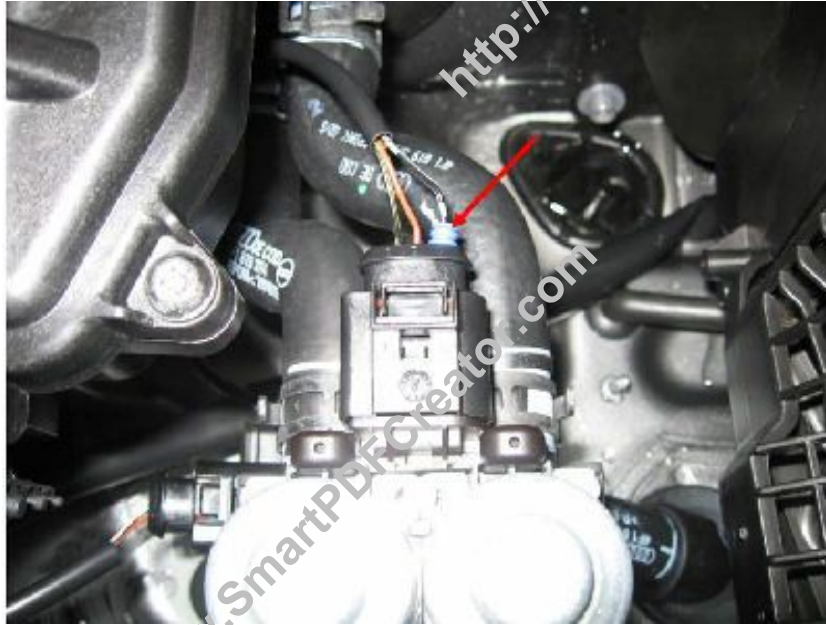
- Debris remaining inside the engine block during production blocks the pump valve unit. As a result, one valve can stay permanently open, allowing warm coolant to flow into one of the heat exchangers.
- Electrical connector not sealed completely or pin is pressed out.
- Outside temperature sensor G17 shows incorrect value.
- Pump valve unit is faulty.

Figure 1. A pressed-out pin.

1. Turn both sides on Low. If the temperatures on the driver and passenger side do not clearly drop to a reasonably equal temperature (one side is warmer than the other), a valve in the pump valve unit is blocked. Replace the pump valve unit.
2. Check the electrical connector on the pump valve unit in the plenum chamber (Figure 1). Seat the plug correctly, or repair the pin with the repair case VAS 1978A.
