**Subject: Radio, Sound Volume May Fluctuate When
Accelerating From a Stop**

Number: 05-11

Model(s): A8, A8L

Date: Jun. 21, 2005

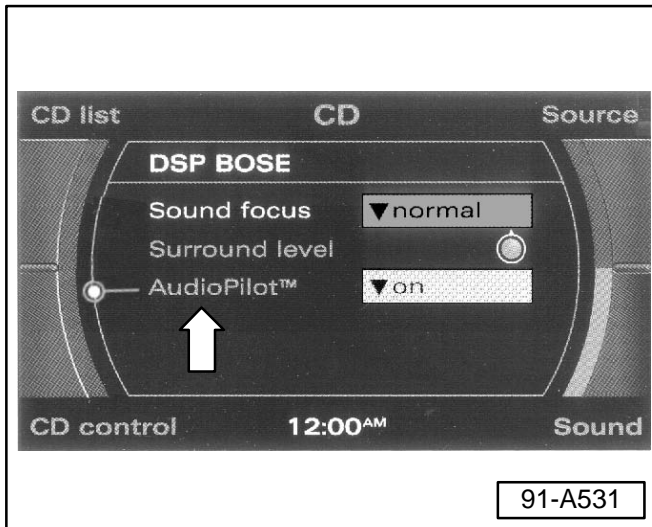
This condition can be encountered, if the MMI Most Bus components and the Data Bus on Board Diagnostic Interface -J533- are not compatible.

◀ The Audiopilot function (arrow) has to be enabled in the MMI Menu Radio.

The Data Bus On Board Diagnostic Interface -J533- has software level 0020 or 0030 and has to be updated (programmed) to 0040. Therefore, use Update CD W42A8317, which was sent free of charge to your Dealership.

- Insert Update CD W42A8317 in the CD drive of the VAS 5051/5052 Diagnostic Tool.
- Connect VAS 5051/5052 to the vehicle and select Addressword 19 – Data Bus on Board Diagnostic Interface -J533- in Vehicle Self Diagnosis.
- Select Function "Update programming".
- Erase possible DTCs in all control units after performing the Update programming.
- Verify, if Audiopilot function works properly now.
