**Subject: Radio, Reception Concerns or Remote Transmitter,
Range Concerns**

Group: 91

Number: 05-04

**Model(s): A4 Sedan, S4 Sedan
A8L**

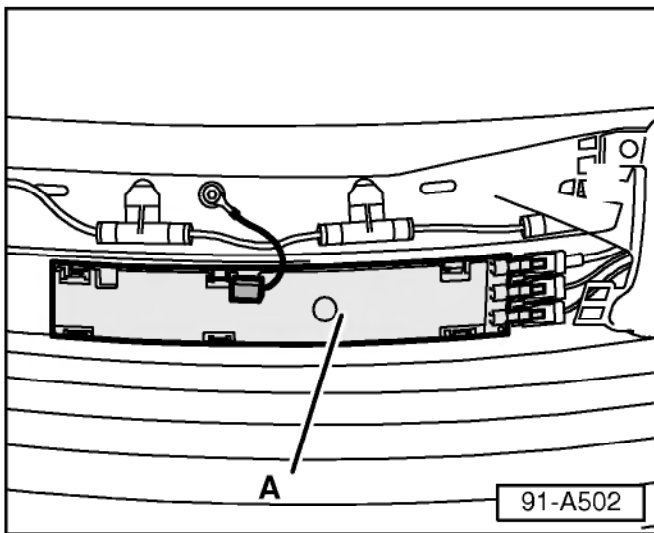
◀ Use the following to help identify if Antenna Selection Control Module -J515- (A) is faulty:

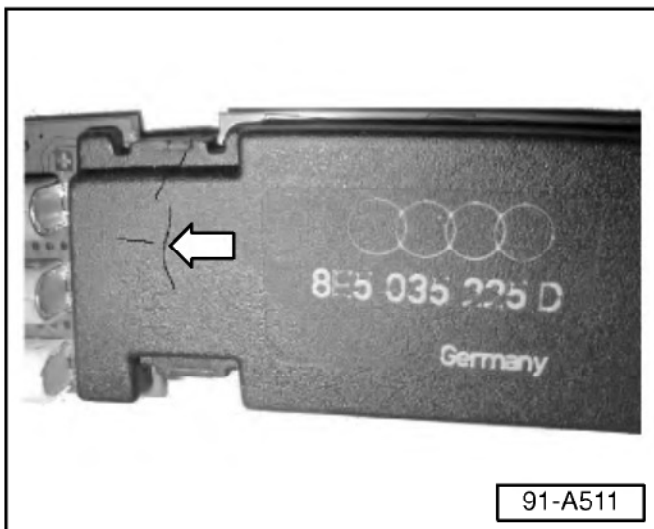
◀ - Inspect Antenna Selection Control Module -J515- housing for cracks (arrow).

If housing is cracked:

- Replace Antenna Selection Control Module -J515-.

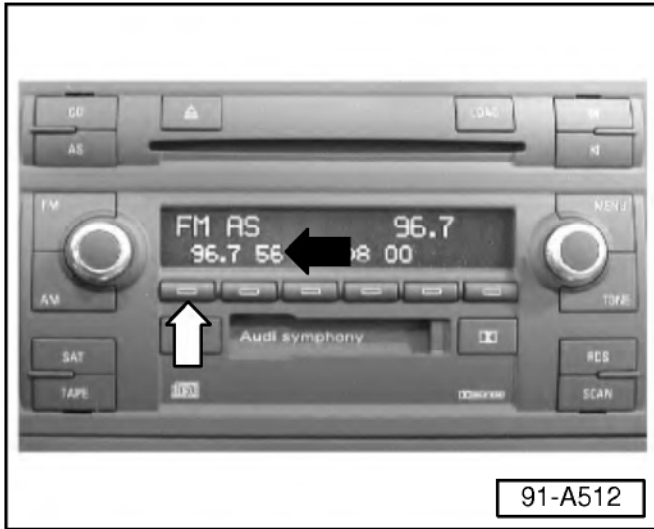
- Select an AM or FM station, that customer states is not satisfactory.
- Switch radio OFF.
- ◀ - Press and hold button (white arrow) and switch radio ON.
- ◆ The first row will show the frequency (radio station) followed by two digits (black arrow) which shows you a number for the field-strength.

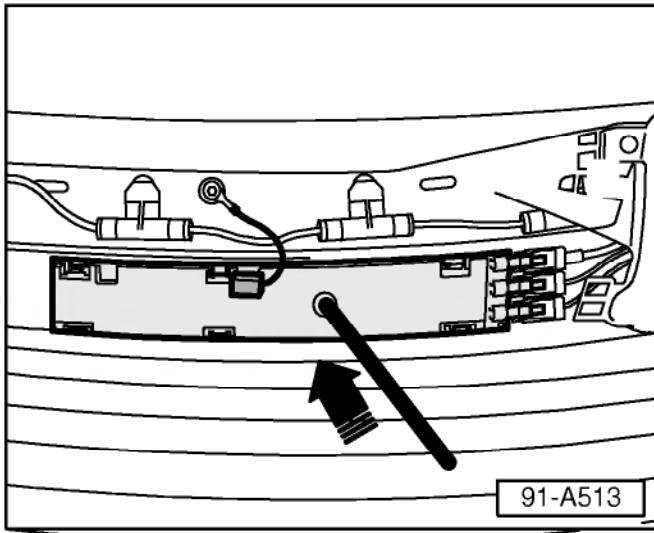
- Select an AM or FM station that customer states has reception issues.
- ◀ - Gently push Antenna Selection Control Module -J515- (in center) against glass using a non-metallic object (such as a wooden dowel or pen).

If the antenna module is faulty:

- ◆ An improvement of the sound quality can be heard and a rise of the field-strength is indicated (Symphony II and Concert II).

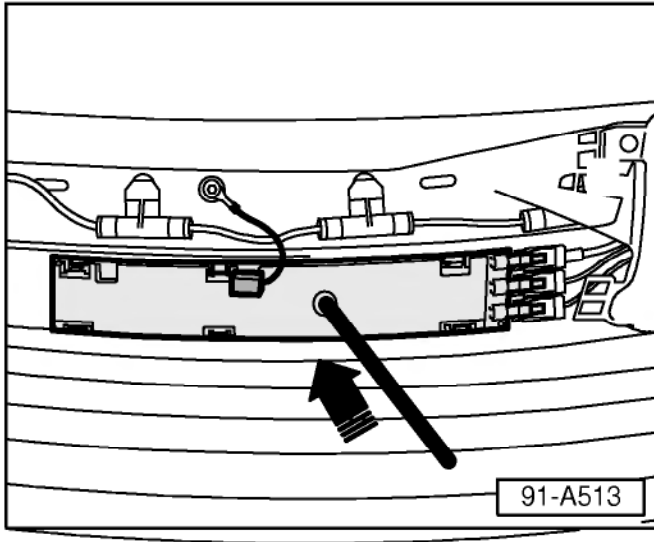
- Gently push antenna amplifier (in center) against glass using a non-metallic object (such as a wooden dowel or pen) while another person checks if transmitter range improves.

If transmitter range improves, antenna amplifier is faulty, replace using Part Nos. as follows:

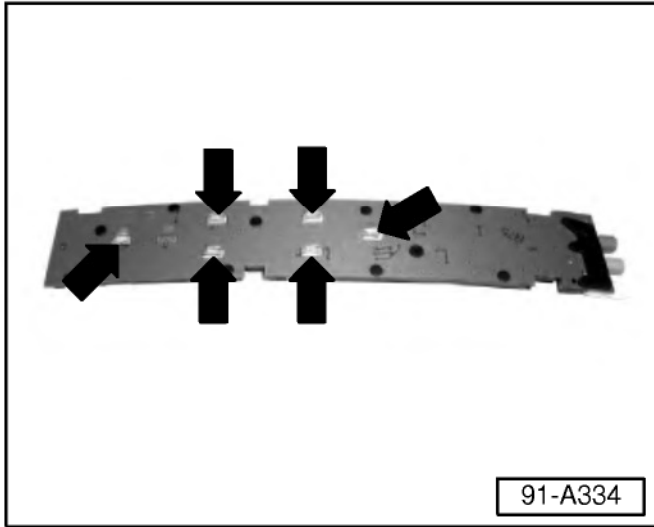
Use extreme care when unwrapping and installing the new antenna amplifier, as the spring contacts (arrows) can be easily bent (damaged).

DO NOT attempt to bend or clean spring contacts!
