Technical Service Bulletin

43 Self-leveling compressor inoperative

43 08 16 2018765/3 December 11, 2008. Supersedes Technical Service Bulletin Group 43 number 08-13 dated November 3, 2008 for reasons listed below.

Model(s)	Year	VIN Range	Vehicle-Specific Equipment
A6	2006 – 2009	All	Air Suspension
A8	2004 – 2009	All	
Audi Q7	2007 – 2009	All

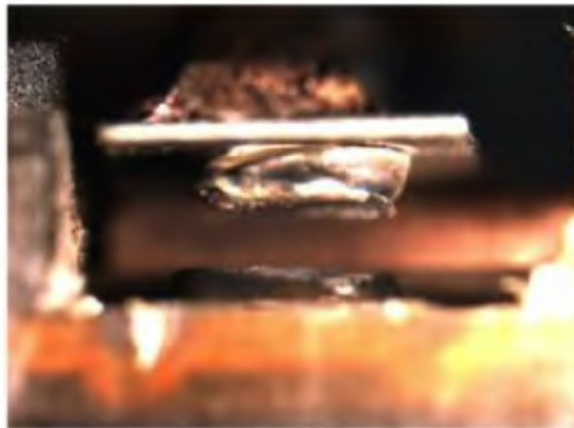
4. Open the relay and assess the contacts. Compare them with the contacts of Figures 1 to 3.

Is the wear is similar, or are there burn marks in the housing?

Figure 1. Strong erosion of both contacts.

If the relay resembles Figures 1 to 3, replace the compressor and relay J403 for the self-leveling system.

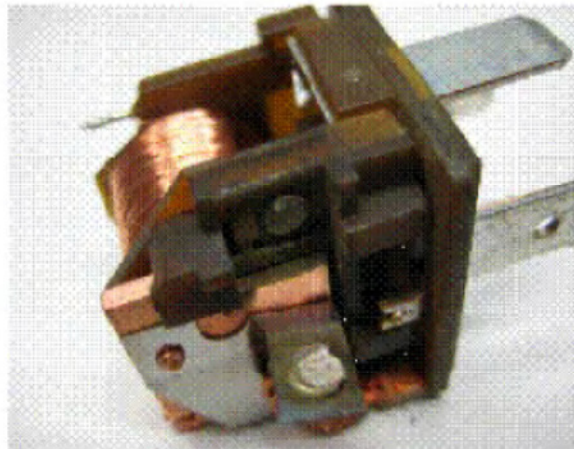
Figure 2. Strong erosion of both contacts.

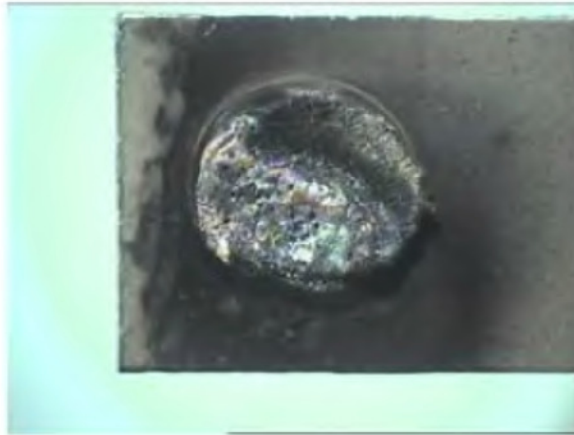
Figure 3. Strong erosion of the spring contact.

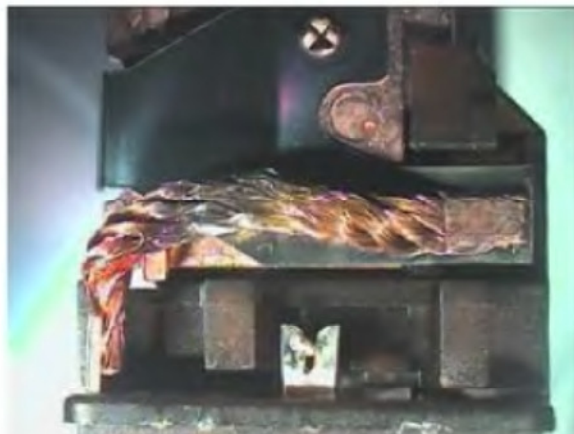
5. Discoloring of the strand is also a clear indication of permanent operation of the compressor (Figure 4).

Figure 4. Overheated strand.

Replace the compressor and relay J403 for the self-leveling system.

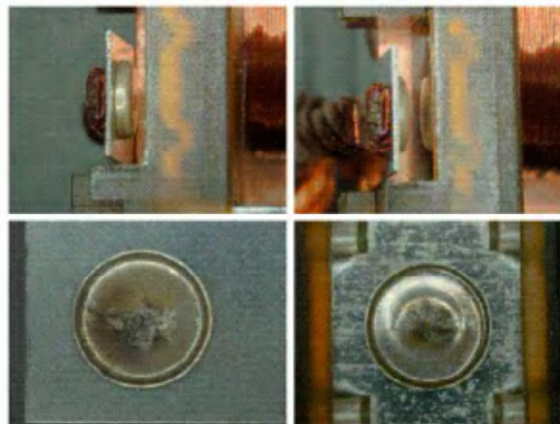
Figure 5. Contacts with minor marks; relay OK.

6. If the contacts resemble those in Figure 5 and the compressor has a working noise similar to a comparable vehicle, replace *only* the opened relay J403 for the self-leveling system.
