Your Vehicle: 2004 Audi A8L Quattro Sedan (4E8) V8-4.2L (BFM)

Attachment Bulletin # 170405

[Oil Filter](#) Cap, Interference with Generator (GEN) Coolant Pipe

A8L with 4.2L (engine code BFM) 2004 > 2005

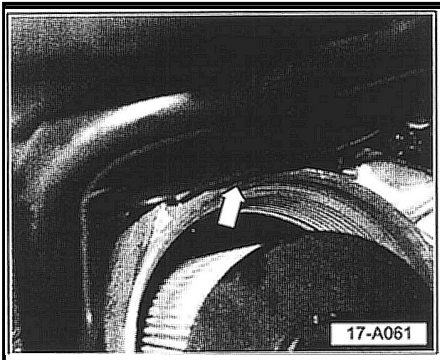
- During engine oil change service, Technician may find that the generator coolant return pipe -arrow- may interfere with removal or installation of the [oil filter](#) cap.

May be caused by an incorrect coolant pipe tolerance allowing the pipe to slightly overlap the [oil filter](#) cap.

Retrofit the generator coolant return pipe as follows.
