91 Hands-free phone function is inoperative

Release date: Feb 11, 2010

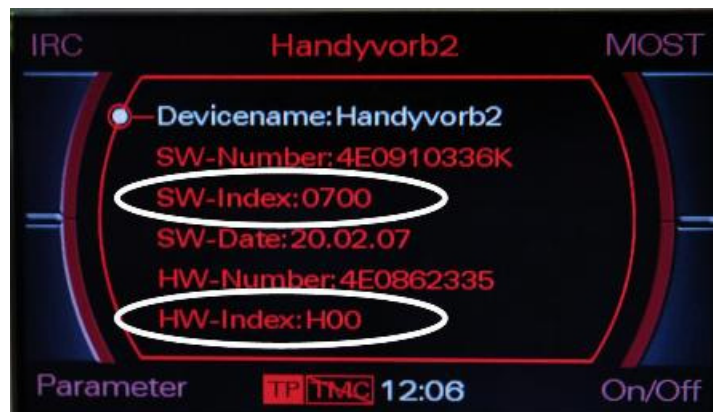
Figure 3 Example.

- If **HW-Index:** **H00** is displayed, replace the phone preparation control module (see *Required parts and tools*). (See *Workshop Manual, Electrical*

*system >>
Rep. Gr. 91
>>
Infotainment,
telephone
system >>
Removing
and
installing
telephone
transmitter
and receiver
unit -R36.)*

Proceed to
Section 4
after the
R36-
replacement
to update
the
remaining
MMI
modules.
The
replacement
phone
module will
already have
the correct
firmware and
software
versions.

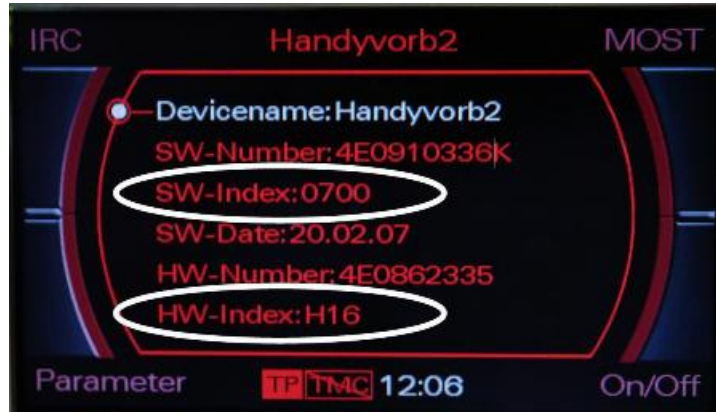
Figure 4. Example.

- If another than H00 **HW-Index** is displayed in the vehicle, proceed to *Section 2.*

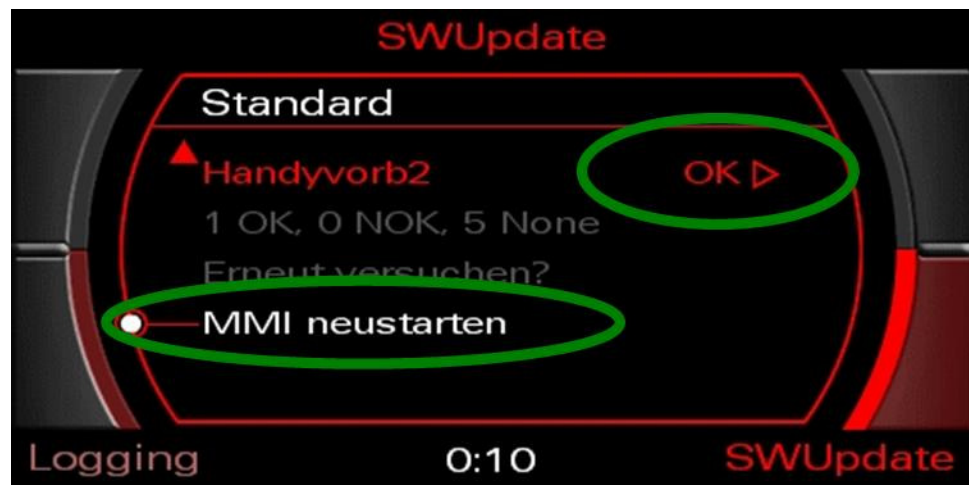
Figure 16.

- If the repair process has been completed successfully, **Handyvorb2** will show **OK>**.

Proceed to *Section 3, Update software of the phone preparation unit.*

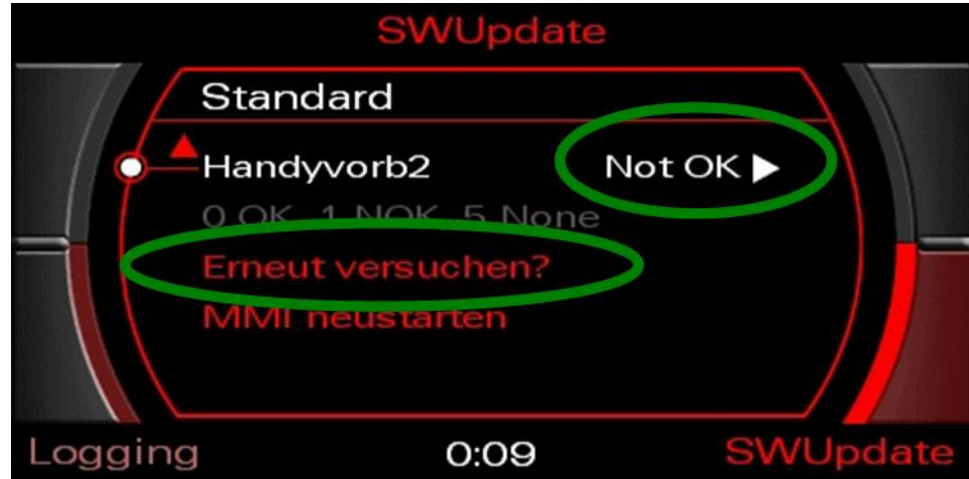
Figure 17.

- If the repair process has not been completed successfully, **Handyvor2** will show **NOT OK**. Proceed to Step 7.

7. Select **Try again?** And press to confirm.
8. If the second repair attempt is not completed successfully either, replace the telephone control module (see *Required parts and tools*). (See *Workshop Manual >> Electrical system >> Rep. Gr. 91 >> Infotainment, telephone system >> Removing and installing telephone transmitter and receiver unit –R36*).

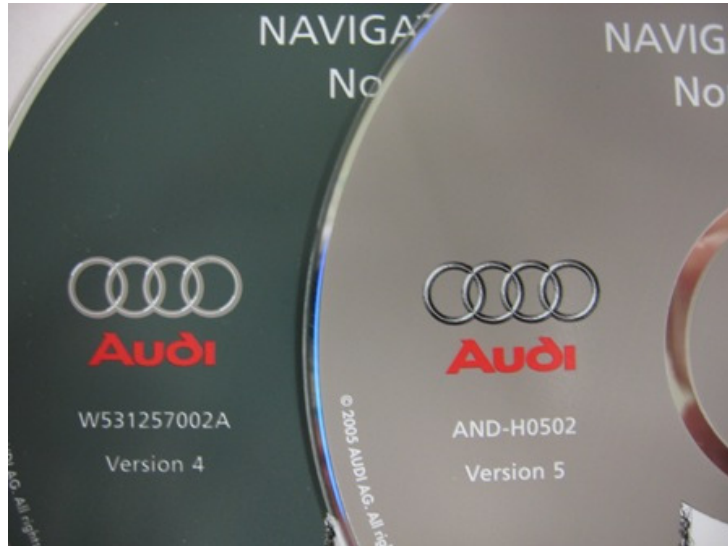
Figure 24. Navigation DVD Version 4 and Navigation DVD Version 5.

1. If the vehicle is MY 2005, it may still have a Version 4 Navigation DVD installed. Replace Version 4 Navigation DVDs with a Version 5 Navigation DVD prior to the MMI component update. The DVD can be obtained through the Navteq hotline and claimed as a sublet part.
