Your Vehicle: 2004 Audi A8L Quattro Sedan (4E8) V8-4.2L (BFM)

## Engine Controls - DTC's P1874/P1875/P1876

2010270/6

November 19, 2008.

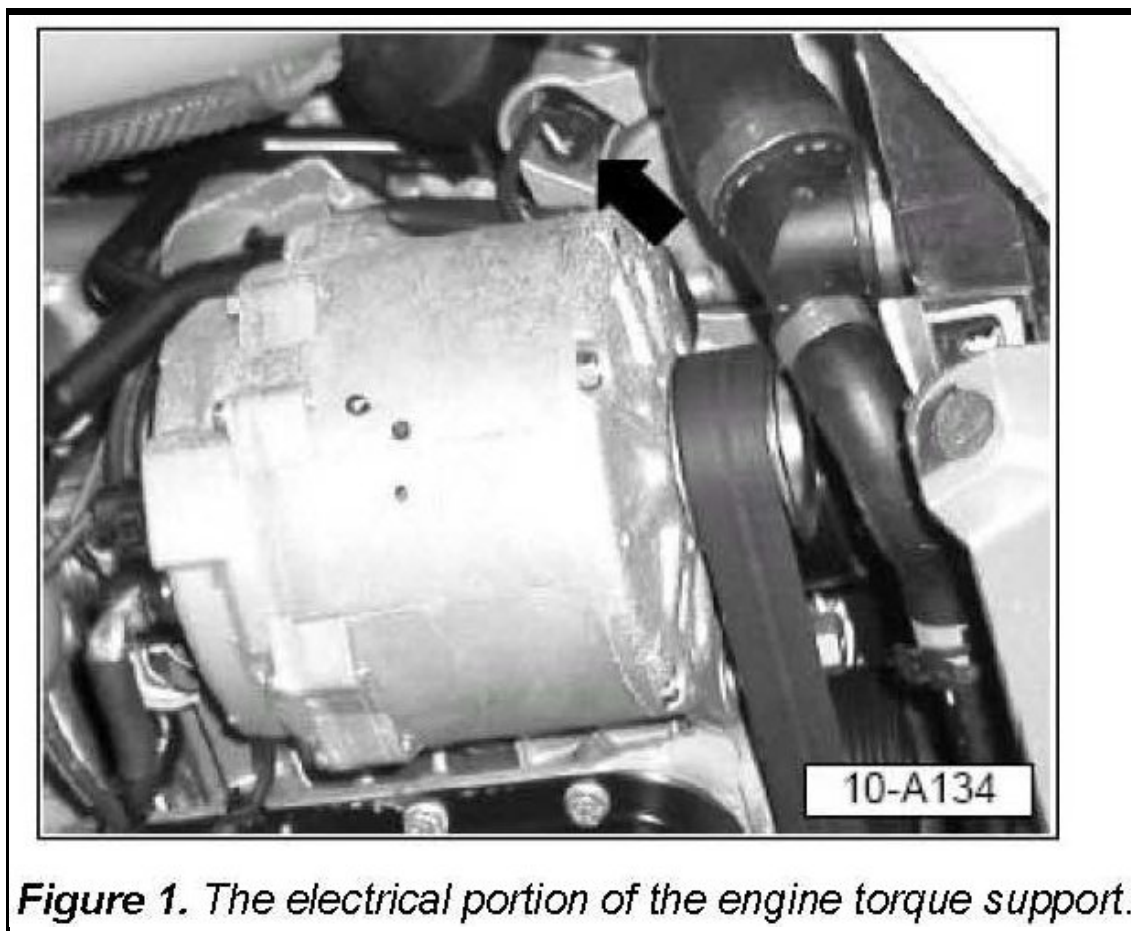
Electrical solenoid valve N382 is no longer used on Engine Torque Support Bearing.

The following procedure will disconnect the electrical portion of the engine torque support -N382- (Figure 1) from the ECM.

- Engine torque support will still function as a normal hydraulic mount.
- ECM will no longer store DTCs listed above.

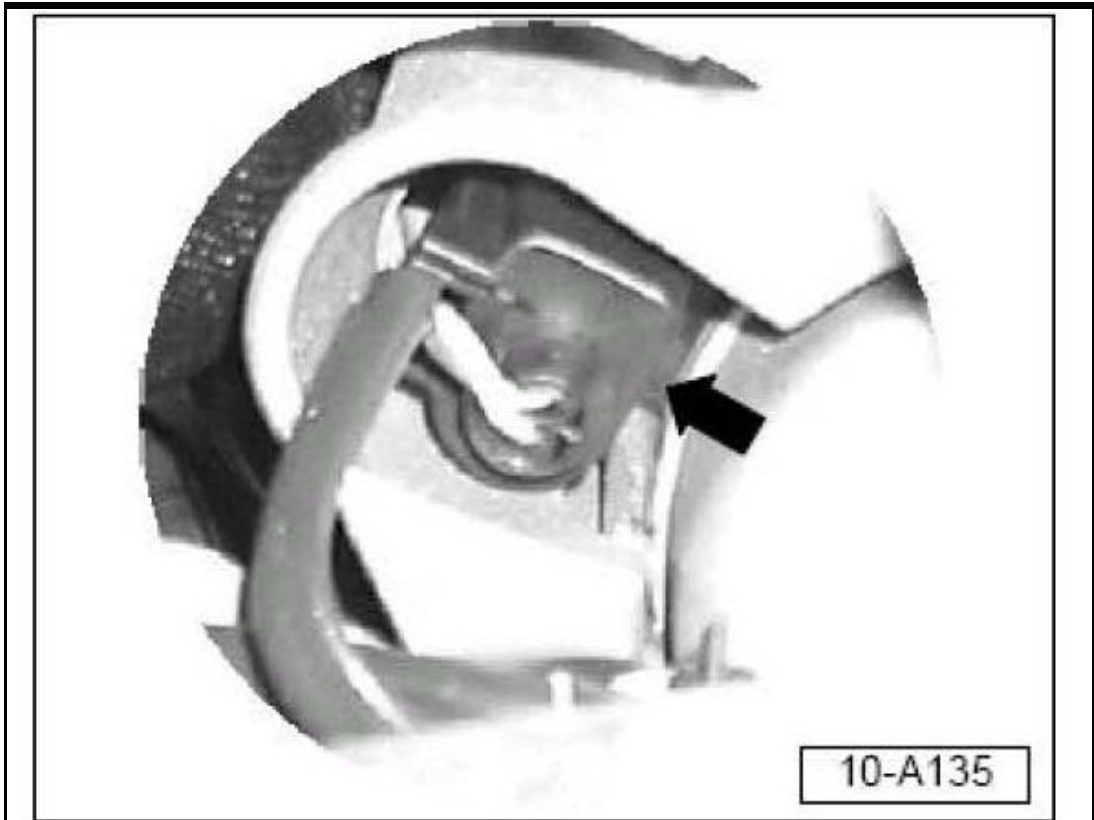
**Figure 2.** *The electrical plug on the engine torque support.*

2. Remove electrical plug (Figure 2) from right front engine torque support - N382-.

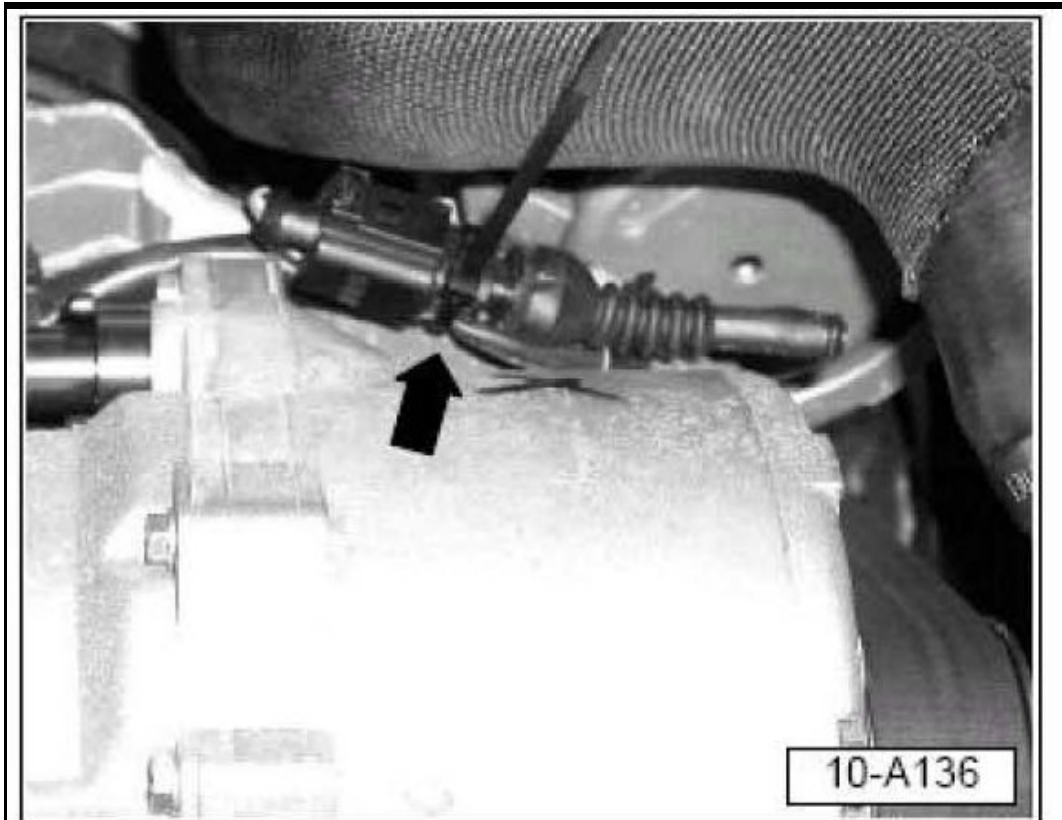
**Figure 4.** *Secure resistor to wiring harness with cable tie.*

4. Secure resistor to wiring harness with cable tie (obtain locally).
5. Cut off excess cable tie.

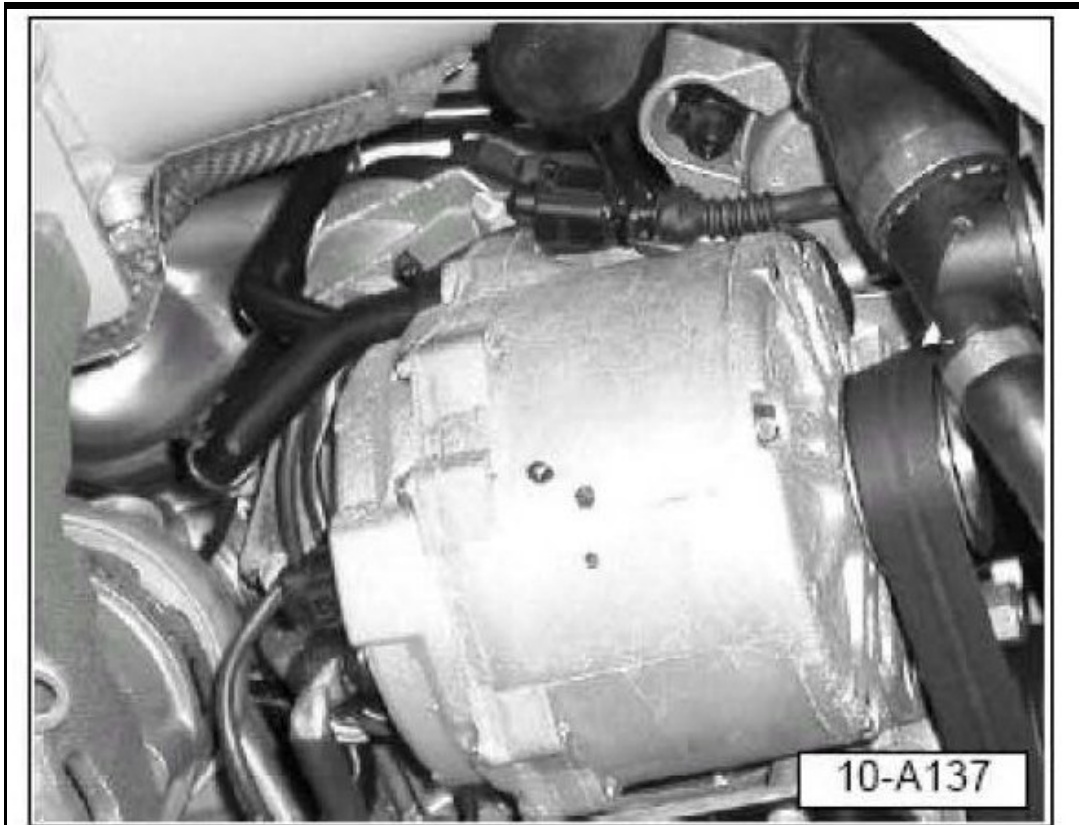
**Figure 6.** Part number. **1J0 973 702** installed on electrical connection of the engine torque support.

7. Install part number 1J0 973 702 on electrical connection of the engine torque support -N382- as shown in Figure 6.
8. Reinstall sound insulation under engine compartment.
9. Clear any stored DTCs.
