# Technical Service Bulletin

27 48V Vehicle electrical system warning, DTC P0CA700 and/or U046900 stored in the starter/generator control module/ECM

27 22 45 2058831/5 September 27, 2022. Supersedes Technical Service Bulletin Group 27 number 22-41 dated March 2, 2022, for reasons listed below.

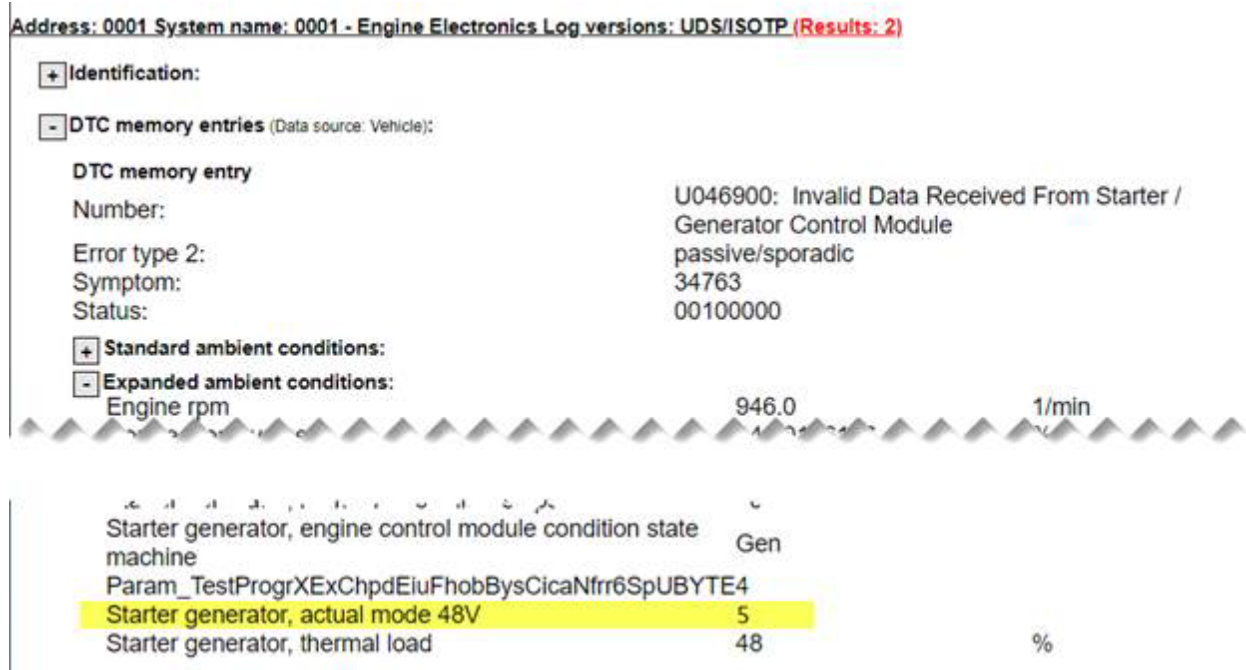
DTC U046900 Symptom 36564 (invalid data received from starter/generator control module).

Figure 1. DTC U046900 with Expanded ambient condition “Starter generator, actual mode 48V” value of 5 in the engine control module (ECM), J623 (address word 0001).

1. If DTC U046900 is found in the ECM, J623 (address word 0001), check the expanded ambient conditions of this DTC for the value of "Starter generator, actual mode 48V".
2. If the expanded ambient conditions value for "Starter generator, actual mode 48V" is 5 (Figure 1) for DTC U046900, then replace the starter generator. If no value is displayed, please submit an ODIS feedback.
