Technical Service Bulletin

94 Rear lighting does not switch from bumper to lid (DTC 03073)

94 13 27 2033675/5 August 13, 2013. Supersedes Technical Service Bulletin Group 55 number 13-31 dated July 18, 2013 for reasons listed below.

Model(s)	Year	VIN Range	Vehicle-Specific Equipment
Q7	2007-2014	All	Not Applicable

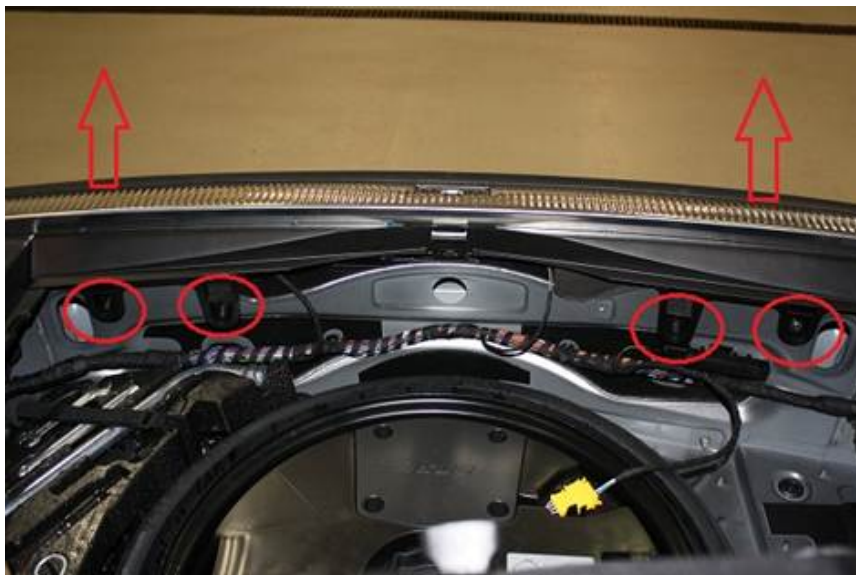
Figure 2. Rear cargo area trim plate removal. The T25 Torx® screws to be removed are circled in red.

1. Remove the rear trim plate by first removing the four T25 Torx® screws (Figure 2), then carefully pulling up on the plate.

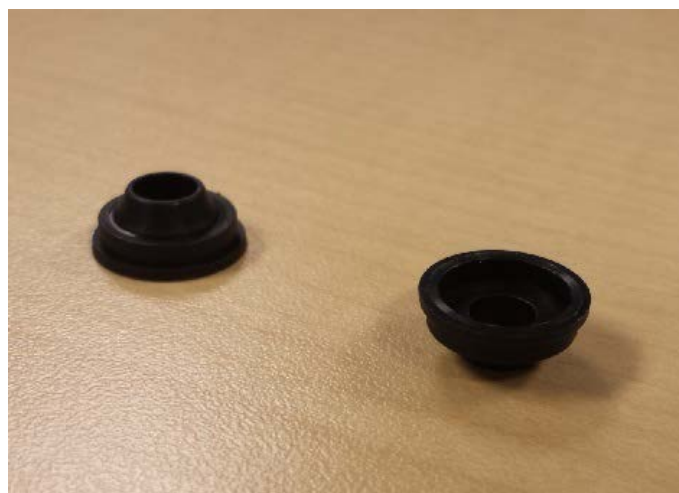
Figure 3. Spacers for underneath paddle switch assembly.

2. Remove the two T20 Torx® screws that hold down the paddle switch assembly. Install spacers (4L0863191A 4PK) (Figure 3) between the paddle switch and the trim. The large diameter faces the switch and small diameter faces the mounting.

Tip: If factory service parts are not available, improvise by using spacers with dimensions of no less than 5.5mm I.D., no greater than 13mm O.D., and no thicker than 5.6mm.

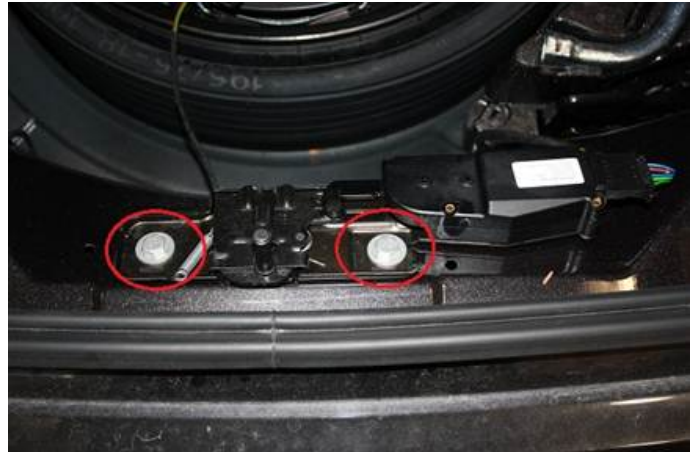
Figure 4. Power lid's motorized striker plate bolted mounting.

Note the current position of the striker plate by using the serrated lines surrounding the bolt or surrounding the nut's integrated washer (Figure 4 and Figure 5).

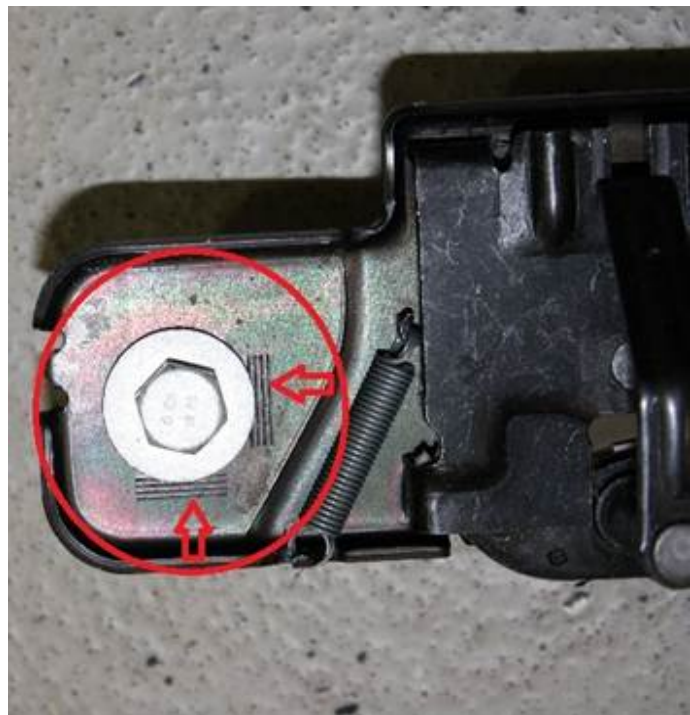
Figure 5. Power lid's motorized striker plate adjustability and serrated indicators.

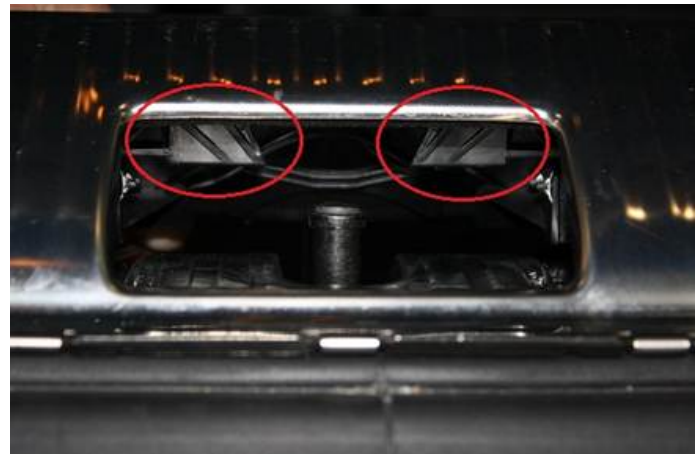
Figure 6. Overhead view of paddles contacted by rear lid latch.

Tip: Moving the striker plate latch towards the front of the vehicle will bring the lid latch closer to actuating the paddle switches (Figure 6). Do not move the latch forward too far to ensure that the lid is not pulled in with greater force than necessary.
