Technical Service Bulletin

94 Rear lights do not switch from bumper to hatchgate

94 16 83 2043851/2 October 12, 2016. Supersedes Technical Service Bulletin Group 94 number 16-78 dated June 27, 2016 for reasons listed below.

Model(s)	Year	VIN Range	Vehicle-Specific Equipment
Q7	2016	All	Not Applicable
Q7	2017	000001 - 010119	Not Applicable

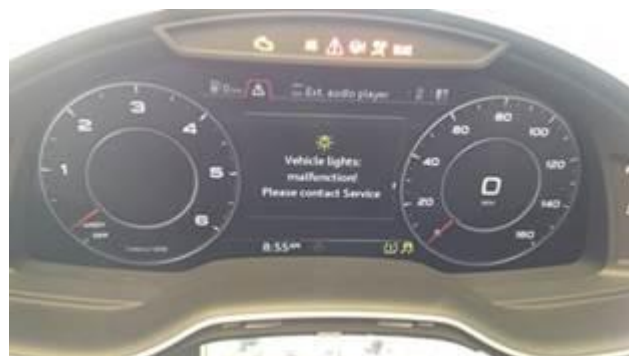
- When the rear lid is closed, the lights in the rear bumper do not switch over to the main lights on the rear lid.
- The error message “Vehicle lights: malfunction! Please contact Service” intermittently appears in the driver information system (Figure 1).
- All of the rear light bulbs are fully functional. None are found to be faulty or incorrect.

Figure 1. Error message.

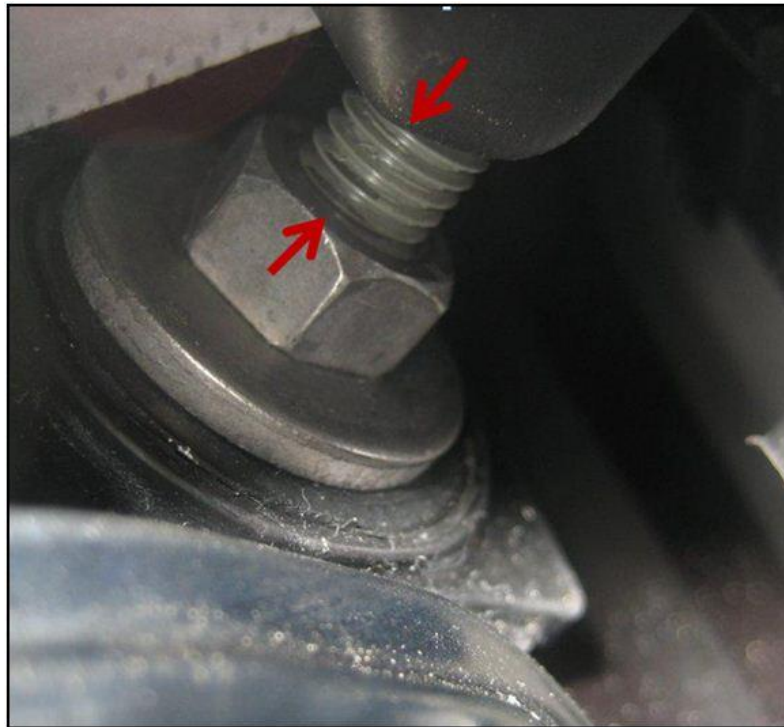
2. Next, perform a visual inspection inside the latch entry, specifically of the clearance of the latch striker mounting studs to the lock carrier trim. If the lock carrier trim is correctly installed, there should be no more than five threads visible between the head of the nut and the lock carrier trim (Figure 2). If the correct number of threads is visible, no further work is necessary on the lock carrier trim.

Figure 2. Correct number of threads visible.

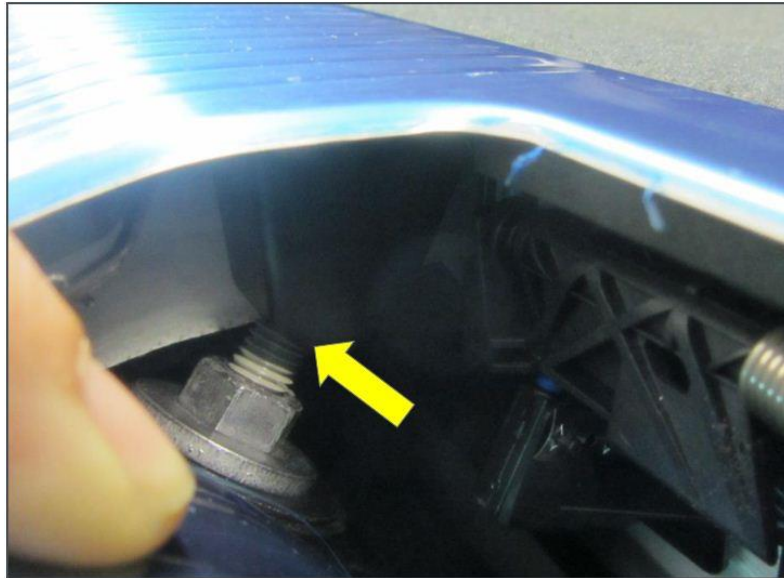
3. If more than five threads are visible (Figure 3), the lock carrier trim is being pushed upward and, as a consequence, it moves the Rear Lid Closed Sensor out of position. If more than five threads are visible, remove the lock carrier trim.

Figure 3. Too many visible threads.

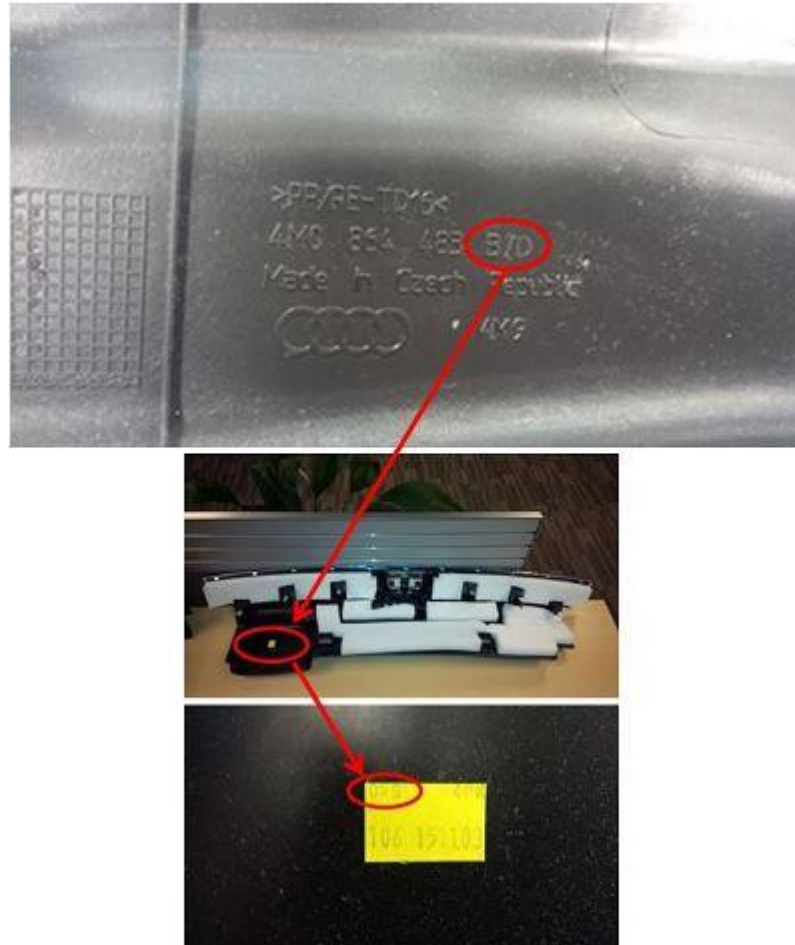
4. On the inside of the trim is stamped the part number of the trim as well as a yellow sticker with a part version stamped on it (Figure 4). If the part number of the trim has an index of B/D (plastic with stainless steel insert) or C/E (plastic without stainless steel insert) and the version number is "04S" or lower, replace the lock carrier trim. If the version number is "05S" or higher, this trim is the improved version and replacement of this version is not necessary unless irreparable damage is found.

Figure 4. Improved lock carrier trim with index B/D and version 05S.

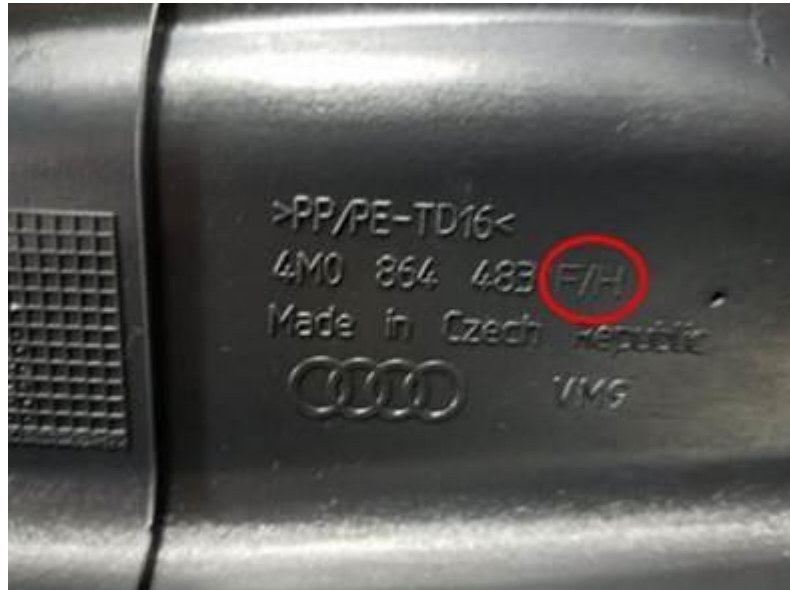
5. If the part number of the trim has an index of F/H or G/J (Figure 5) then all versions of this index are the improved version and replacement of this index trim is not necessary unless irreparable damage is found.

Figure 5. Improved lock carrier trim with index F/H.

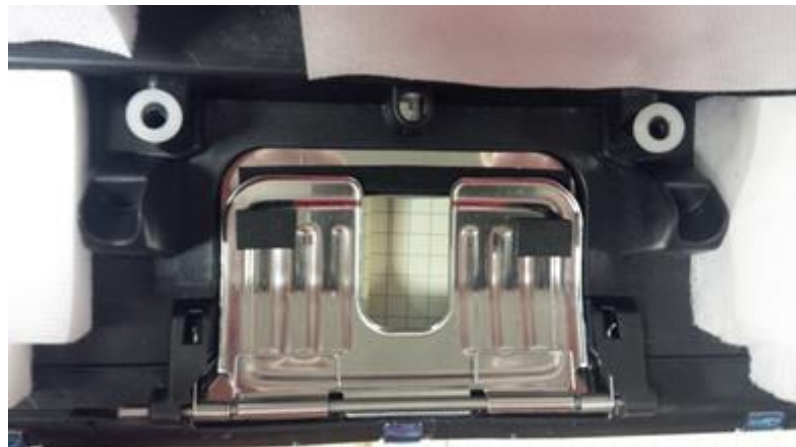
Figure 6. Washers N 912 006 01 as they should be installed.

7. Carefully inspect the installation of the Rear Lid Closed Sensor G525/G526. Remove the screws and the sensor. There should be a washer (part number N 912 006 01) at each screw point separating the sensor from the mounting buss. If incorrect washers are installed or if the washers are missing, order these washers, install them, and reassemble as shown in the illustration (Figure 6). If the Rear Lid Closed Sensor G525/G526 or

the related wiring is damaged, replace or repair it as well.

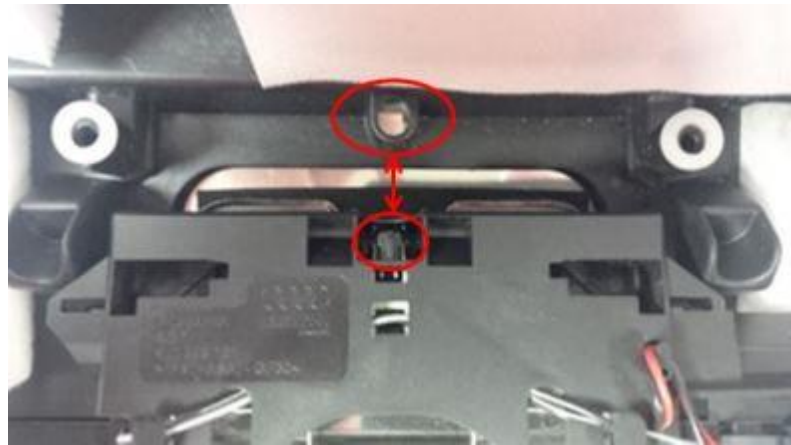
Figure 7. Sensor indexing pin.

8. The Rear Lid Closed Sensor G525/G526 has an indexing pin cast into the housing (Figure 7). Ensure that it is not damaged and that it is properly seated in the corresponding opening in the lock carrier trim.

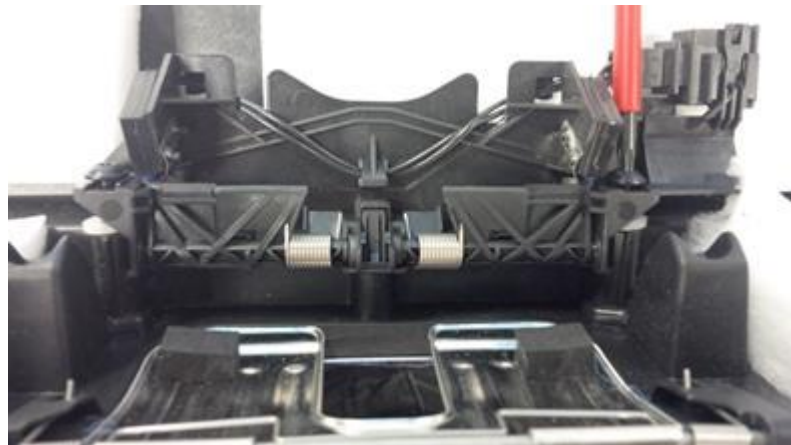
Figure 8. Proper sensor to lock carrier trim assembly order.

9. Reassemble and reinstall the lock carrier trim. Proper assembly is critical to correct rear lighting change-over operation (Figure 8).

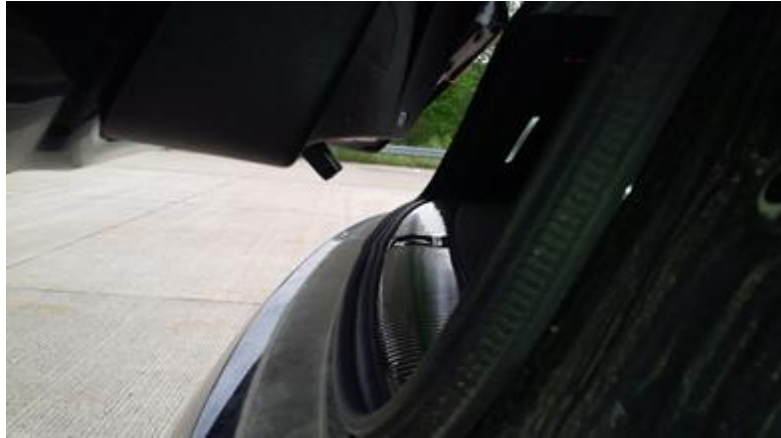
Figure 9. Rear Lid Latch V53 as it enters the lock carrier during closing.

10. Finally, the mounted angle of the Rear Lid Latch (V53) will be checked (Figure 9).

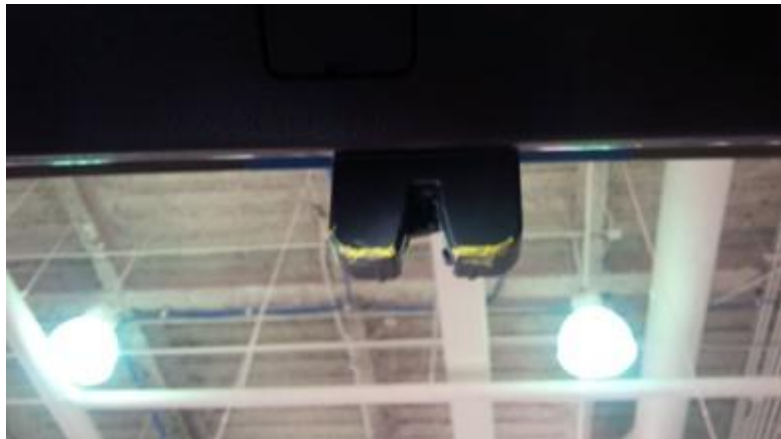
Figure 10. Tire grease pencil applied to the leading edge of the Rear Lid Latch V53.

11. Apply a marking medium (such as chalk or a tire grease pencil) on the inner edge (the edge that first contacts the G525/G526 paddles) to the Rear Lid Latch (Figure 10).

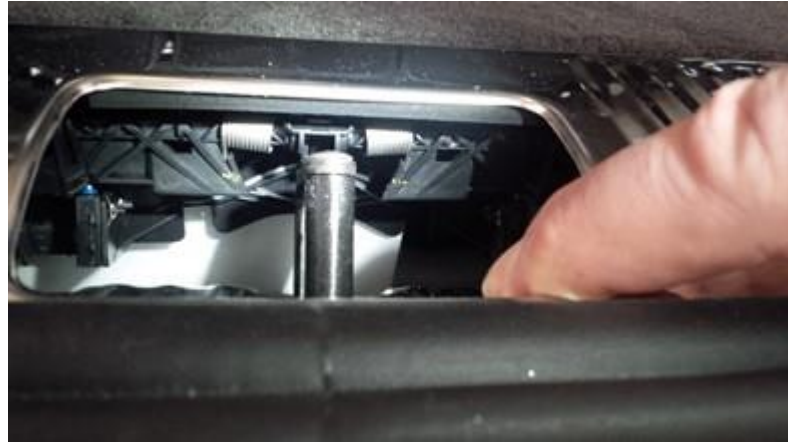
Figure 11. Tire grease pencil marks transferred to the paddles.

12. Close the rear lid normally, then open it normally. A mark on each paddle of the G525/G526 sensor will have been transferred to the paddle surfaces (Figure 11).

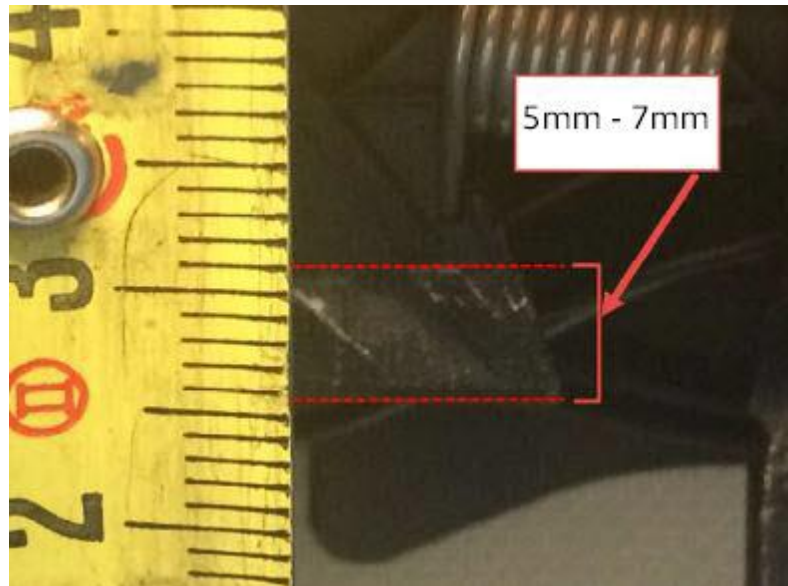
13. Measure the width of the mark. The ideal width is 6mm +/- 1mm (Figure 12). If this dimension is achieved, no further work is necessary.

Figure 12. Ideal contact width of the rear lid latch and the sensor paddles.

14. If the Rear Lid Latch V53 angle is at issue, the contact width will be approximately 4mm or less. If this is the case, the Rear Lid Latch V53 angle will need to be adjusted inward for higher contact with the paddles.

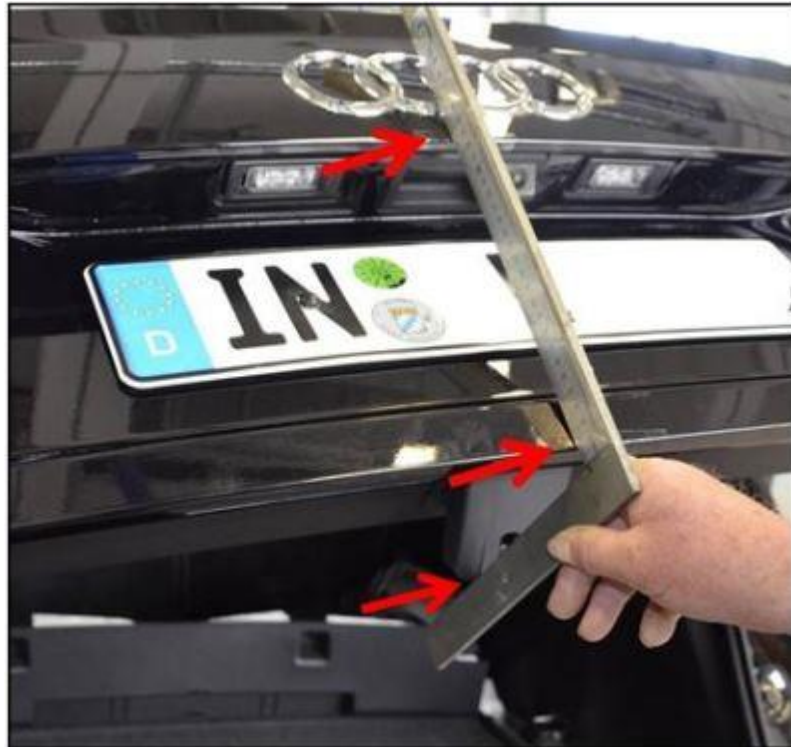
Figure 13. Checking the Rear Lid Latch geometry.

To make this adjustment, a 2 x 4 board (100cm long (39 3/8")) and a carpenter's square (preferably with metric graduations) are needed. Apply a small piece of tape to the areas that will come in contact with the square to protect the paint. Apply the square to the three points on the rear lid shown in the illustration (Figure 13).

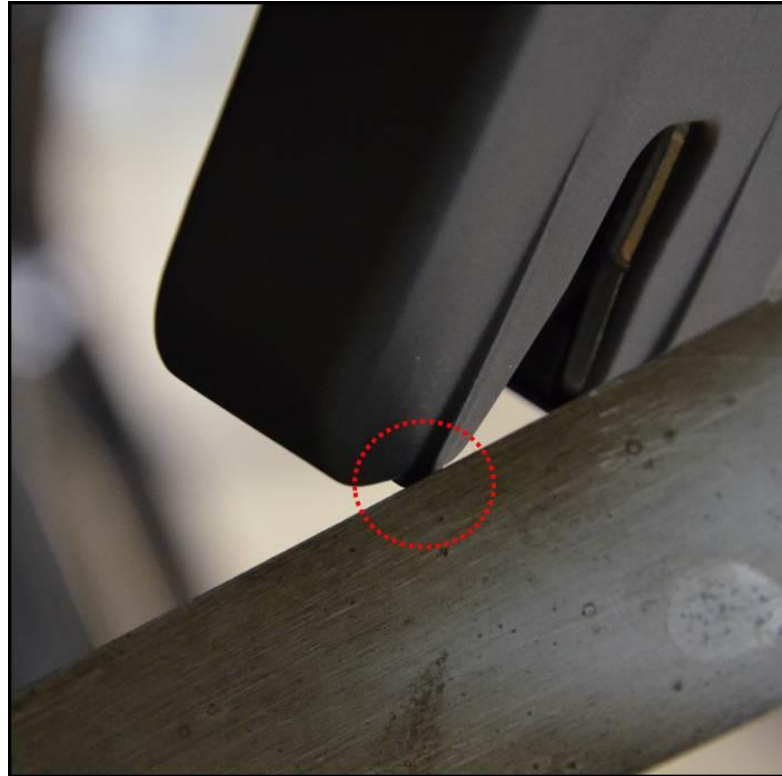
Figure 14. Lower axis of carpenter's square in contact with the Rear Lid Latch lug.

15. The lower axis of the square must contact the lug of the rear lid latch as shown in the illustration (Figure 14).

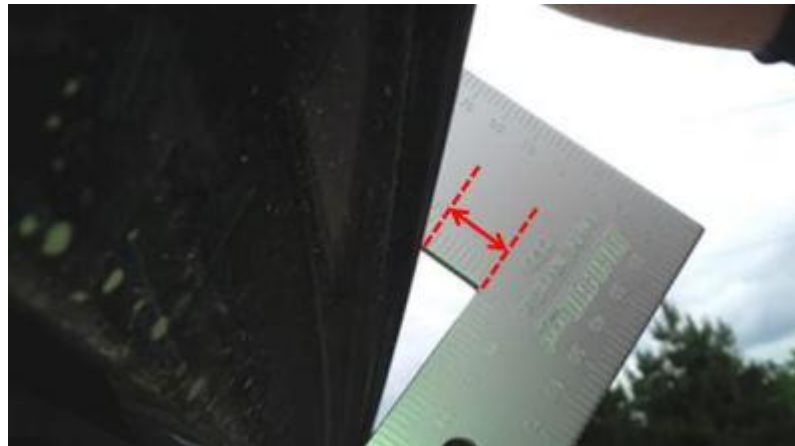
16. The gap between the lower edge of the rear lid and the apex of the square should ideally be 15mm +/- 1mm (Figure 15). With a G525/G526 paddle mark width measurement of 4mm or less, the measurement on the square could likely be less than 14mm, assuming the installation and position of the lock carrier trim and Rear Lid Closed sensor are correct.

Figure 15. Measuring the gap.

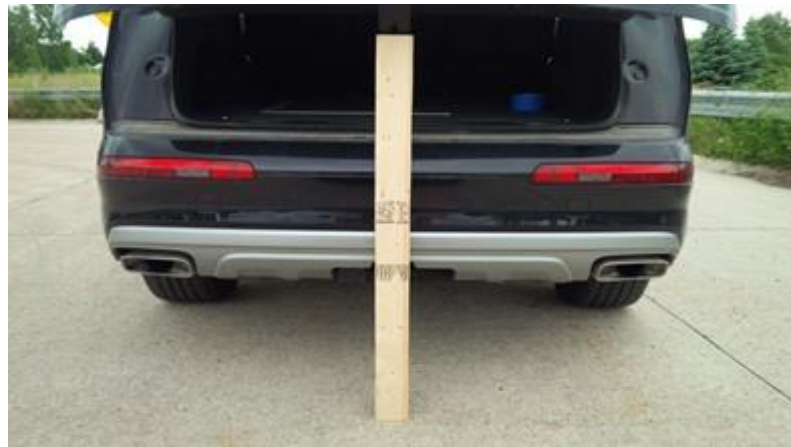
Figure 16. Rear Lid Latch on 2 x 4.

17. To move the Rear Lid Latch angle forward, bring the rear lid down and rest the latch on the 2 x 4 board as shown in the illustration (Figure 16). Ensure that the board does not make contact with the rear bumper cover.

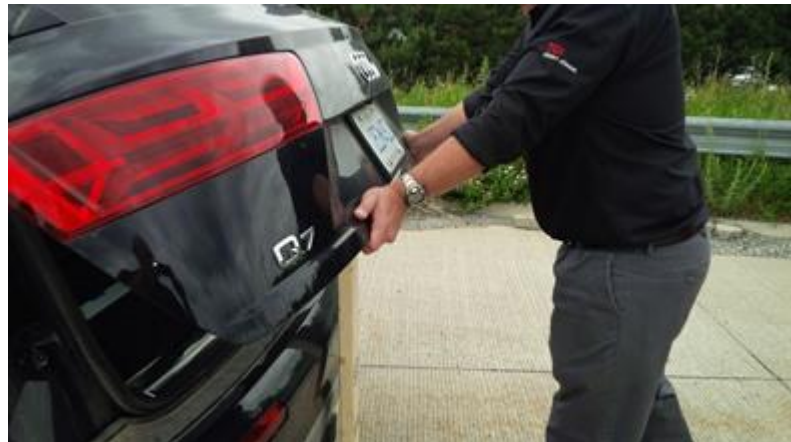
Figure 17. Applying downward pressure to rear lid to adjust latch angle.

18. Push down slightly on the rear lid with light pressure to move the latch angle as shown in the illustration (Figure 17). Reapply the marking medium, open and close the rear lid, and recheck the contact width on the paddles. Repeat this process until a contact width on the paddles is 6mm +/- 1mm.
