Technical Service Bulletin

Transaction No.: **2030465/10**

91 MMI 3G+ MMI inop; blank screen at startup; various technical issues (K0942 ZUG update; supersedes K0814 update)

Release date: Aug 18, 2016

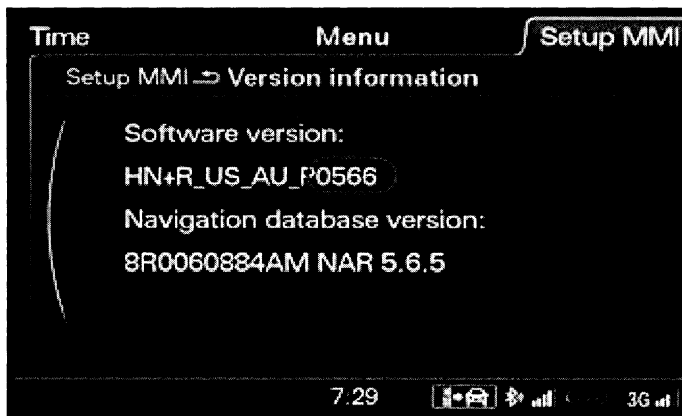
**Tip:** The MMI software version can be found under *Menu >> Setup MMI >> Version Information*. The software version will show the 4-digit software version number with a “P” or “K” prefix (“P” for Production and “K” for Service”) (Figure 1).

Figure 1. Example showing MMI software version (0566).

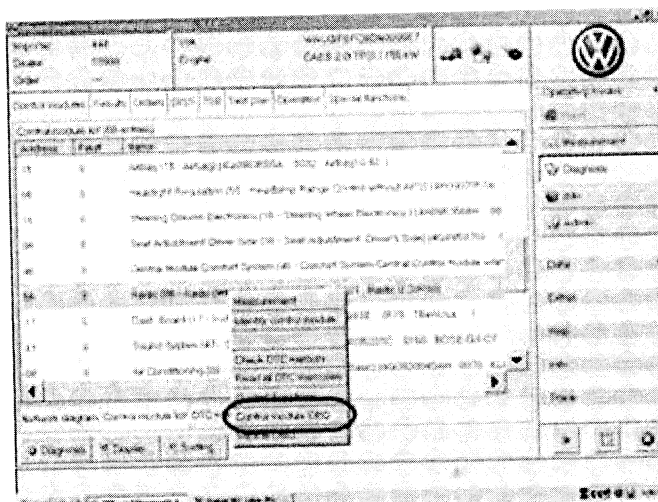
Figure 2. Radio self-diagnosis.

- Using ODIS, right-click on **56 – Radio** in the Control module list, and select **Control Module OBD** (Figure 2).

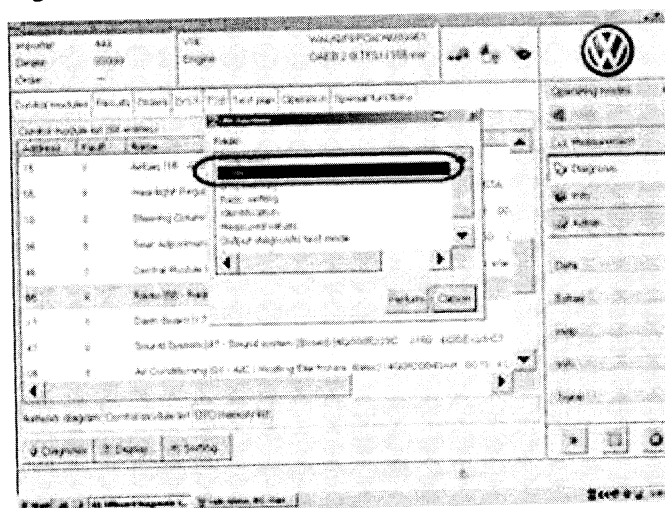
Figure 3. Code radio option.

- Select **Code** (Figure 3).

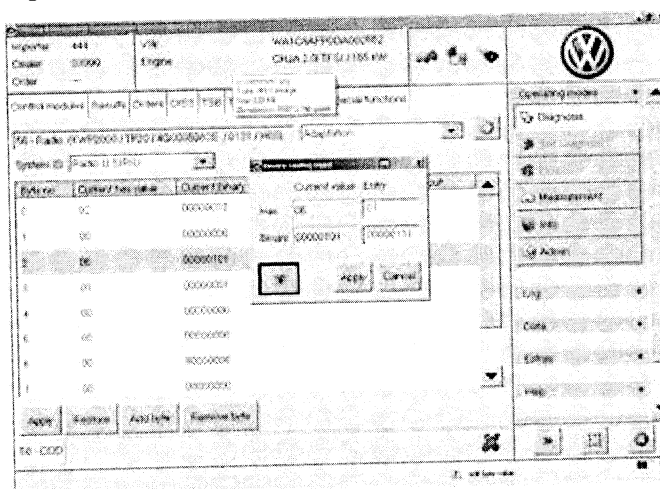
Figure 4. Changed radio coding.

- If it is not HEX 07, change the coding to HEX 07. Apply changes (Figure 4).

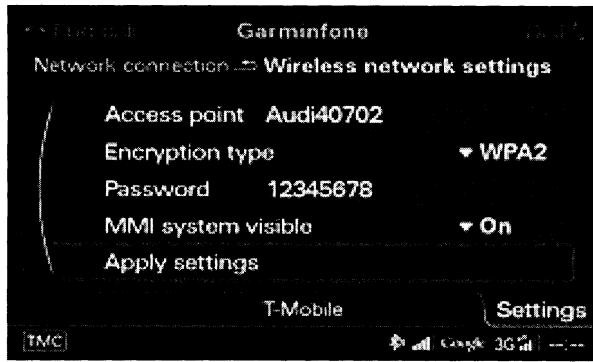
Figure 5. Wireless network settings.

As part of the update, wireless settings and paired devices will be deleted. All devices will need to be re-paired after the update, and all wireless settings restored to the customer's settings. To access the Wireless network settings on the MMI (Figure 5), press *TEL >> Settings >> Wireless network connection >> Wireless network settings*. Record all settings so they can be re-entered at the end of the update.

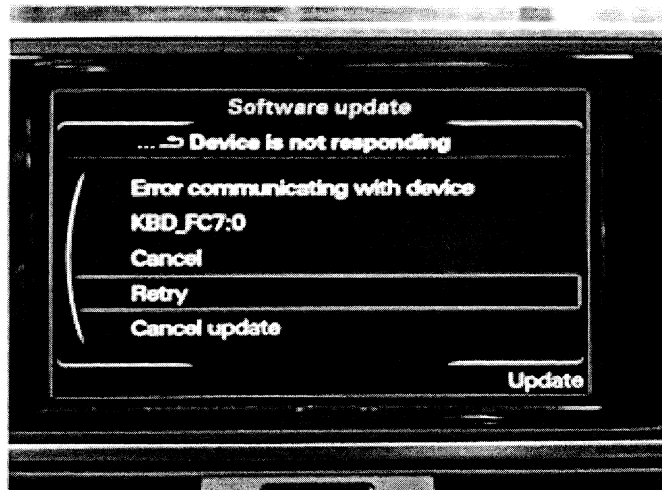
Figure 6. A device requiring a 'Cancel' selection.

Some earlier model year 2012 vehicles, or vehicles equipped with Bose® sound systems may experience certain modules that will not update properly during Step 16 of TSB 2028141. If this should occur, either choose 'Cancel' (Figure 6), or 'Skip device' (Figure 7), depending on the type of error. Do *not* choose 'Cancel update', as this may cause the software update to fail entirely. After the update is finished and the summary page is shown, select

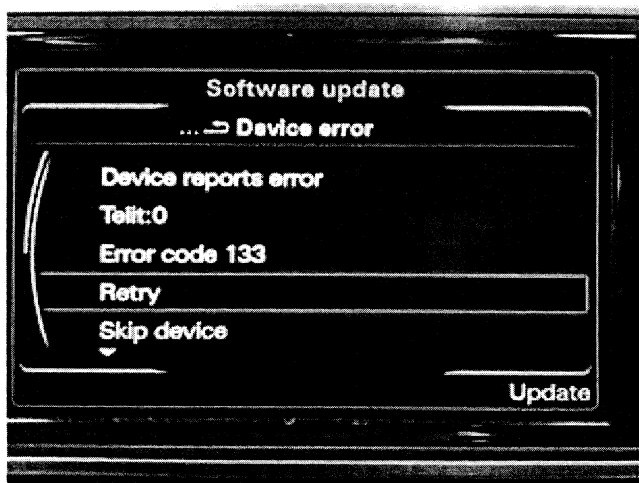
Figure 7. A device requiring a 'Skip device' selection.

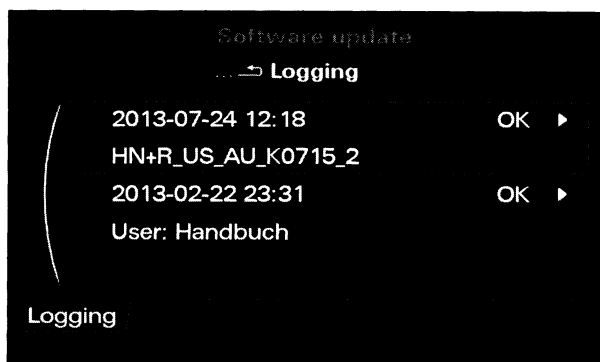
Figure 8. Software update log showing a successful software installation.

- Verify that the software update has been completed successfully by accessing the logging page (Figure 8). To access this screen, proceed to step 8 in TSB 2028141 and press the lower left softkey. A successful update will show the date the update was performed and the software that was installed (HN+R_US_AU_K0715_X), with 'OK' listed on the right (example 0715 installation). The 'X' may be one of several different numbers. If K0715_X does not have any rows with 'OK', the update must be retried until it is successful. For the latest P0942 update, this line would show K0942_X.

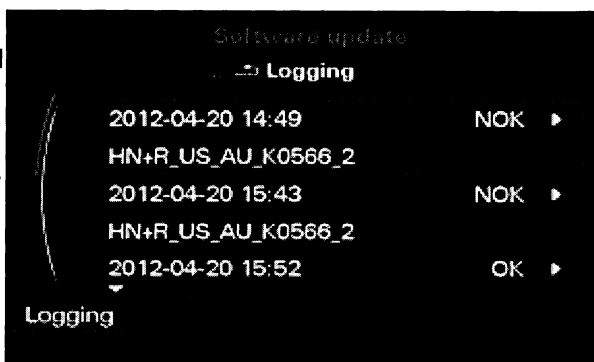
Figure 9. Software update log showing 2 failed attempts before a successful installation.

Tip: If the update must be performed two or more times due to modules not updating correctly, a screenshot of the software update log is required (Figure 9). This should be kept on-hand for warranty auditing purposes. To take a screenshot, insert an SD Card into slot 1. For A6/A7/A8/Q7, press and hold the left and right arrow keys at the same time. For A4/A5/Q5, press and hold the bottom two softkeys at the same time. All 4 softkeys will flash when the screenshot is taken. A screenshot should be taken of each page in the logging display.
