16730/P0346

From Ross-Tech Wiki

16730/P0346 - Camshaft Position Sensor (G163): Implausible Signal

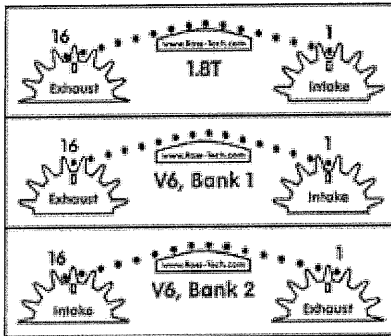
- Please see TPI 2012630 for information about Camshaft Adjusters binding.
 - If the camshaft adjuster is suspected you may be able to swap the left and right side components to see if the fault code moves (*providing the parts are compatible*).
- On engines with chain driven intake camshaft(s), but belt driven exhaust camshaft(s), verify the number of chain roller links between the intake and exhaust camshafts is correct. Click on thumbnail to enlarge:
