# Safety Recall Circular

Code: 20L8/JY

Subject: 2001-2004 MY Audi A6 quattro® 2.7L, 2.8L, 3.0L or 4.2L

Reinforce Fuel Tank Rollover Valve Nipple

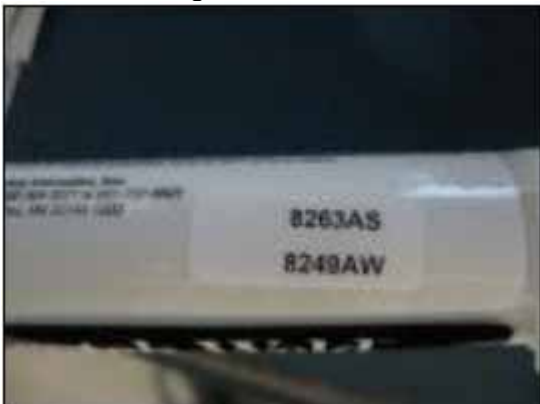
**Old date coding method**

An expiration date label from 3M will be affixed on top of the original date stamp. See pictures below.

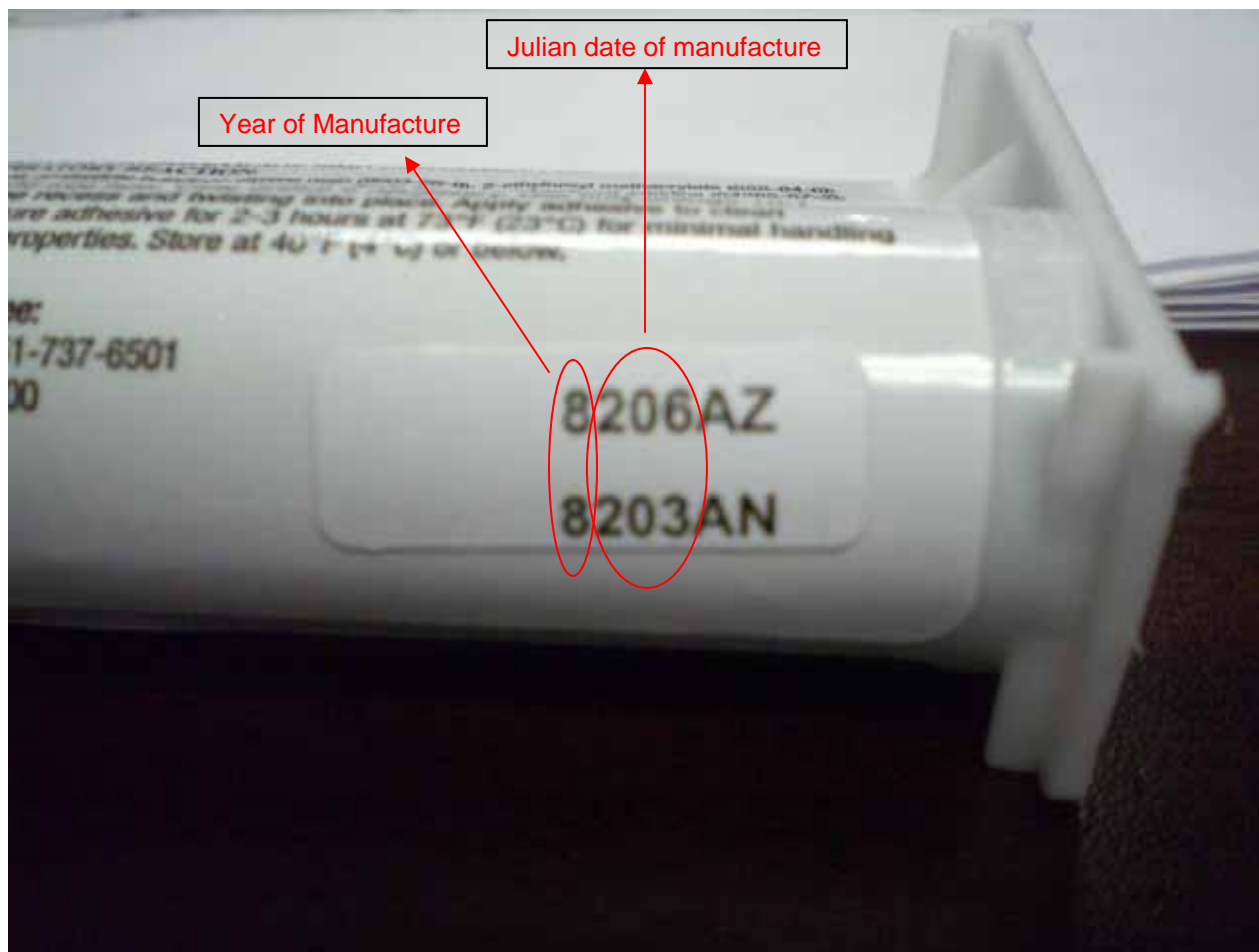
### JULIAN DATE CODE METHOD

**8206AZ**

FIRST NUMBER (**8**) = YEAR OF  
MANUFACTURE

SECOND 3 DIGITS (**206**) = JULIAN DATE OF  
MANUFACTURE

LAST 2 CHARACTERS (**AZ**) = LOT CODE (random, not  
sequential)

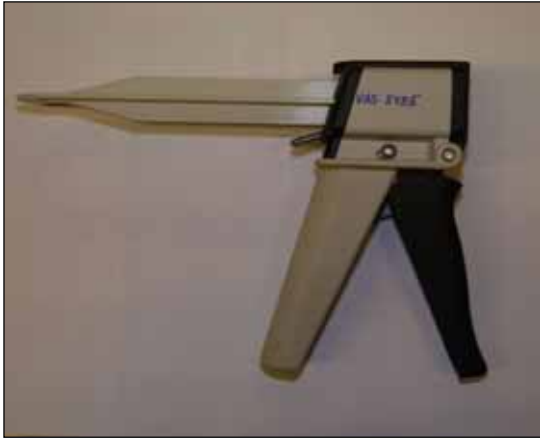
- ⇐ Applicator gun VAS 5155  
*(Dealers received one (1) each of these tools, free of charge. Additional or replacement tools can be obtained at dealer expense by calling Equipment Solutions at 1(800) 892-9650.)*

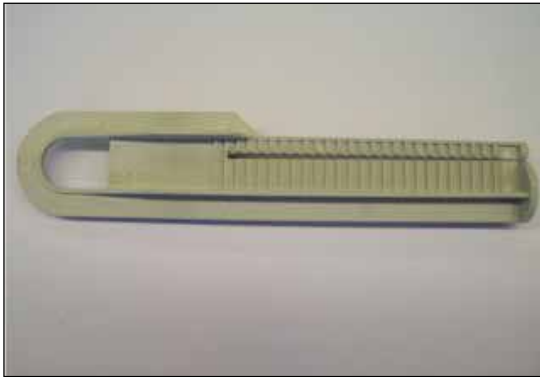
- ⇐ Feed plunger VAS 5155/3  
(for glue cartridge with mixing ratio 1:10)  
*(Dealers received one (1) each of these tools, free of charge. Additional or replacement tools can be obtained at dealer expense by calling Equipment Solutions at 1(800) 892-9650.)*

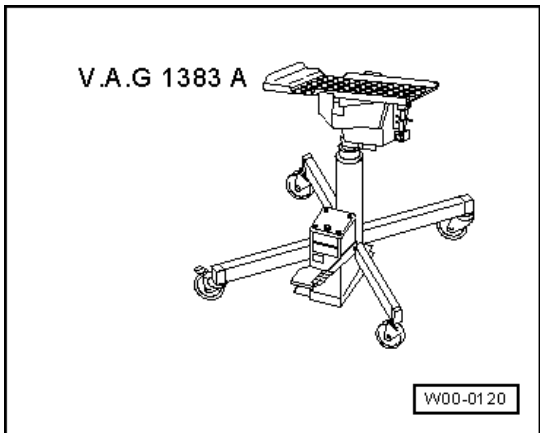
- ⇐ V.A.G. 1383 A with universal support V.A.G. 1359/2 or equivalent

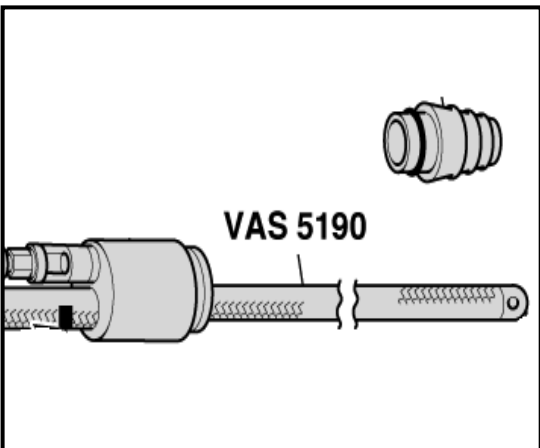
- ⇐ Fuel siphoning device VAS 5190 or equivalent

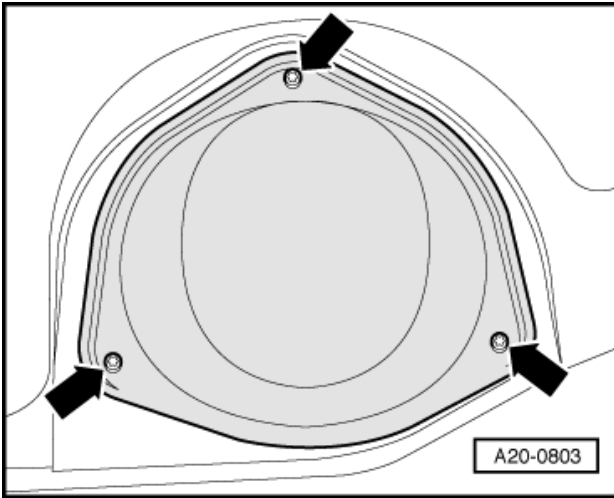
- Remove rear seat bench
- ⇐ Remove cover for flange on fuel tank under rear seat bench (driver side)

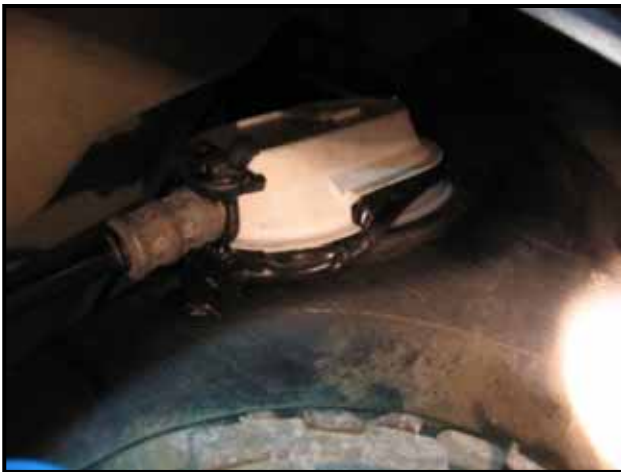
If black mold (shown white in picture) and 3M™ adhesive are present, no further work is required; otherwise, proceed to **Section B**

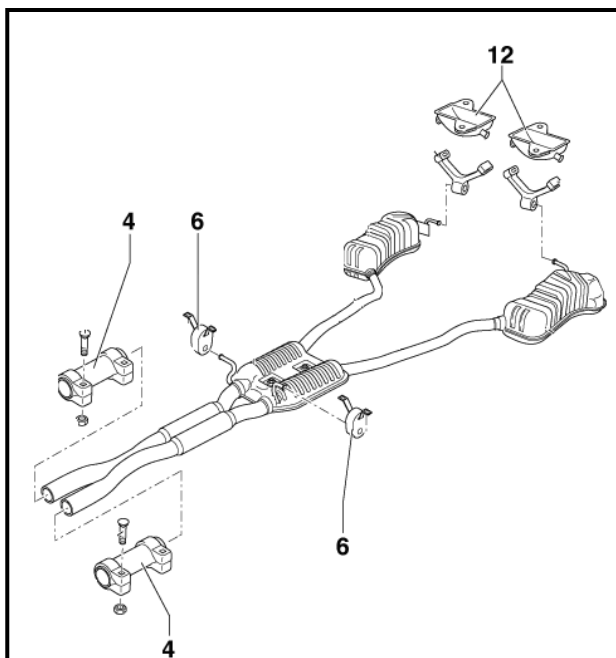
- Lift vehicle
- ⇐ Disconnect rear exhaust at clamps <4>
- ⇐ With assistance of another person, disconnect rear support brackets <12> and <6> and lower exhaust onto floor
- Move exhaust from underneath vehicle and place aside

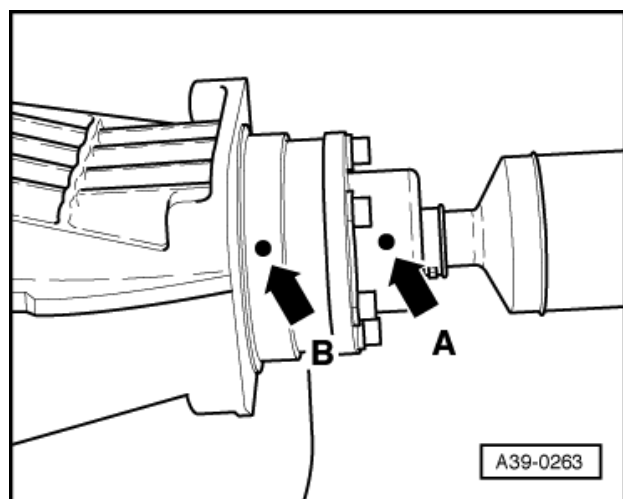
- ⇐ Check whether there is a factory marking (paint) on driveshaft. If not, mark location of driveshaft flange <arrow A> to rear final drive <arrow B>

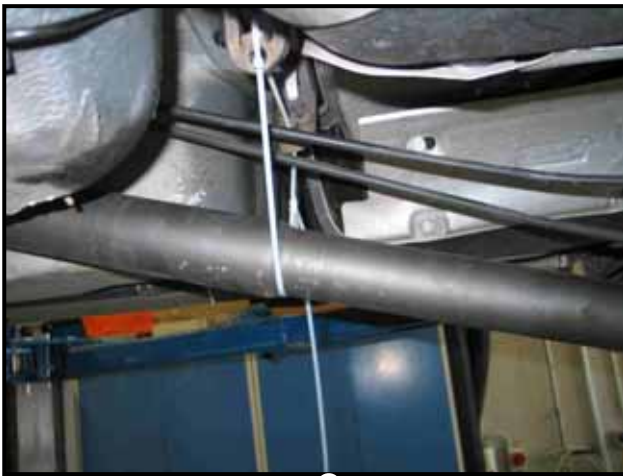
⇐ Detach driveshaft from rear final drive, lower it slightly (max. permissible angle 15°) and tie wrap to exhaust system brackets

⚠ Note: To prevent damage to transmission ensure driveshaft not lowered more than 15°

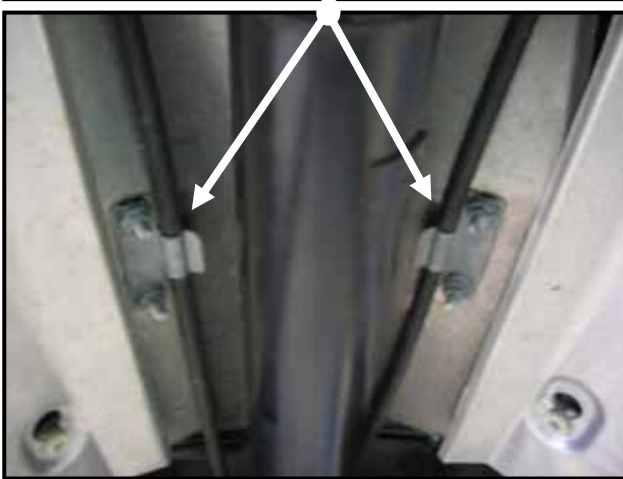
⇐ Detach parking brake cable from heat shield clips located on each side of the driveshaft

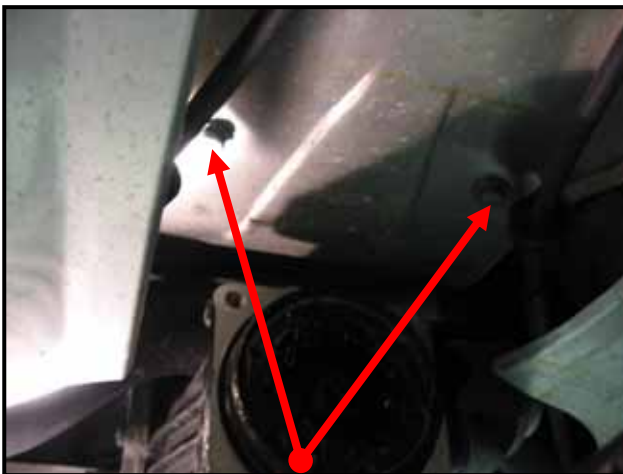
⇐ Remove 2 bolts in heat shield above rear differential and driveshaft <arrows>

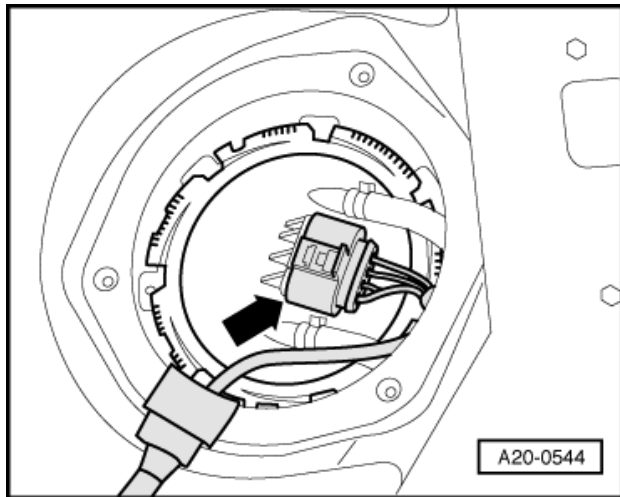
- Lower vehicle
- ⇐ Carefully release 4-pin connector <arrow> and disconnect harness for fuel sending unit

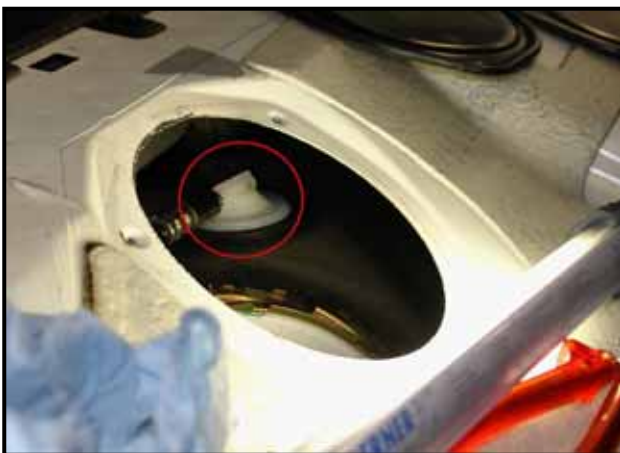
⇐ Clean rollover valve carefully with cleaning fluid (D 009 401 04) to ensure valve is free of dust and grease

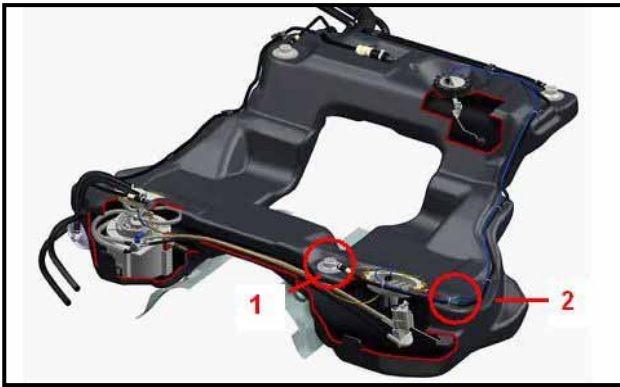
⇐ Install serrated rubber clip <2> from kit (4B0 298 403) onto ventilation line leading to rollover valve connection and release clip from mounting on fuel tank

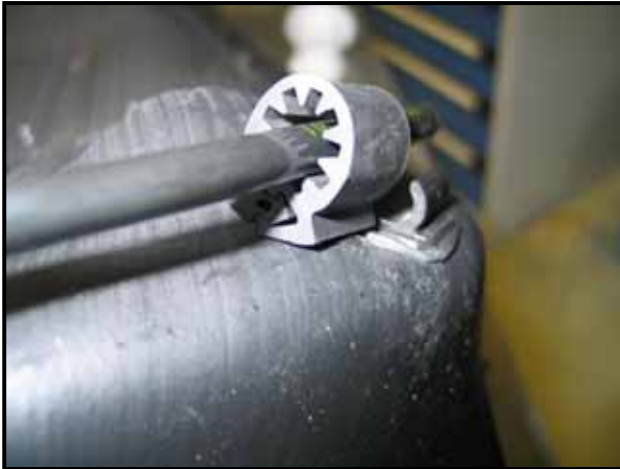
⇐ Close rubber clip and allow ventilation line to rest on fuel tank (as shown); **proceed to Section C**

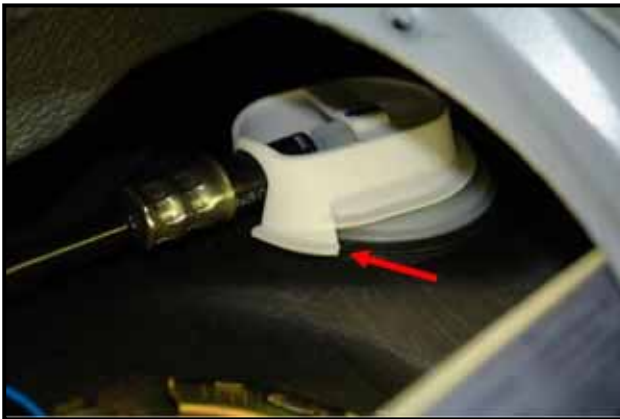
- Test fitting of the mold
- ⇐ To ensure proper fit, place mold for adhesive in position on rollover valve **without** butyl cord

⚠ Note: Mold must be pushed toward hose connection and shoulder of mold must fit against flange of fuel tank <arrow>, not against the flange of the rollover valve

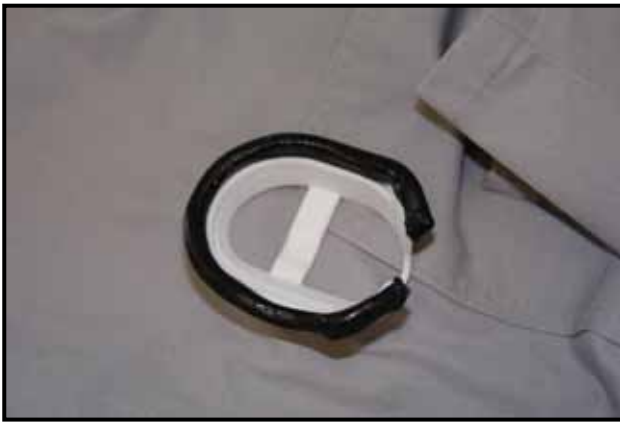
⇐ Remove mold from rollover valve, then place butyl cord around mold

⚠ Note: Leave an opening for the ventilation line connection

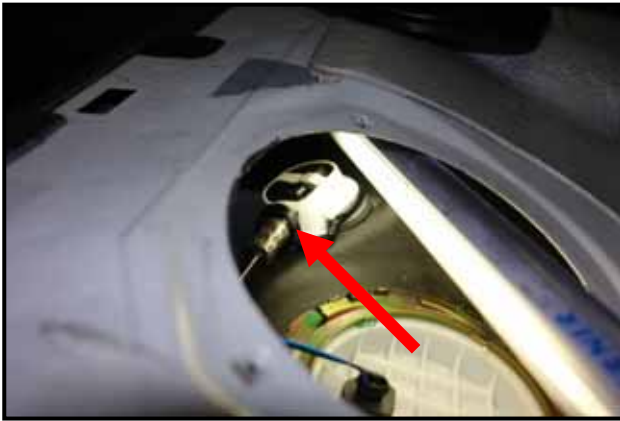
- Install mold with butyl sealant cord (AKL 450 005 05) into position over rollover
- ⇐ Seal off remaining openings at the connection with the butyl sealant cord (AKL 450 005 05) <arrow>

⚠ Note: Ensure all openings are closed completely to prevent leaking from mold

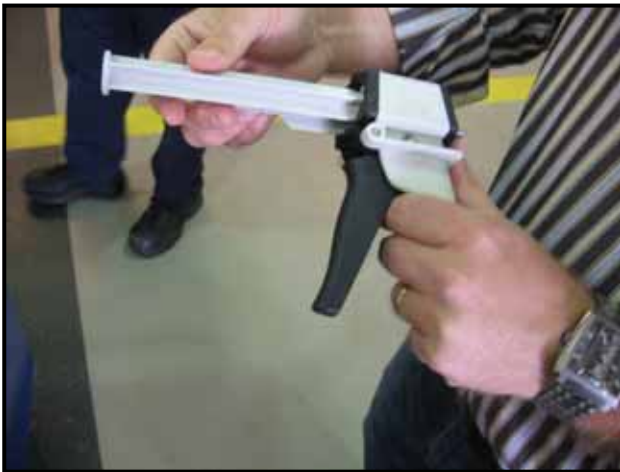
⇐ Assemble VAS 5155 applicator gun by sliding the VAS 5155/3 (10:1) plunger into applicator gun

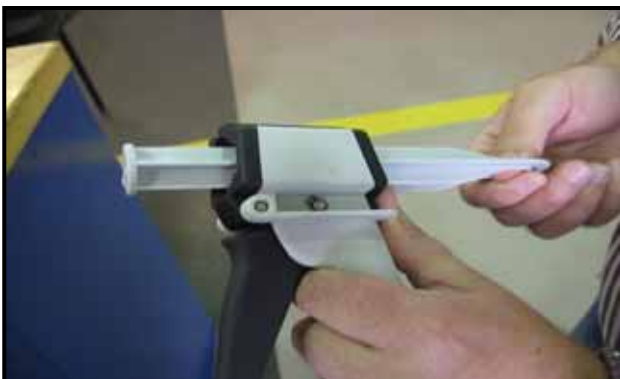
⇐ Pull plunger VAS 5155/3 to rear

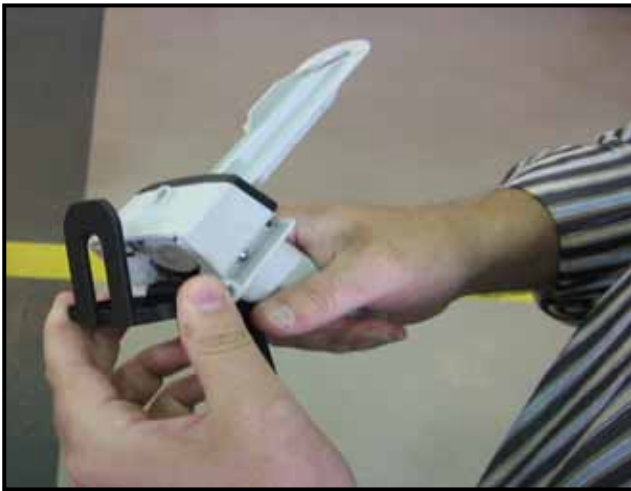
⇐ Lift black tab and fold to front of applicator gun

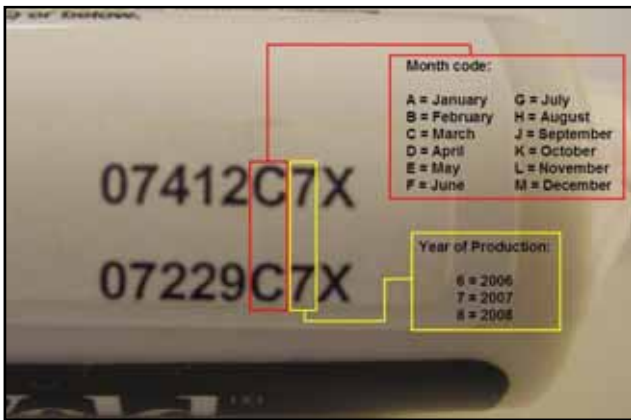
⇐ Production date located on 3M™ adhesive tube label

⚠ Note: DO NOT use expired adhesive

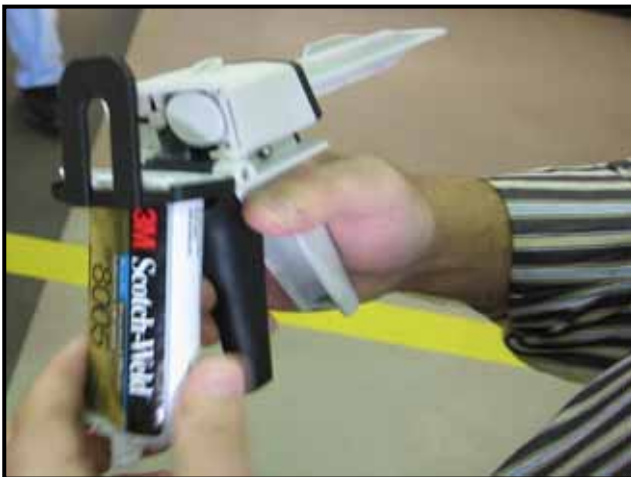
⇐ Insert adhesive cartridge (Z3MDP8005) in the VAS 5155 applicator gun and remove cap

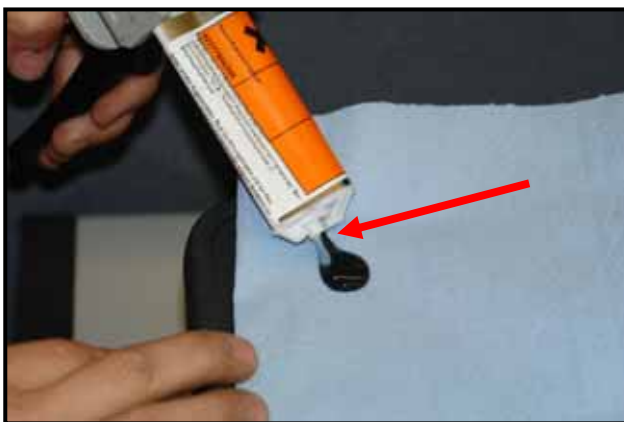
⇐ Operate adhesive gun **without** the mixing nozzle (D 001 001) until visible amount of adhesive comes out of both chambers of the cartridge <arrow>

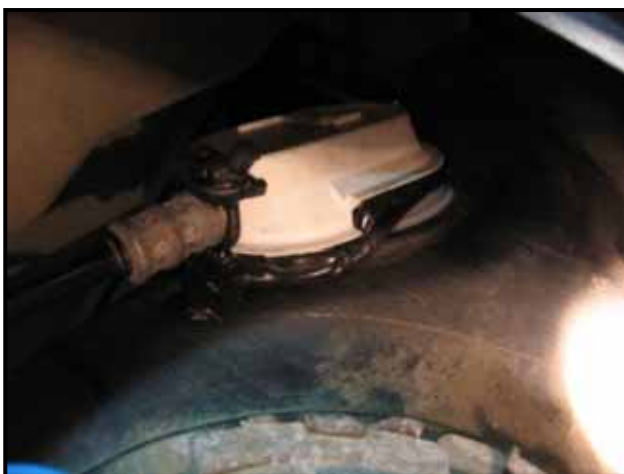
- Clean tip of cartridge and fit the mixing nozzle (D 001 001)
- With nozzle installed, check 3M™ adhesive flow to ensure compounds are blended

⚠ Note: Compounds must be blended as exiting the applicator nozzle  
If compounds separate, **DO NOT USE!**  
If compounds appear clumpy or gel-like, **DO NOT USE!**

⚠ Note: Adhesive must be applied within 10 minutes from time cartridge is opened

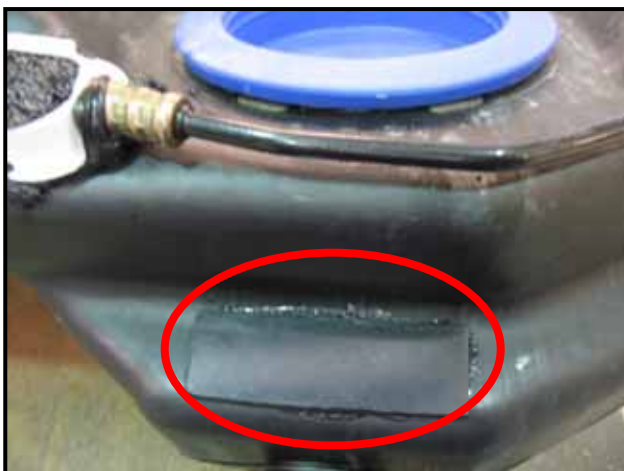
- Lift vehicle
  - Apply small amount of adhesive to spacer plate
- ⇐ Attach spacer plate to contact surface of fuel tank <circle>

⚠ Note: Ensure that the spacer plate fits flat onto the surface of the fuel tank and not over the upward curve of the fuel tank wall

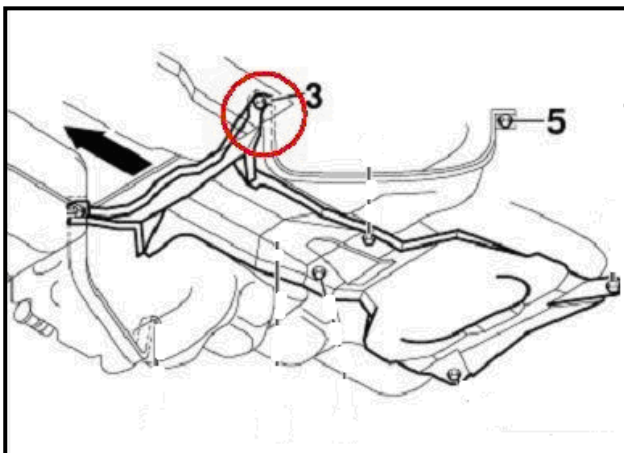
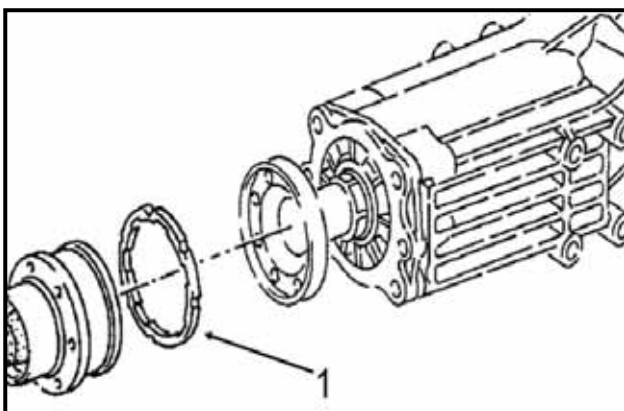
- Raise fuel tank carefully to its original position
  - Fit retaining strap on passenger side of vehicle into original position
  - Loosely tighten bolts
- ⇐ Fit both 3 mm spacer washers (N 904 773 02) between carrier plate and vehicle underside <3> with M8x35 mm bolt (N 908 706 02)
- ⇐ Torque retaining strap bolts <3> and <5> to 23 Nm
