Technical Service Bulletin

Poor performance because of leak in vacuum system

24 08 29 2017521/1 June 26, 2008

Model(s)	Year	VIN Range	Vehicle-Specific Equipment
RS4	2007 – 2008	All	4.2L V8 FSI Engine
RS4 Cabriolet	2008	All

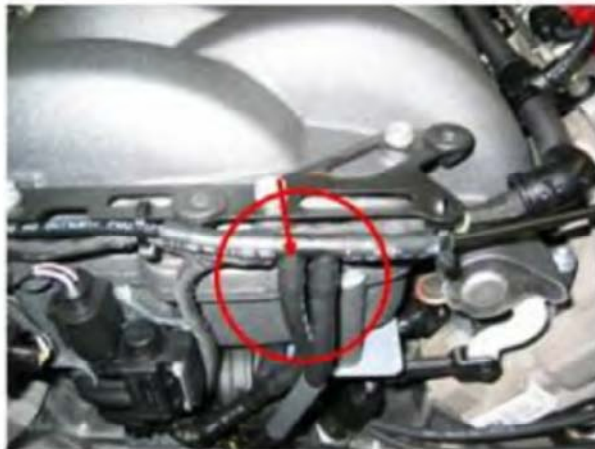
1. Remove the front intake manifold cover and bracket.
2. Remove the lower right hose on the double T piece in driving direction (Figure 1).

Figure 1. The lower right hose on the double T piece.

3. Connect VAS 6213 vacuum gauge to the hose.
4. Start the engine.
5. Ensure the measured vacuum on the vacuum gauge at idle speed is at least 500 mbar.
6. Switch off the engine.
7. If vacuum readings are not correct, reference TSB 2012844 regarding intake manifold vacuum supply hose.
8. If vacuum reading is correct, reconnect hose and continue the system checks.
9. Start engine and run at idle for two minutes to fill vacuum reservoir.
10. Shut off engine.
11. Test vacuum system components using VAS5051 in *Vehicle Self Diagnosis >> 005 Output Diagnostic Test Mode*. The tests will not start if the engine is running.

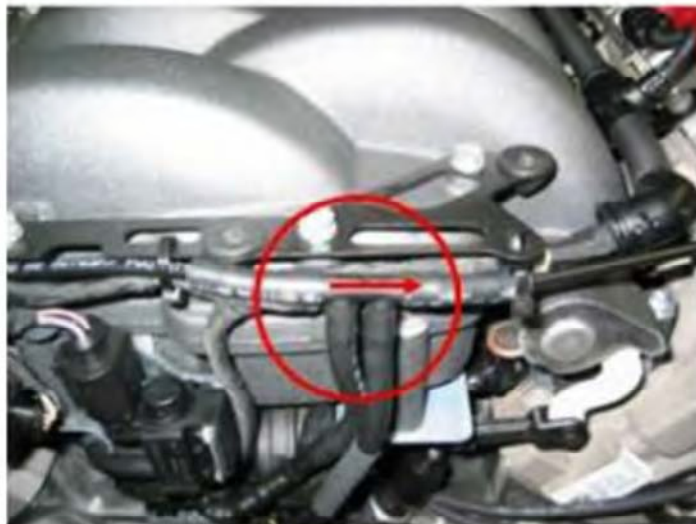
1. Remove the upper left hose on the double T pipe in driving direction (Figure 2).

Figure 2. The upper left hose on the double T pipe.

2. Connect a vacuum gauge to the hose.
3. Activate Exhaust Flap Valve N321 with *Vehicle Self Diagnosis >> 005 Output Diagnostic Test Mode*.
4. Create a vacuum of at least 500 mbar.
5. Within a minute the vacuum must not drop by more than 10 mbar. Both exhaust flaps must be closed.

6. If not correct, inspect the vacuum pipes between engine compartment and exhaust flaps for leaks and kinks.

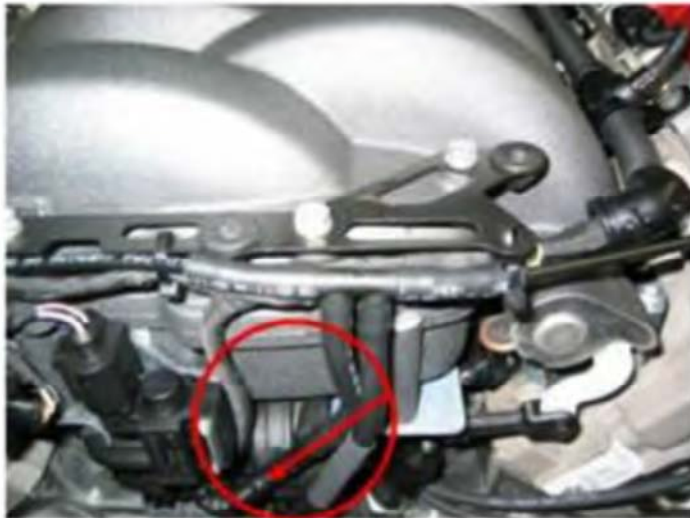
1. Remove the lower T pipe of the lower hose (Figure 3).

Figure 3. The lower T pipe of the lower hose.

2. Connect a vacuum pump to the hose.
3. Activate Intake Manifold Runner Control (IMRC) Valve N316 with *Vehicle Self Diagnosis >> 005 Output Diagnostic Test Mode*.
4. Create a vacuum of 500 mbar.
5. Within a minute the vacuum must not drop by more than 10 mbar. Both tumble flaps must be operated.
6. If not correct, check the vacuum pipe between T pipe and tumble flaps for leaks and kinks.

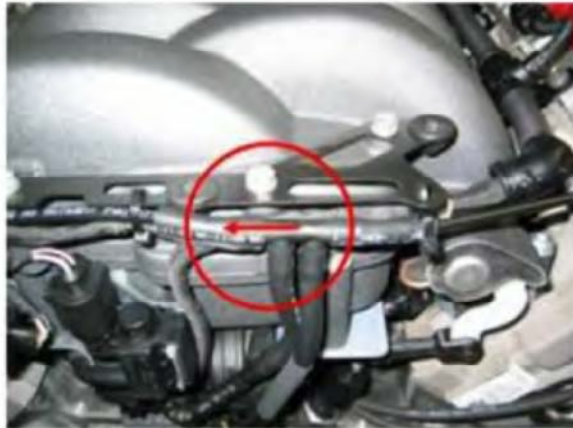
1. Remove the upper right hose on the double T pipe in driving direction (Figure 4).

Figure 4. The upper right nose on the double T pipe.

2. Connect a vacuum pump to the hose.
3. Activate Intake Air Switch-over Valve N335 with Vehicle Self Diagnosis > 005 Output Diagnostic Test Mode.
4. Create a vacuum of 500 mbar.
5. Within a minute the vacuum must not drop by more than 10 mbar. The air filter flap must be open.
6. If not correct, check the vacuum pipe between T pipe and air filter flap for leaks and kinks.

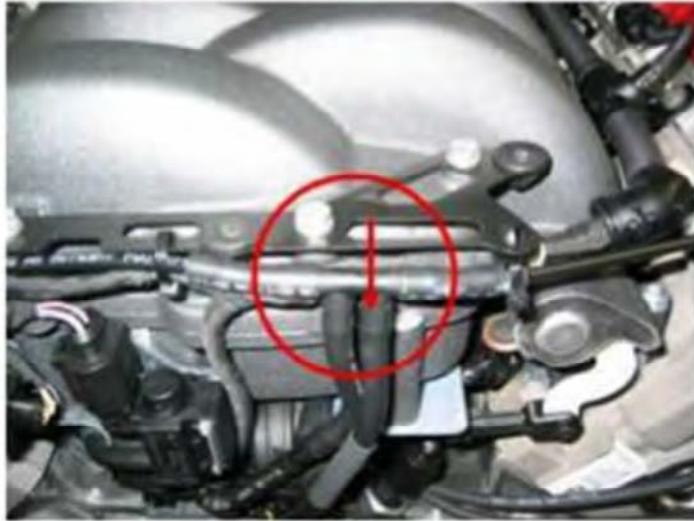
1. Remove the lower left hose on the double T pipe in driving direction (Figure 5).

Figure 5. The lower left hose on the double T pipe.

2. Connect a vacuum pump to the hose.
3. Create a vacuum of 500 mbar.
4. Within a minute the vacuum must not drop by more than 10 mbar.
5. If not correct, check the vacuum pipes between T pipe and changeover valve under the intake manifold for leaks and kinks.
