Your Vehicle: 2010 Audi Q7 Quattro (4LB) V6-3.0L DSL Turbo (CATA)

[Vehicle](#) » [Technical Service Bulletins](#) » [All Technical Service Bulletins](#) » [Body - Noises From The Sunroof Area](#) » [Service](#) » [Audi Q5/Audi Q7](#)

Audi Q5/Audi Q7

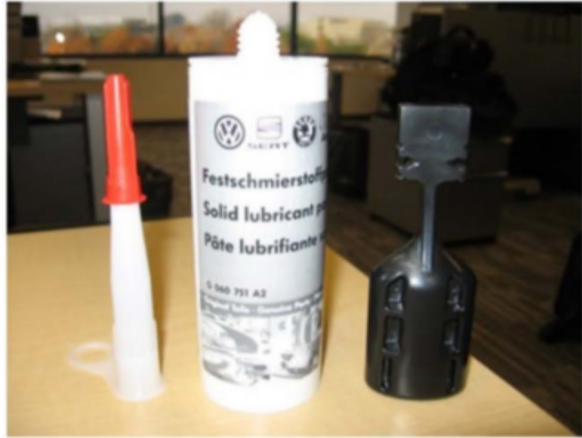
Figure 23. Lubricant and VAS 6621.

1. Thread the VAS 6621 tool onto the lubricant canister (G 060 751 A2). Install the assembly into the VAG 1628.

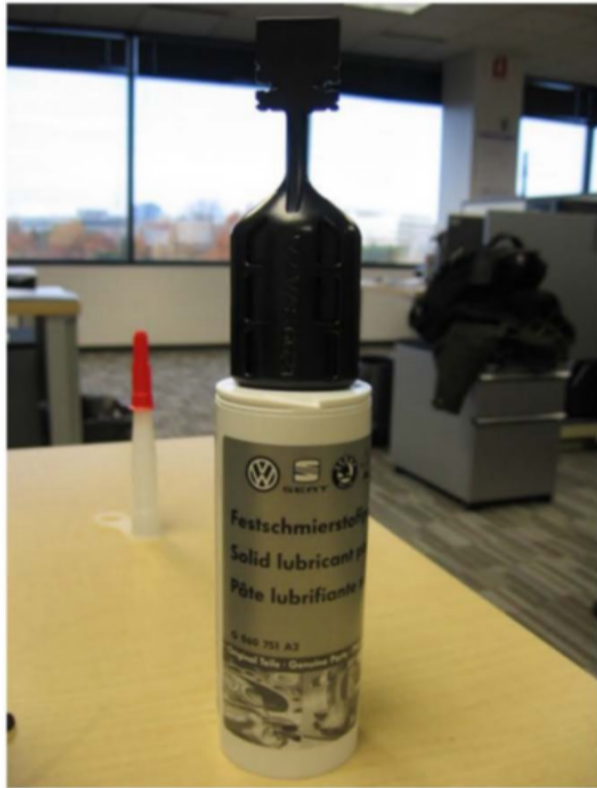
Figure 24. Lubricant with VAS 6621 installed.

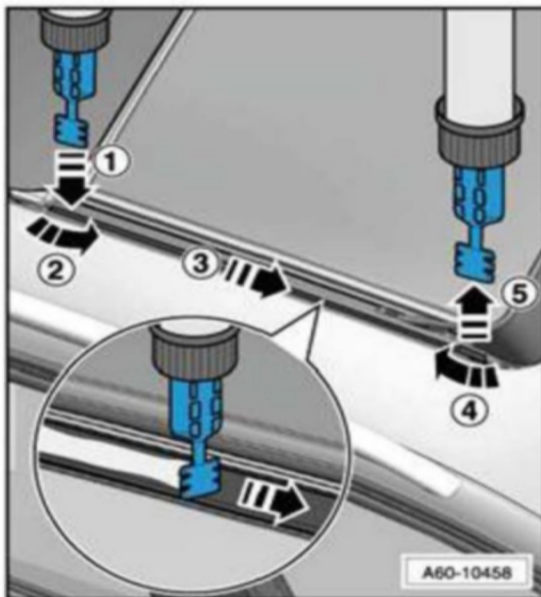
Figure 25. Install VAS 6621 with canister.

2. Insert the VAS 6621 into the guide rails in the same way as the cleaning procedure and inject the lubricant evenly along the guide rails. Perform this along the entire length of the guide rails and to both sides.

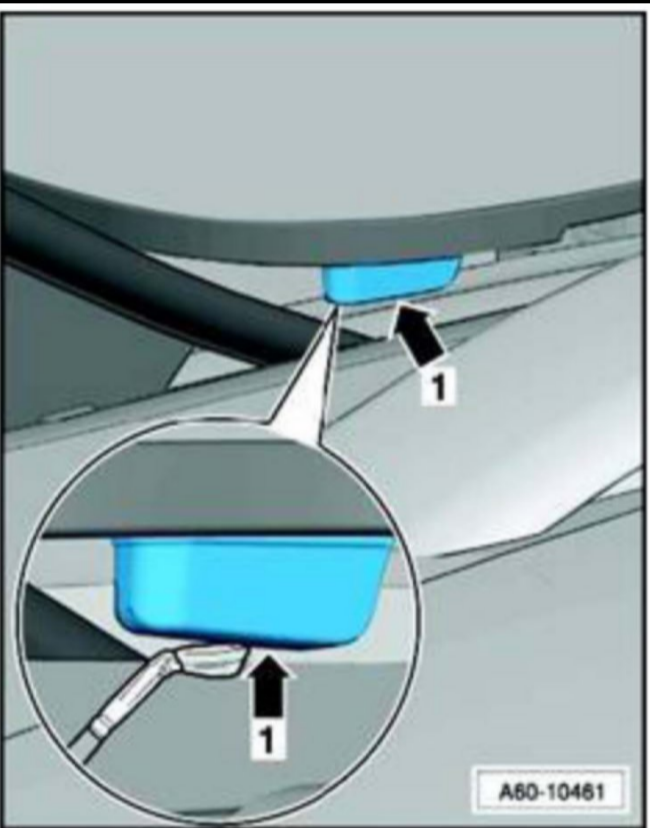
Figure 29. Cleaning and lubricating slides.

1. Clean the slides with a lint-free cloth. Apply lubricant G 060 751 A2 to the slides with a brush to both slides.

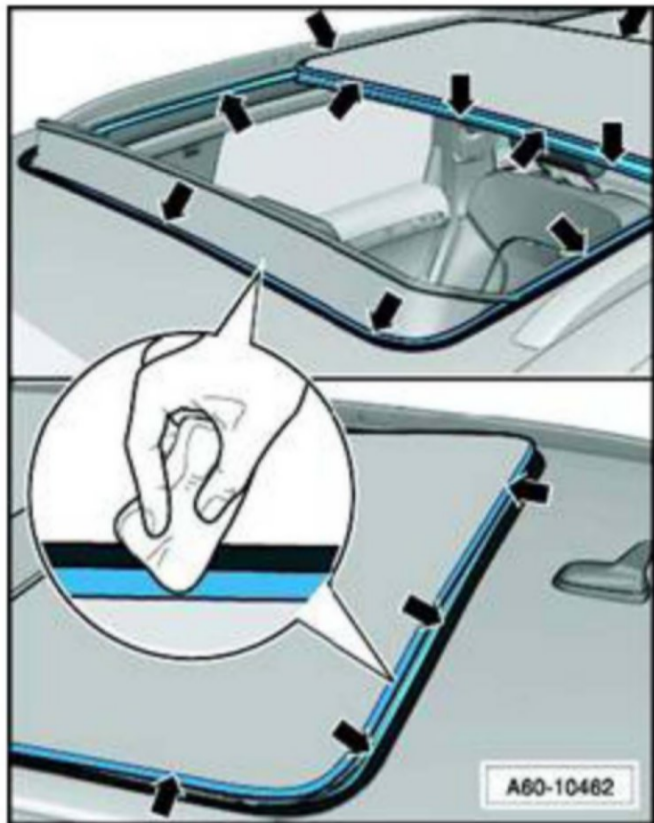
Figure 30. Cleaning the seals.

1. Clean all the seals with all-purpose cleaner D 009 401 04 and a lint-free cloth.

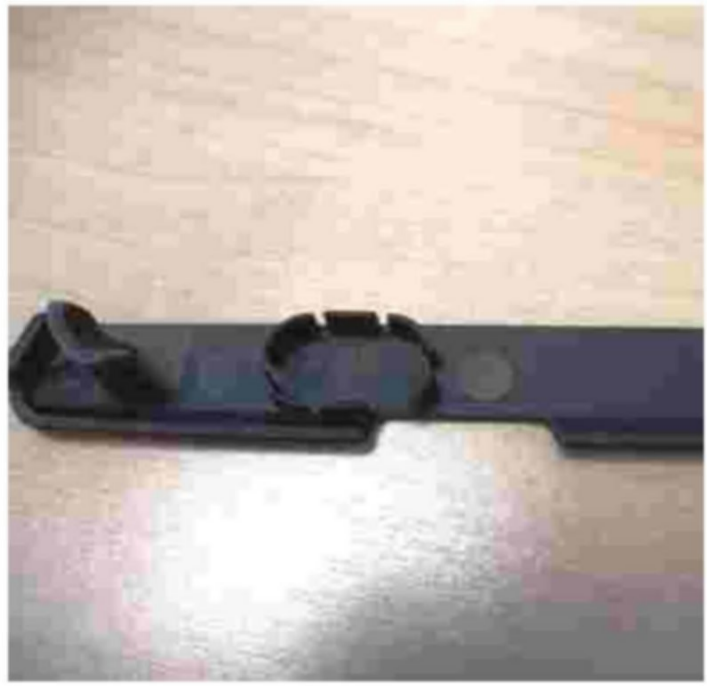
3. Another source of noise can come from the sunroof panel trim. Make certain that all of the sunroof trim is intact and correctly installed.

Figure 36. *Intact sunroof trim.*
