Your Vehicle: 2010 Audi Q7 Quattro (4LB) V6-3.0L DSL Turbo (CATA)

Body - Sun Roof Various Squeaks and Rattles

70 Noises from [headliner](#) / sunroof area

2038029/4

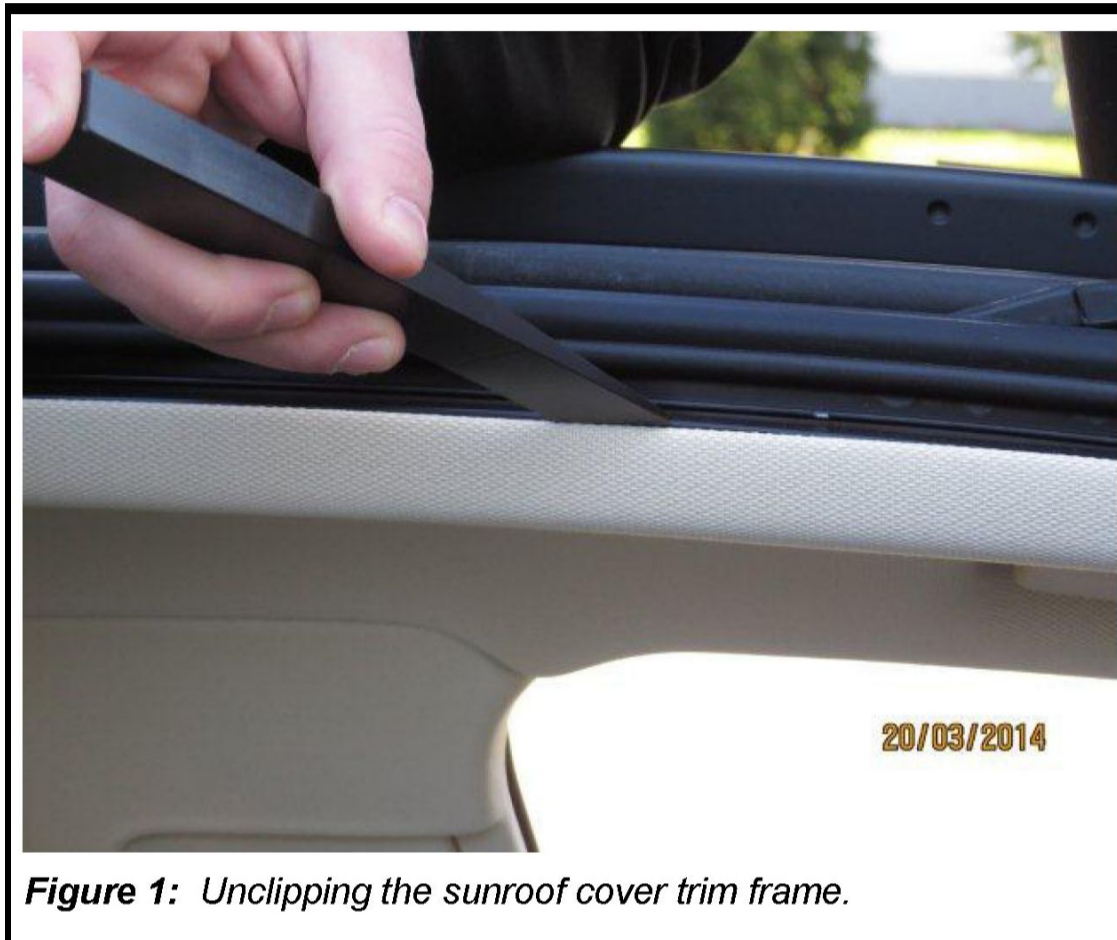
Figure 1: Unclipping the sunroof cover trim frame.

1. Remove the glass sliding roof panel(s). Remove the beam for the sunroof rollershade. Carefully unclip and remove the sunroof cover trim frame (Figure 1).

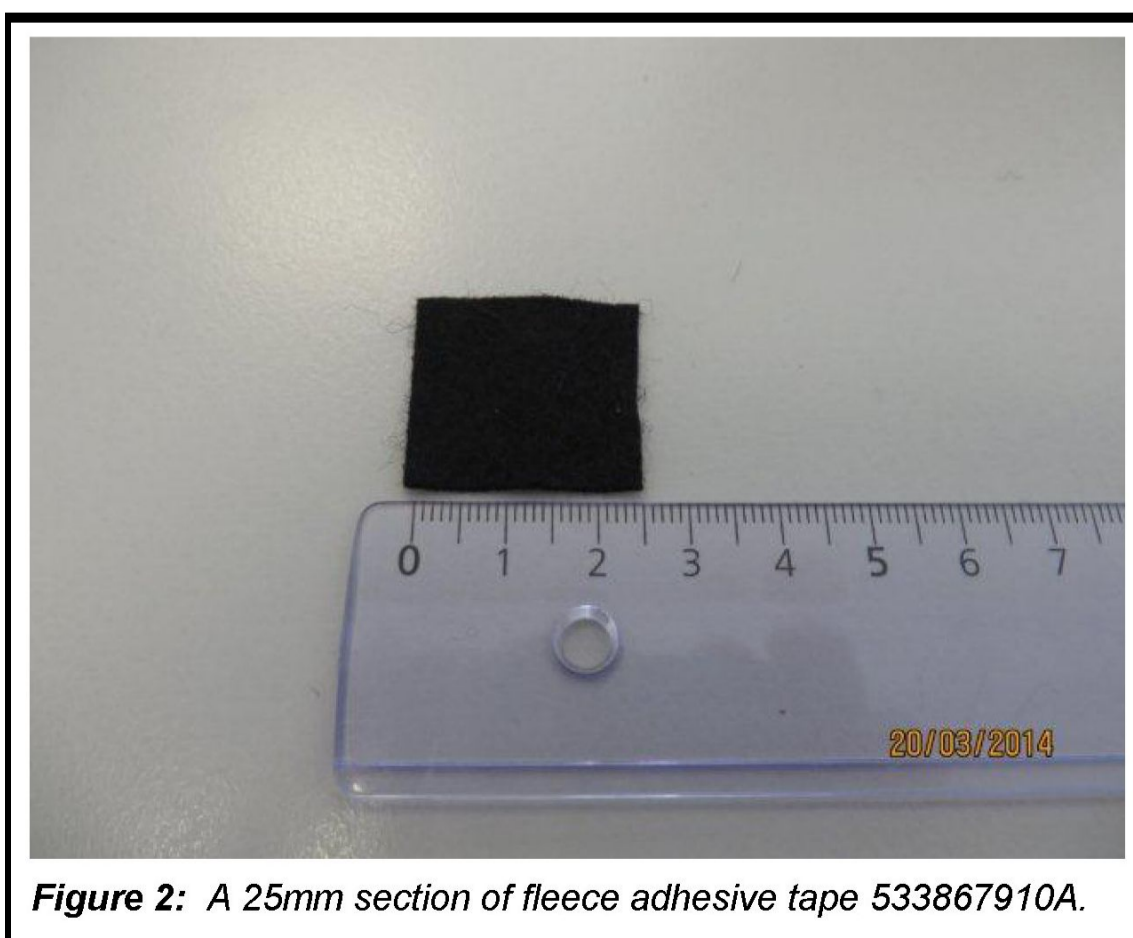
Figure 2: A 25mm section of fleece adhesive tape 533867910A.

2. The number of retaining clips will vary by model. A piece of dampening tape (fleece adhesive tape 533867910A) will be applied to each clipping point. Cut pieces of the tape 25mm long (Figure 2).

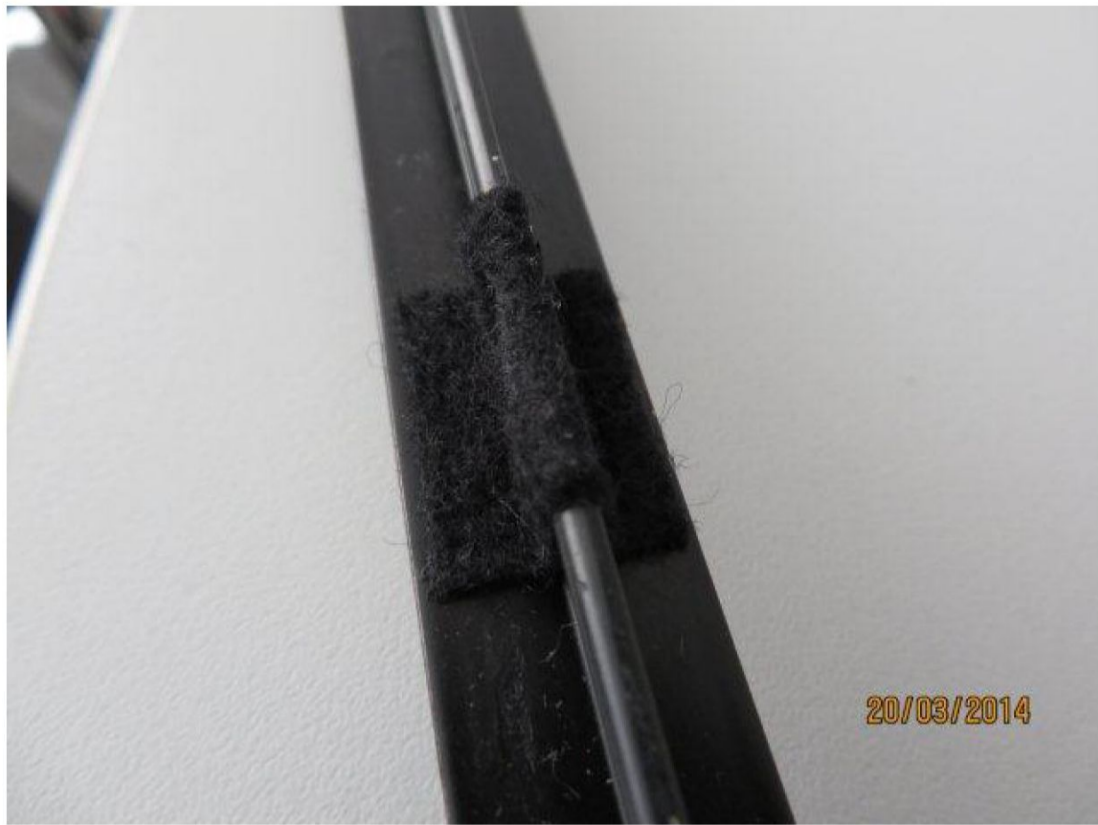
Figure 3: Fleece tape section applied.

3. Apply the sections of fleece tape to the sunroof cover trim frame to each clipping point as shown (Figure 3 and Figure 4).

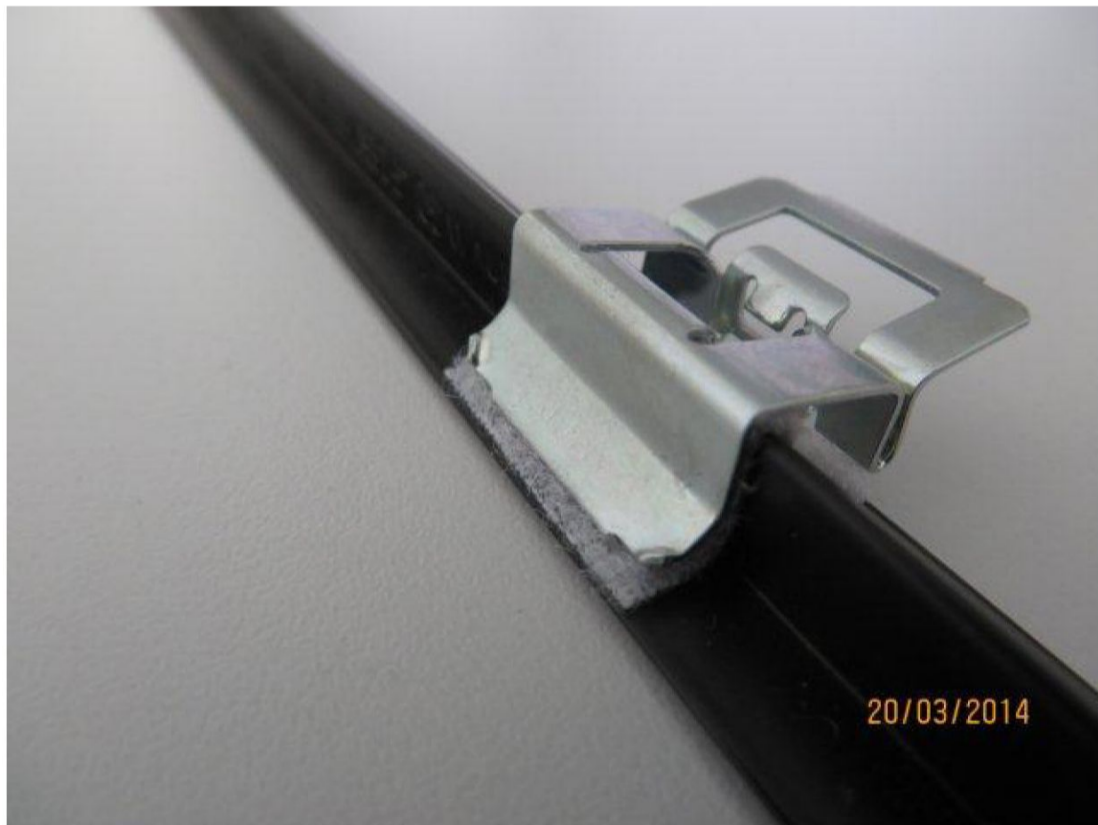
Figure 4: Retaining clip isolated with the fleece tape.

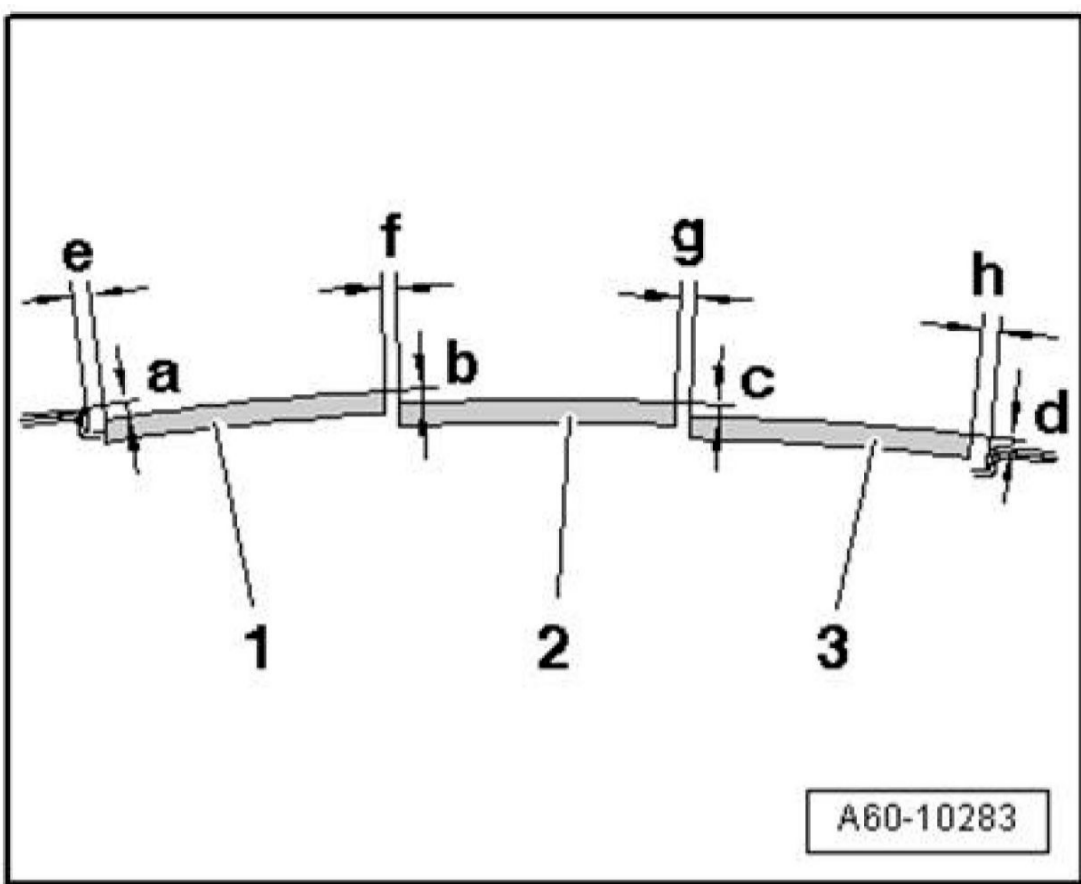
Figure 5: Adjustment of the glass sliding roof panels.

4. Reassemble the components removed for this modification. Ensure that the glass sliding roof panels are adjusted properly according to the repair manual (Figure 5).
