Your Vehicle: 2010 Audi Q7 Quattro (4LB) V6-3.0L DSL Turbo (CATA)

[Vehicle](#) » [Technical Service Bulletins](#) » [All Technical Service Bulletins](#) » [Body - Noises From The Sunroof Area](#) » [Service](#) » [Audi Q5/Audi Q7](#)

## Audi Q5/Audi Q7

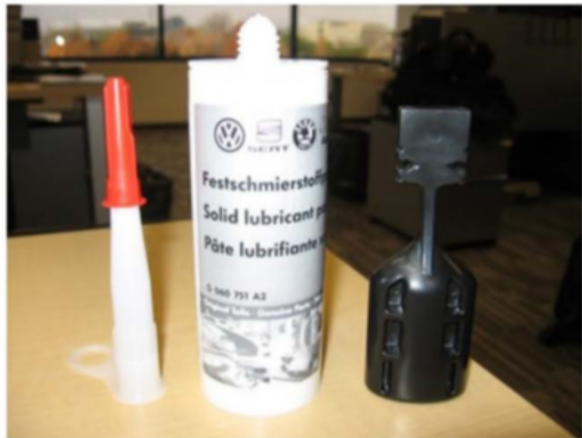
**Figure 23.** Lubricant and VAS 6621.

1. Thread the VAS 6621 tool onto the lubricant canister (G 060 751 A2). Install the assembly into the VAG 1628.

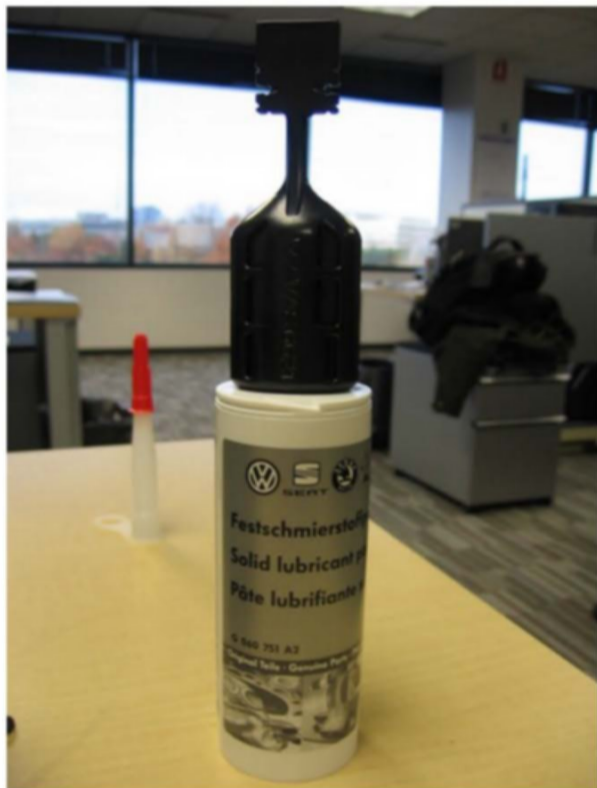
**Figure 24.** Lubricant with VAS 6621 installed.

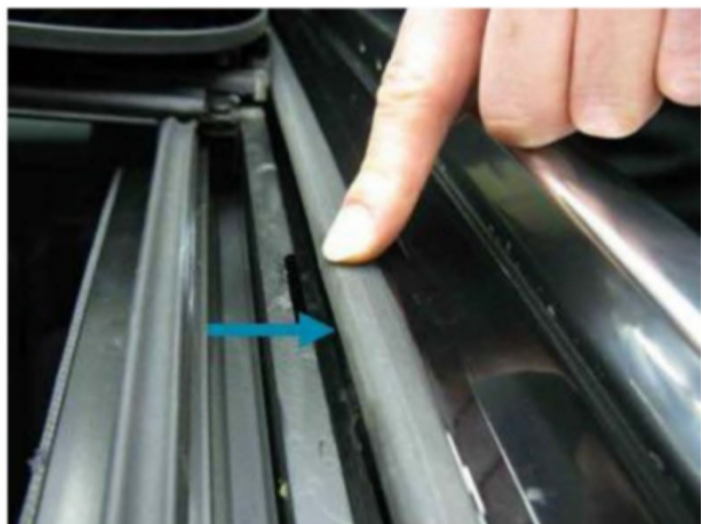
**Figure 31.** Perimeter seal.

2. Lubricate all the seals with special lubricating paste G 052 141 A2 using a brush.

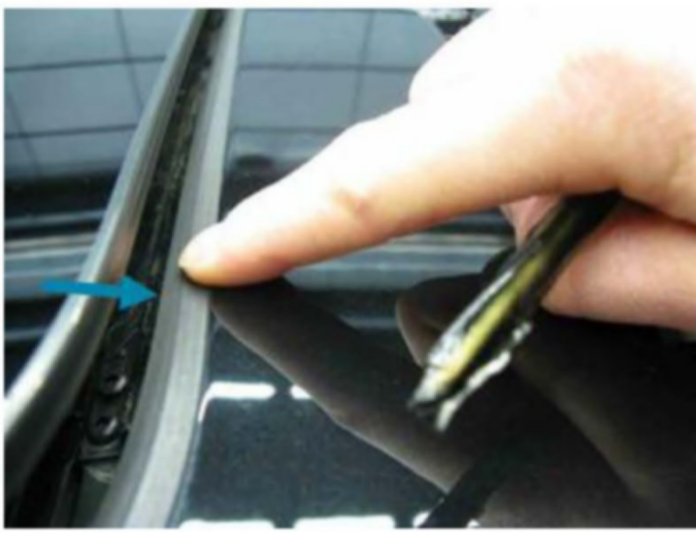
**Figure 32.** Audi Q7 seal for cover 3.

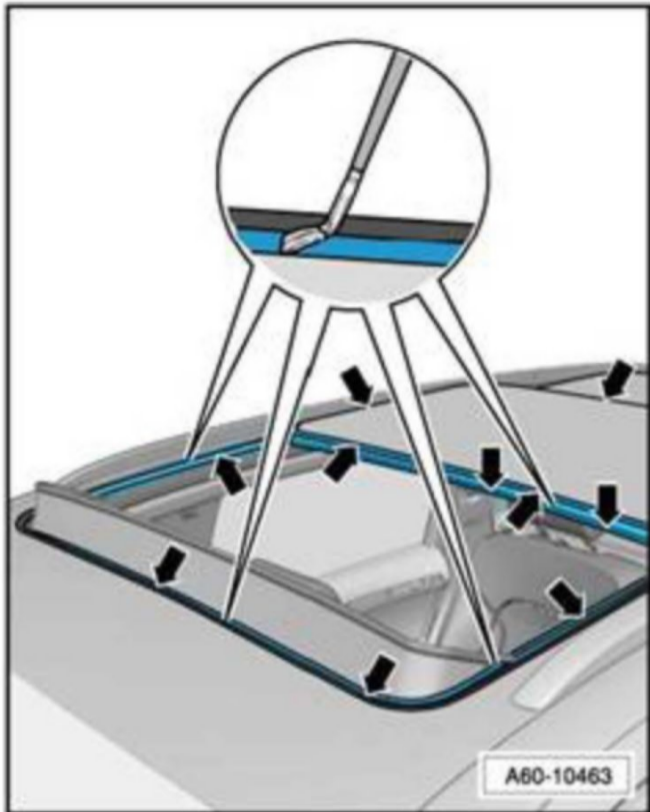
**Figure 34.** Lubrication of the seals.

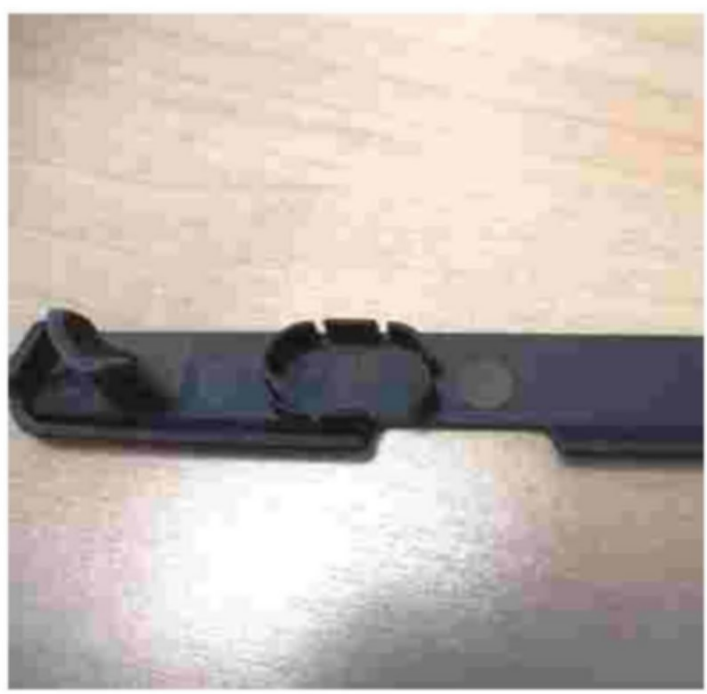
**Figure 36.** *Intact sunroof trim.*

3. Another source of noise can come from the sunroof panel trim. Make certain that all of the sunroof trim is intact and correctly installed.
