From: Botelho, Michael <michael.botelho@vw.ca>
Sent: March-16-16 2:44 PM
To: Colin Willis
Cc: Ireland, Greg; Schnuelle, Ingo
Subject: Ticket 1558403_WAUF2CFC5DN089092_4993201

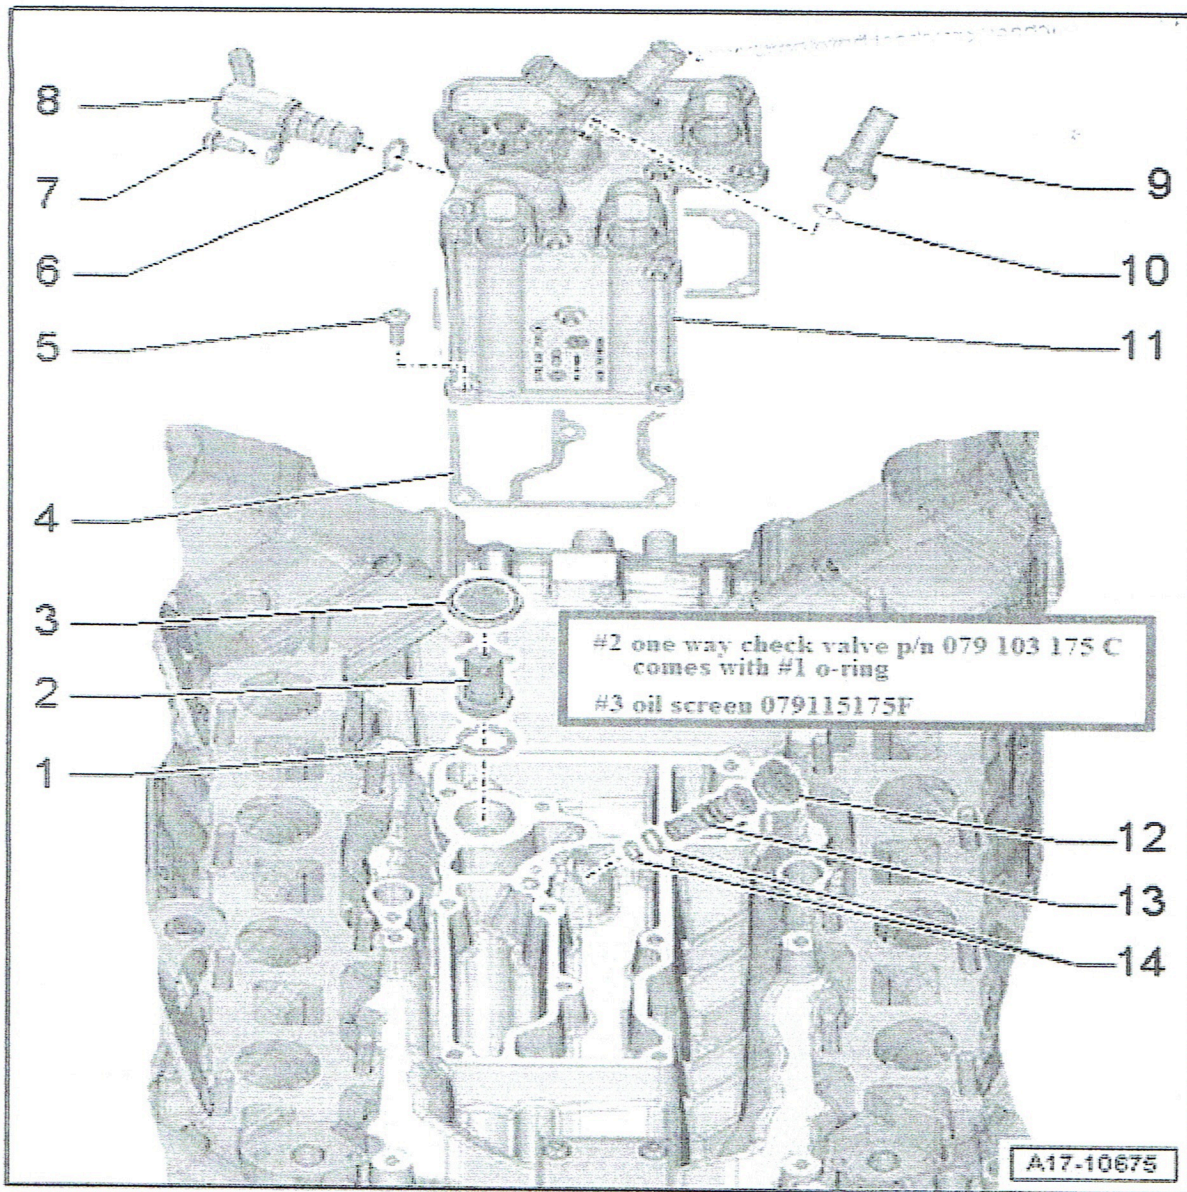
#1 o-ring comes with #2

#2 brass one way check valve 079103175C (comes with o-ring #1)

#3 oil screen 079115175F

#4 breather gasket as per vin.

1. Replace both turbo's ✓
2. Replace the PCV valve ✓
3. Replace both intake manifolds ✓
4. Replace the pistons ✓
5. Replace the spark plugs ✓
6. Change the oil and filter ✓
7. Clean out the turbo oil lines
8. Clean out the intercooler housing
9. Prime the engine before starting (disconnect the crank sensor and crank the engine over)
10. Also replace components 1-4 below as per Elsa.

Can you please package all the old parts and send them in to my attention? if there is any debris on the oil screen, please preserve it as best you can and place it in a plastic bag.
