91 MMI High System software update (Zug 864 - update)  
procedure

Release date: Jul 31, 2009

This document describes the MMI System Software Update procedure (also called Zug Update procedure) for all MMI High-equipped models prior to model year 2009.

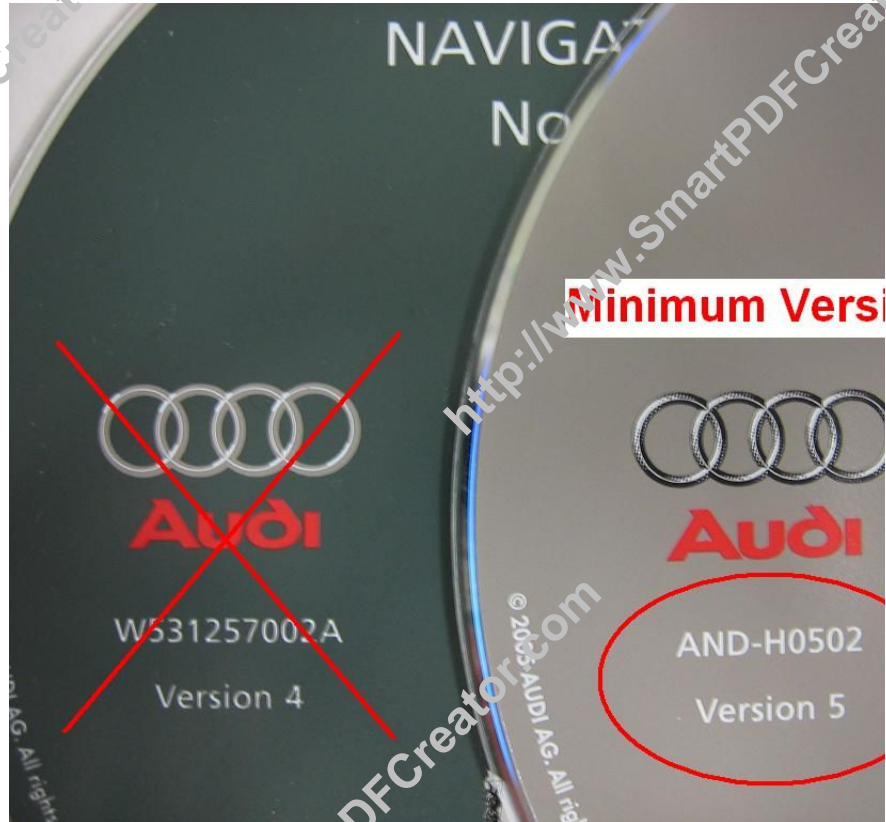
If the Navigation DVD is Version 4, replace it with a Version 5 Navigation DVD.

The Version 5 DVD can be obtained through Navteq at a reduced price.

See details in section Required Parts and Tools
