# Customer pay – MMI System Update

### Verification, if an MMI system update is necessary

## Update procedure

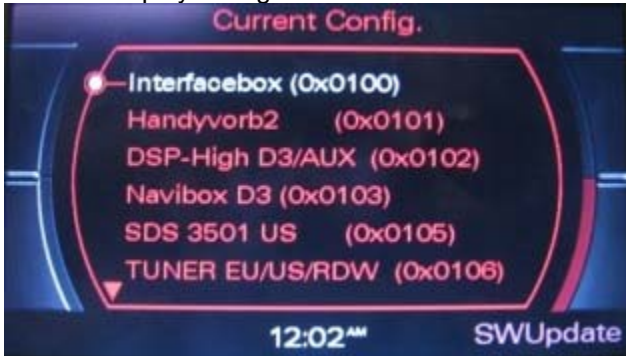
1. Press and hold the SETUP button, then additionally the RETURN button of the MMI controller E380 until the MMI display changes to the red screen.

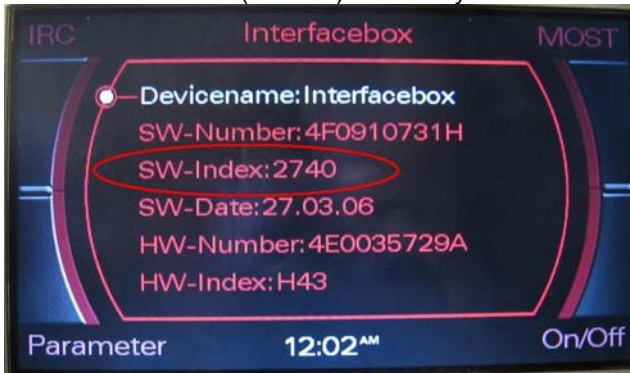
2. Select Interfacebox (0x0100) and verify the SW-Index

(NOTE: This is an **example** for software 2740)

**If the SW-Index is 4140, an update is not required.** The vehicle has the latest version and the customer must not be charged. Reason might be a prior update to the latest Zug software.

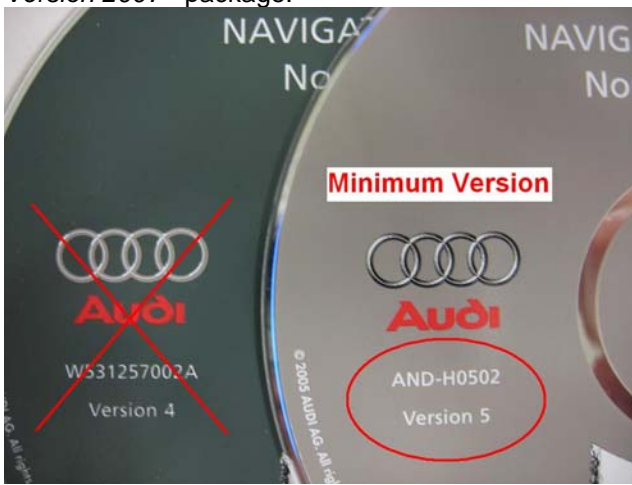
3. In case of a **MY2004/2005 vehicle**: Verify that the **Navigation DVD is at least of Version 5**.  
If the Navigation DVD is Version 4, the customer must purchase the *MMI System Update + Navigation DVD Version 2007* - package.

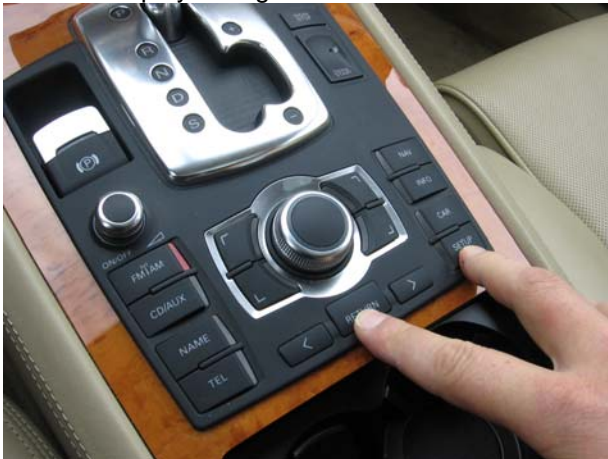
1. Connect a battery charger/maintainer to the appropriate studs in the vehicle.
2. Write down the following Adaptation values in 07 – Display/Control unit for subsequent verification  
1, 2, 3, 4, 11, 12, 16
3. Install the MMI Update CD in the first slot of the CD changer.  
Note: Eject potentially installed CD's beforehand!
4. Press and hold the SETUP button, then additionally the RETURN button of the MMI controller E380 until the MMI display changes to the red screen.

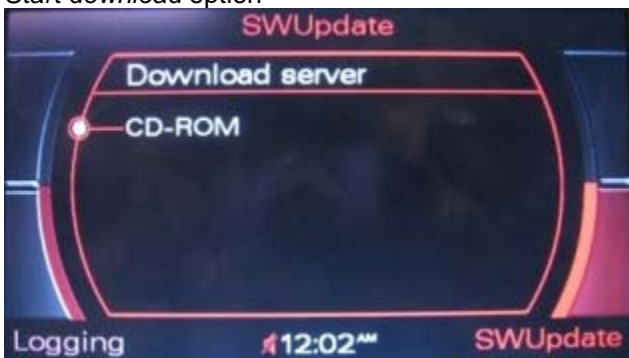
5. Select **SWUpdate** with the lower right soft key and navigate with the Main knob through the menus to the *Start download* option

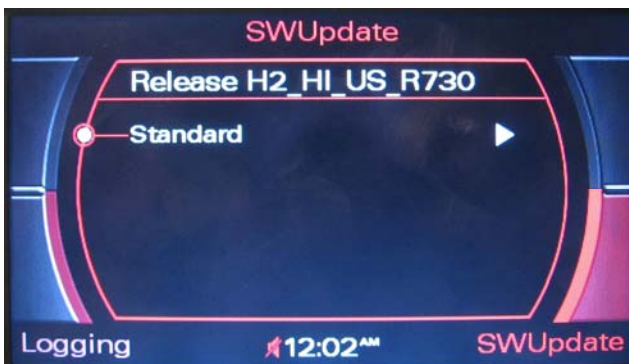
Select *CD-ROM*

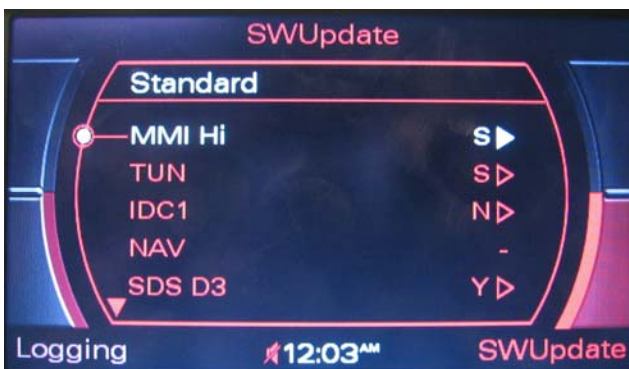
Select *Standard*

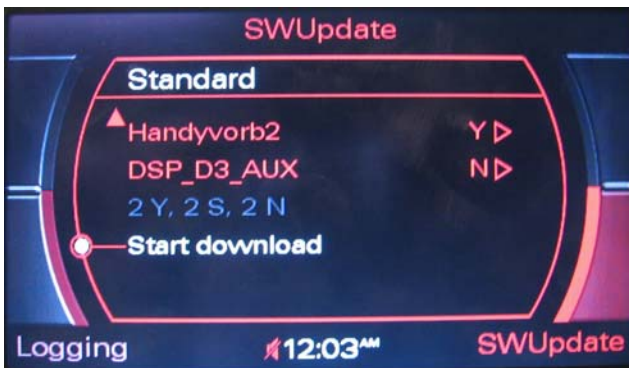
Scroll down to *Start download*

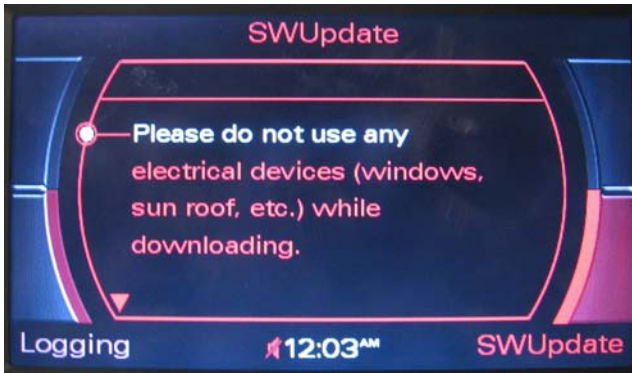
Select *Start download*

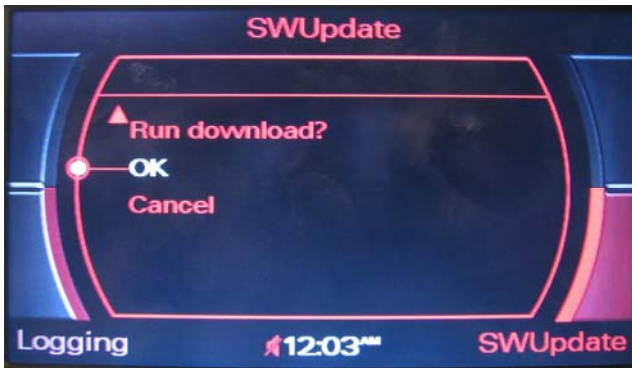
Obey the displayed warning, scroll down ...

... and accept the *Run download?* - request.

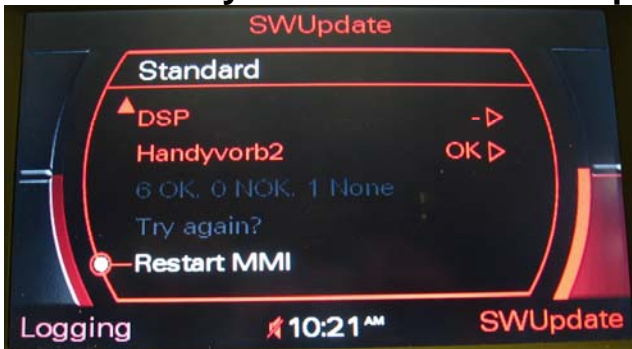
**Note: The SW Update can take up to 80 minutes and usually runs automatically. However check the progress every 20 minutes.**

After the Update press *Restart MMI*

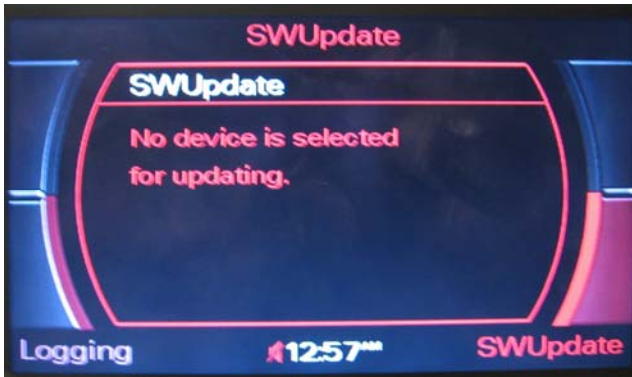
6. In some cases not all MMI components are updated in the first update. **To ensure that all components are updated, repeat the update procedure, until the following message is displayed after accepting the *Run download?* request.**
