Technical Service Bulletin

00 Software Version Management (SVM), operating instructions

00 10 02 2011732/8 March 24, 2010. Supersedes Technical Service Bulletin Group 01 number 09-06 dated May 13, 2009 for reasons listed below.

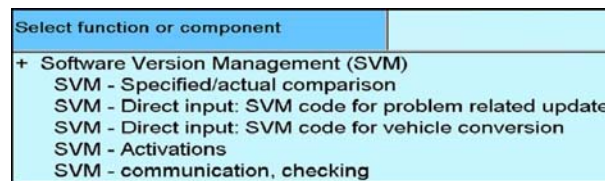
Figure 1. SVM options.

SVM is a function within GFF with the options illustrated in Figure 1 and explained below.

SVM – Specified/actual comparison

After comparing the actual data within the vehicle's control units to the data specified in the SVM database for that specific vehicle, this function will:

- Document changes to hardware or software part numbers; hardware levels; or software levels contained in any of the vehicle's control modules.
- Suggest repair solutions such as coding changes, parameterization changes, or hardware replacements.
