Your Vehicle: 2010 Audi Q7 Quattro (4LB) V6-3.0L DSL Turbo (CATA)

Reduction Agent Injector, Checking

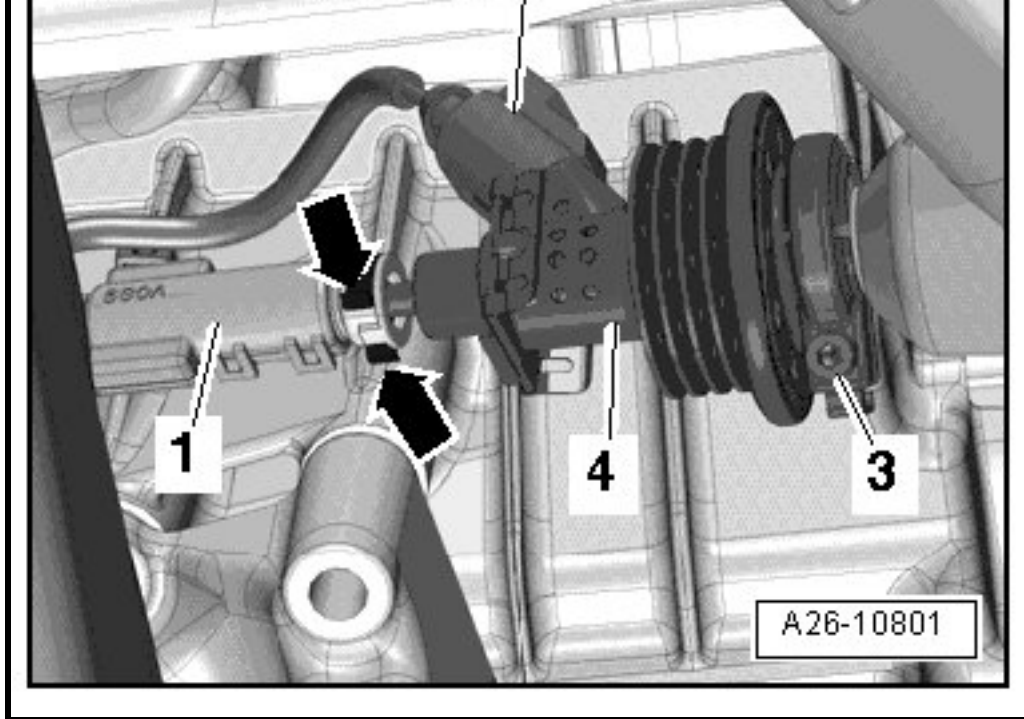
- Disconnect the Reducing Agent Injector (N474) electrical harness connector.- 2 -

If the specified value was Not obtained replace the Reducing Agent Injector (N474).
