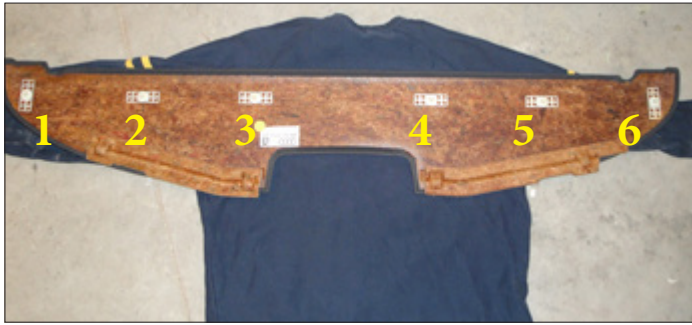
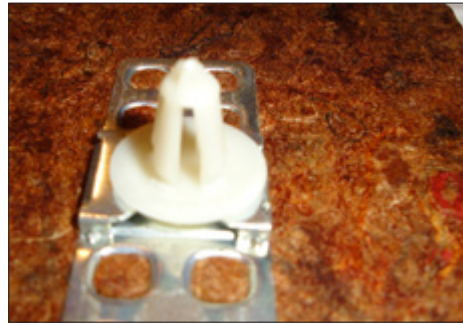
**Step One:** Remove the roller shade cover. There are six push clips along the front of the cover that hold it in place. Start on an end and work your way across the shade cover. The metal L brackets the holds cover in place is circled.

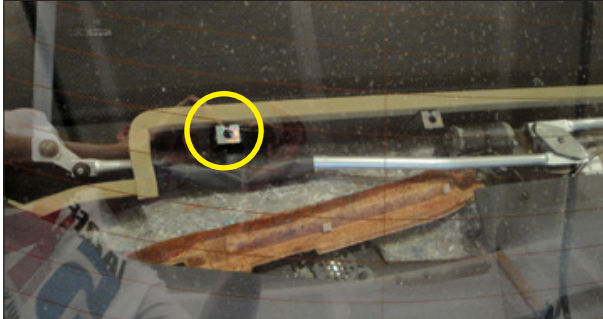
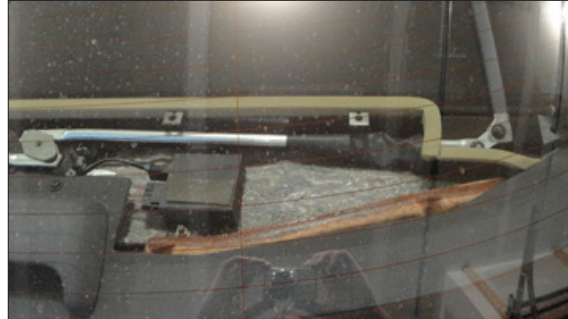
**Step Two:** There is a rubber plug that the shade sits in when it's retracted. I noticed the rubber plug had developed a very deep impression and the metal bracket that was suppose to stop the shade from being pulled back to far had shifted over time and the shade was slipping past it. Photo below shows shade retracted and missing the metal bracket. Rubber plug right above it. I took a pliers and bent it back into place so it would stop the shade. I also turned the rubber plug 90 degrees so the shade was not hitting in the indented area of the plug. Test the shade up and down to make sure shade hits the metal bracket and moves smoothly.

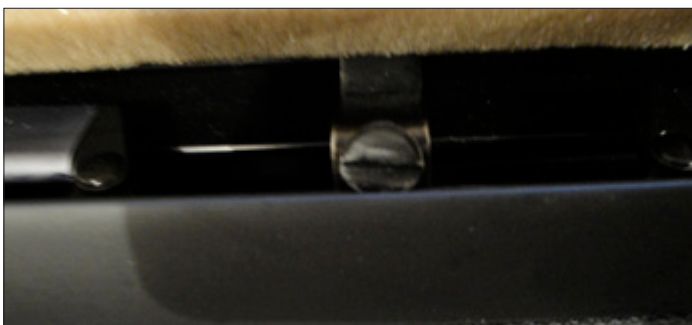
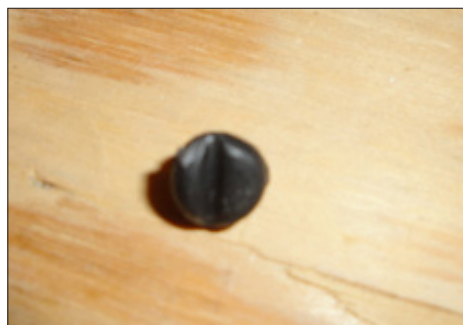
**Step Three:** When reinstalling the roller shade cover I only pushed in one push clip (clip #3) to hold in the shade cover in place. I found that by using just the one clip, it held the cover in place and it allowed the shade to move up and down easier. I figured with the roller shade motor over 13 years olds anything to make its job easier is a good decision. I've enjoyed over a month of perfect roller shade operation.

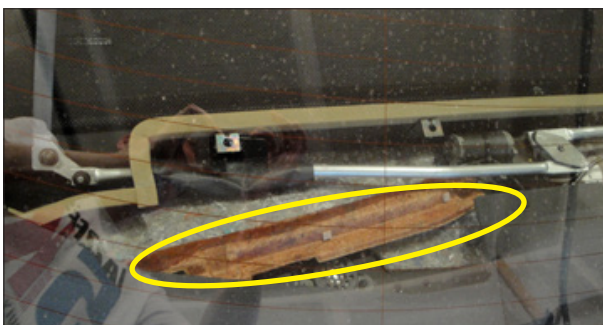
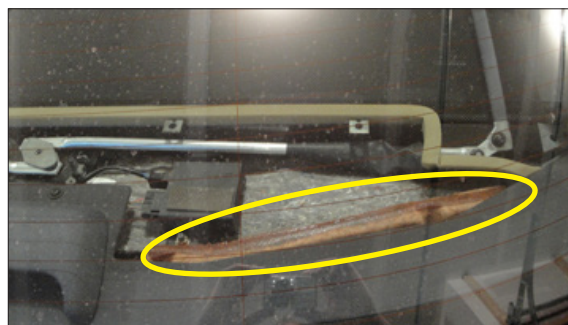
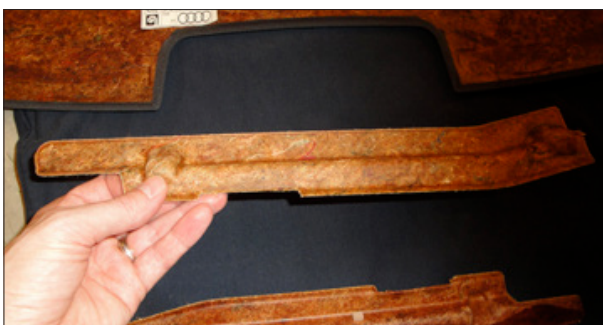
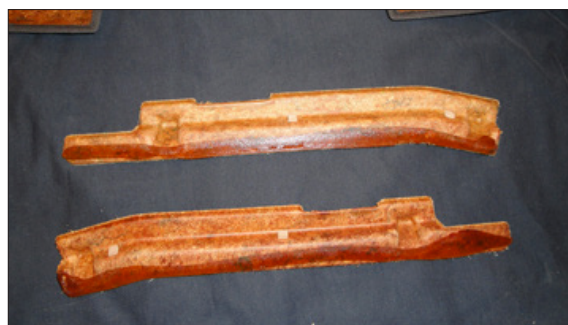
As for that annoying rattle I mentioned earlier. If you looked carefully on the second set of photos there are two brown color objects laying on the rear shelf.

It seemed that over time the glue that held the two objects in place failed and left the two objects laying on the metal rear shelf. When ever I went over a bump or rough surface the two objects would mover around causing the rattle. Once the two objects were removed; the rattle was gone.
