Technical Service Bulletin

01 MIL on (P0491 and P0492 stored at same time

01 16 69 2033001/8 July 27, 2016. Supersedes Technical Service Bulletin Group 01 number 14-97 dated October 2, 2014 for reasons listed below.

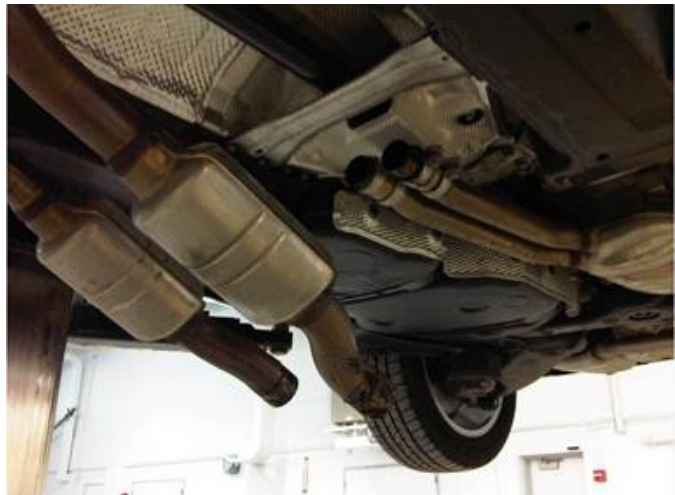
Figure 7. Lowered catalytic converter pipes

1. Move the exhaust sliding bushings (that connect the catalytic converter and muffler) back, then lower the catalytic converter pipes (Figure 7).

For Q7, unbolt muffler from catalytic converter. Cover mufflers with plastic bag to prevent water from entering.

Cleaning water will drain out of the catalytic converter pipes during the cleaning process.

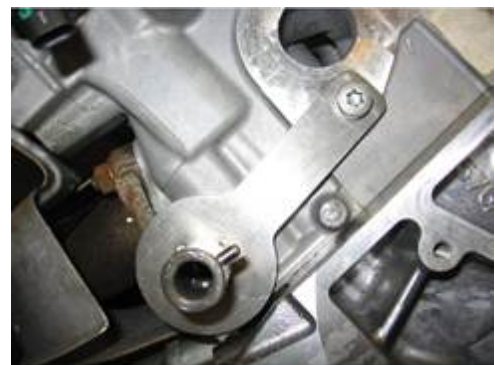
Figure 13. Engine adaptor on bank one.

2. To catch water, put a pan under the front of the engine and under the disconnected catalytic converter pipes.
3. Install engine adaptors on the appropriate banks (Figure 13, Figure 14).

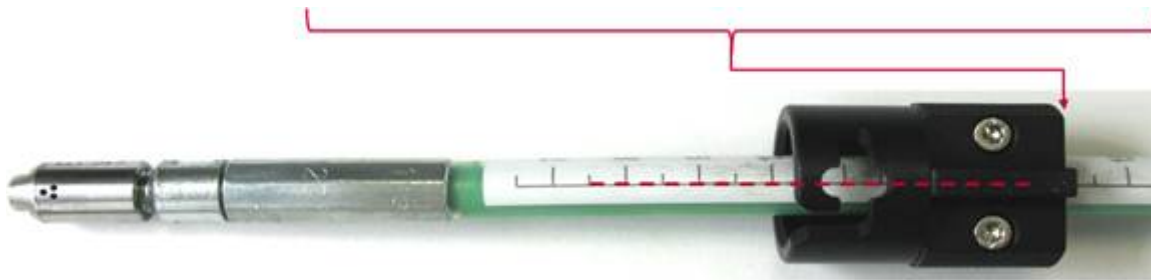
1. Because every port has a different distance to the cylinder head, use the table below to position the hose adaptor for the special single port cleaning hose (the hose with the scale) correctly into the hose. The back side of the hose adaptor must align with the number on the scale of the cylinder to be cleaned (Figure 14). The longitudinal slot on the hose adaptor must align with the black line on the scale for correct rotational positioning (Figure 15).

Dimensions Port	1	2	3
Bank One	10.5	19.5	28.5
Bank Two	13.7	22.7	31.8

Figure 15: Arrow indicating how the back side of the adaptor must align with the scale. Red dotted line indicating how the longitudinal slot must align with the black line on the scale.

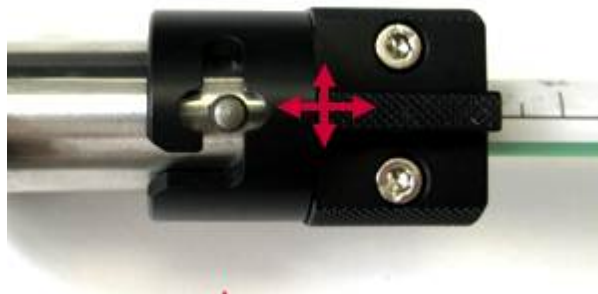
Figure 16. Locking position / transvers longitudinal movement and of the hose adaptor

2. After adjusting the position of the hose adaptor, insert the special single port cleaning hose into the hose adaptor, and bring it back into locking position (Figure 16).

3. While cleaning, make sure that the pressure washer is supplying pressure greater than 1800 psi.
4. Based on the washer's pressure, clean the port based on the table below. While cleaning, continuously move the hose adaptor within the longitudinal and transvers slots (Figure 16).

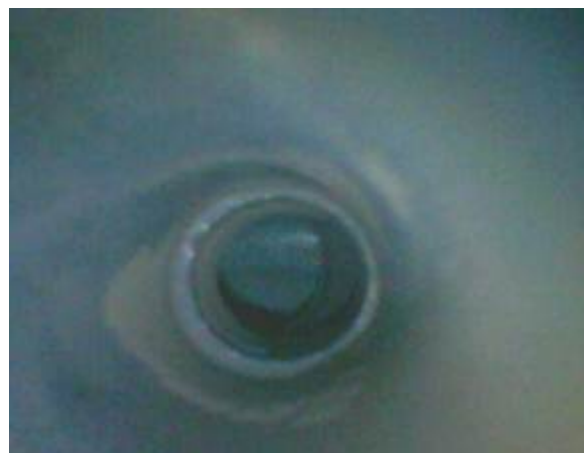
Figure 17. Clean single port.

5. Do the same for all remaining cylinders.
6. It is recommended that after cleaning, all single ports are checked with snap-on boroscope BK6000 (or similar, with 90-degree lens), to make sure all ports are clean (Figure 17).
