## Checking ATF level

### Special tools and workshop equipment required

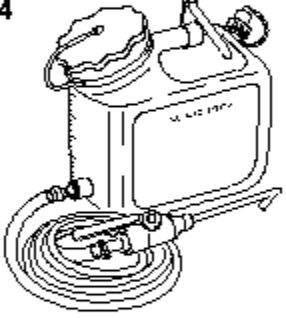
<p style="text-align: right;">G37-10017</p>

<p><b>VAS 5051 B</b></p>

<p><b>V.A.G 1782</b></p>

<p><b>V.A.G 1924</b></p>

- ◆ Vehicle diagnostic, testing and information system -VAS 5051B-
- ◆ Used oil collection and extraction unit -V.A.G 1782-
- ◆ ATF filling unit -V.A.G 1924-
- ◆ Safety goggles
