Model description: **Q5 quat. 2.0 R4185/DQ5A7**

Technical Service Bulletin

Transaction No.: **2053028/1**

91 Top view camera setting changes to graphic view intermittently after startup

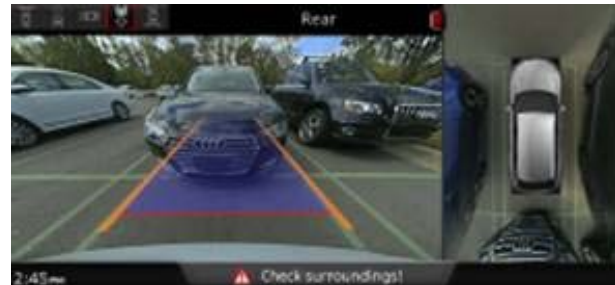
- When the reversing camera is active showing the Top view camera to the right, the display changes intermittently at startup from camera view to graphic view. Compare the images to the right (Figure 1 and 2).

Figure 1. Correct camera view.

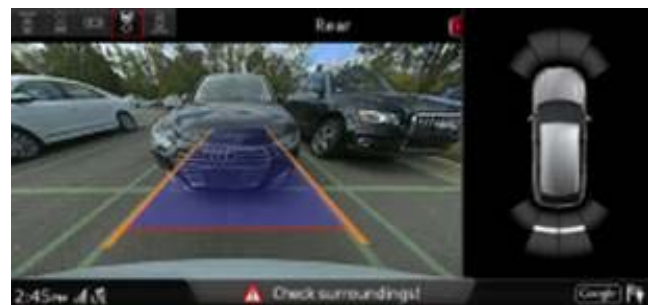
Figure 2. Incorrect graphic view.

The software needs to be updated. The optimized software will correct the view switch.

New software in the information electronics control module 1, J794 (address word 005F) addressed the condition.

1. Follow all instructions in TSB 2011732: *00 Software Version Management (SVM), operating instructions* and TSB 2047812: *00 SD Creator: How to setup and use the SD Creator for obtaining vehicle software updates via the MirrorServer*.
2. Update the information electronics control module 1, J794 (address word 005F)) using the SVM action code as listed in the table below, if necessary:
